Product Update: 2023 HR-V Rear Window Inspection

BACKGROUND

During the assembly process for some vehicles, the sealer used to secure the rear glass have contacted the defroster heating elements. This can lead to a hot-spot and the weakening of the glass over time as the defroster is used.

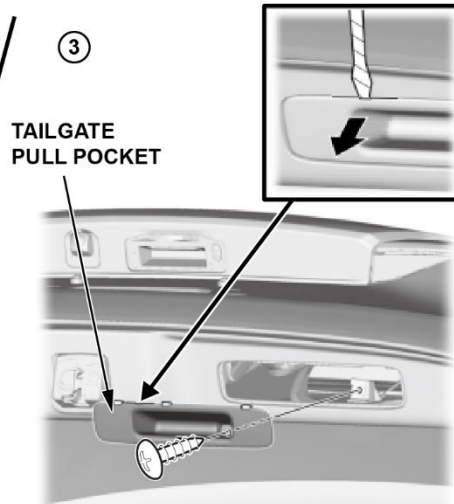
1. Lift the tailgate and remove the following trim pieces:

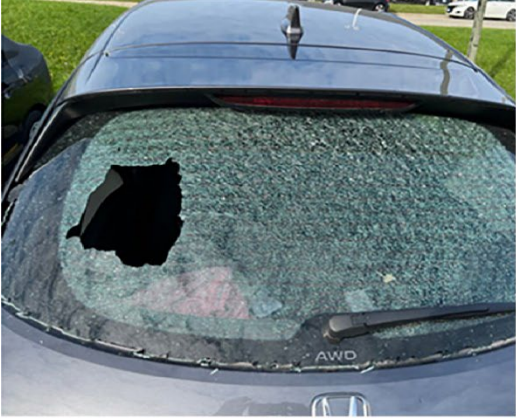
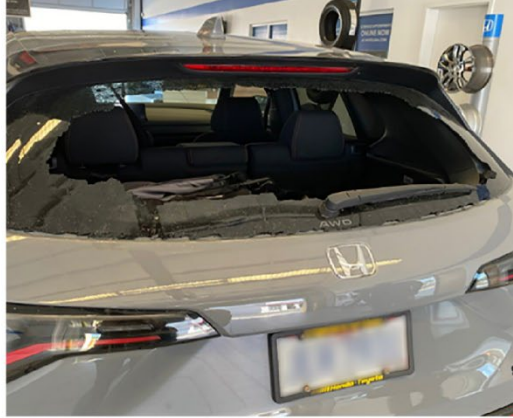
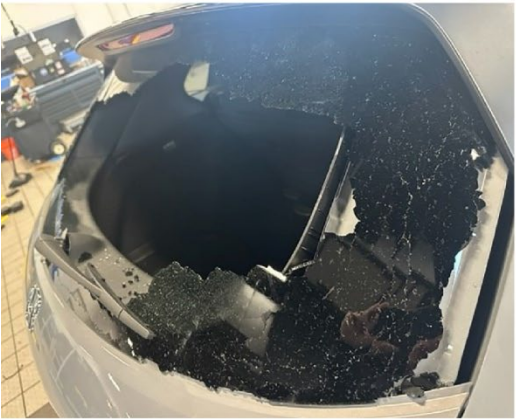
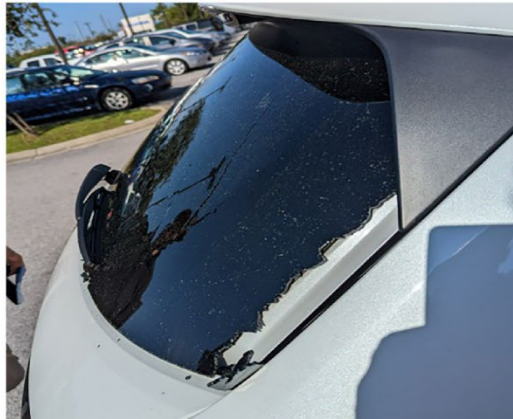
NOTE: Make sure that the vehicle does not have any visual body damage that could have caused the rear glass to shatter.

1. Take a photo of the **VIN plate** plus **two photos** of the broken windshield and upload to the warranty claim.
2. Clean any debris in the rear cargo area, and inside of the rear tailgate, caused by the shattered glass.
3. If there are no signs of damage to the bumpers, tailgate, wiper, or body alignment issues, and the tailgate opens and closes properly, go to the **REPAIR PROCEDURE** and replace the rear windshield glass.

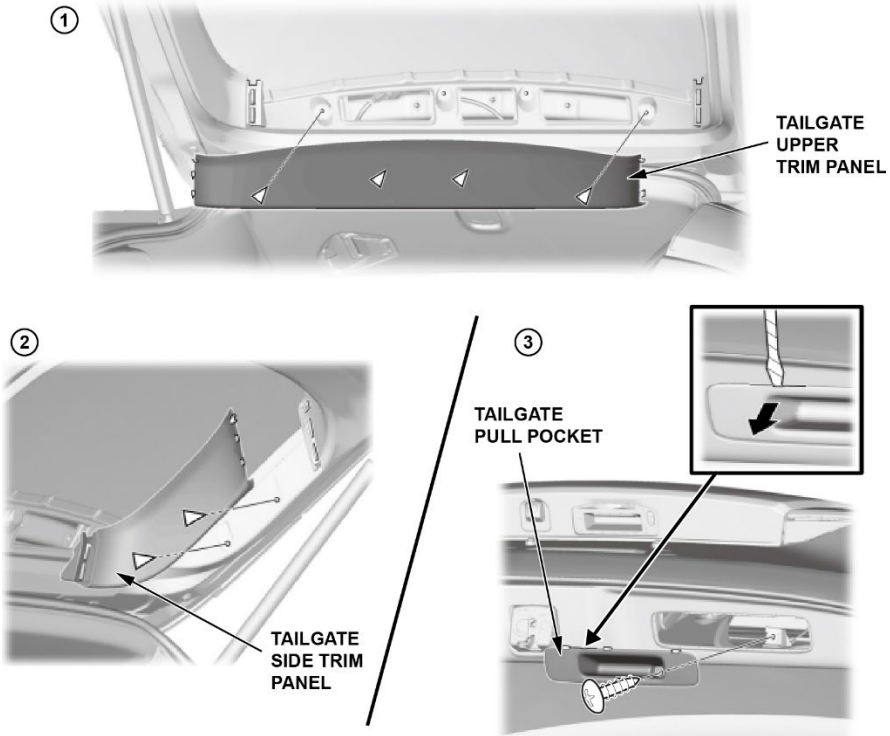
1. Lift the tailgate and remove the following trim pieces:

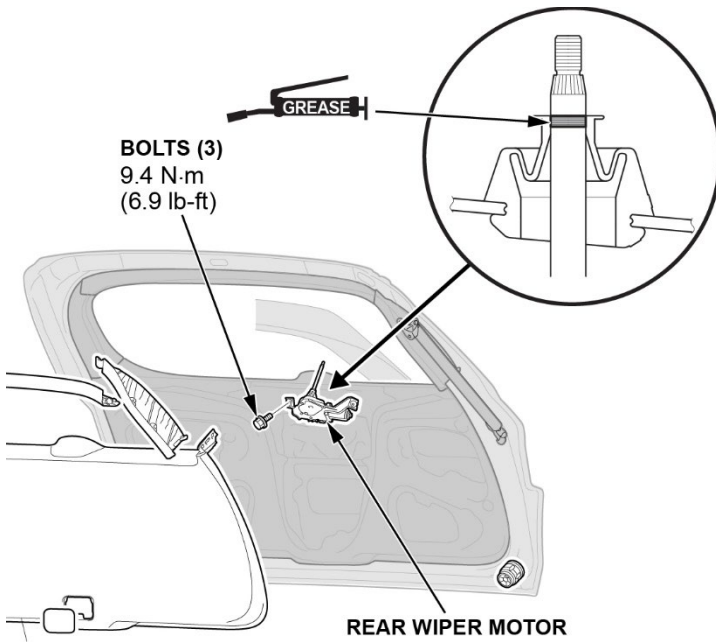
5. Remove the rear wiper motor.

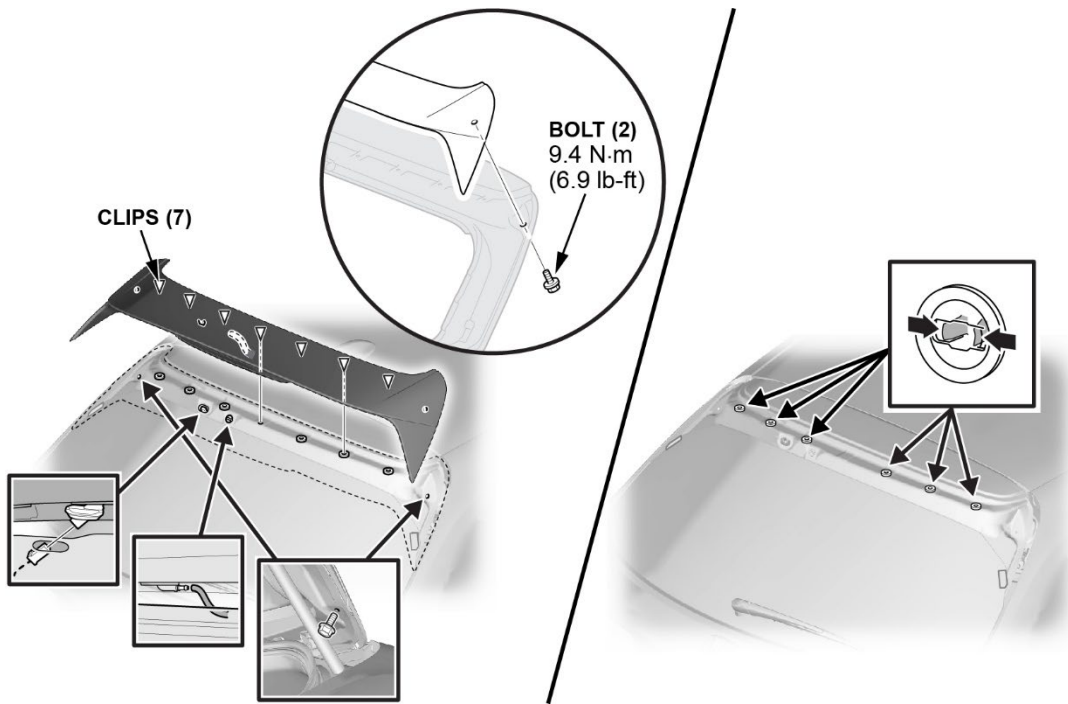
6. Remove the tailgate spoiler.

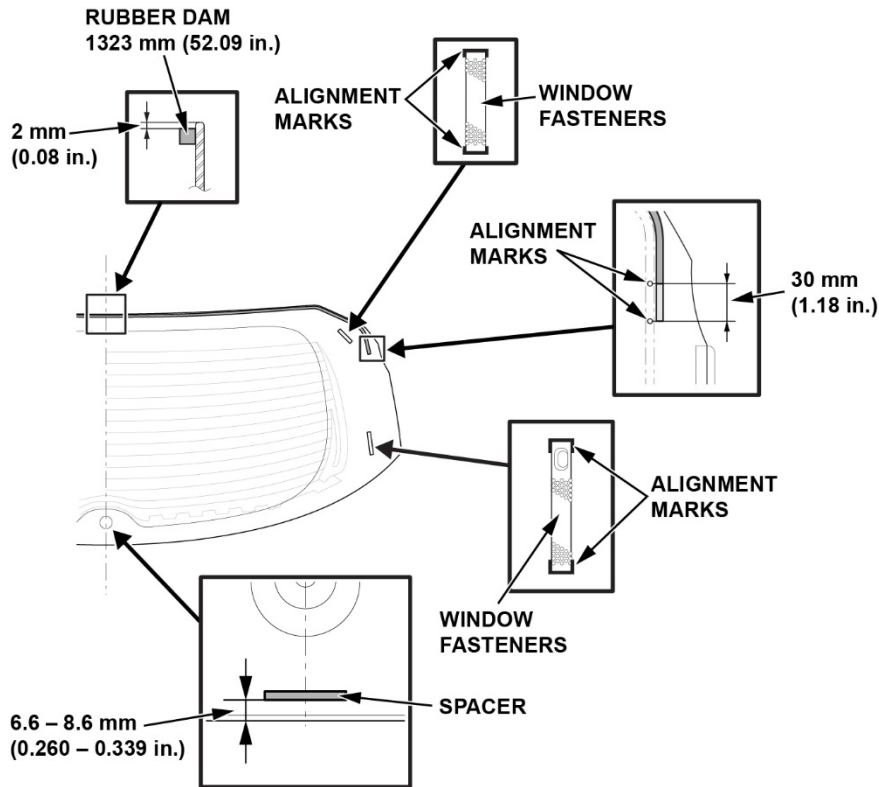
14. Install the following on the new glass:

- Before installing the fasteners and spacer, apply glass primer to the area where the adhesive tape will be applied.
- **Do not** touch the rear window where the adhesive will be applied.
- Make sure all fasteners line up with the alignment marks.

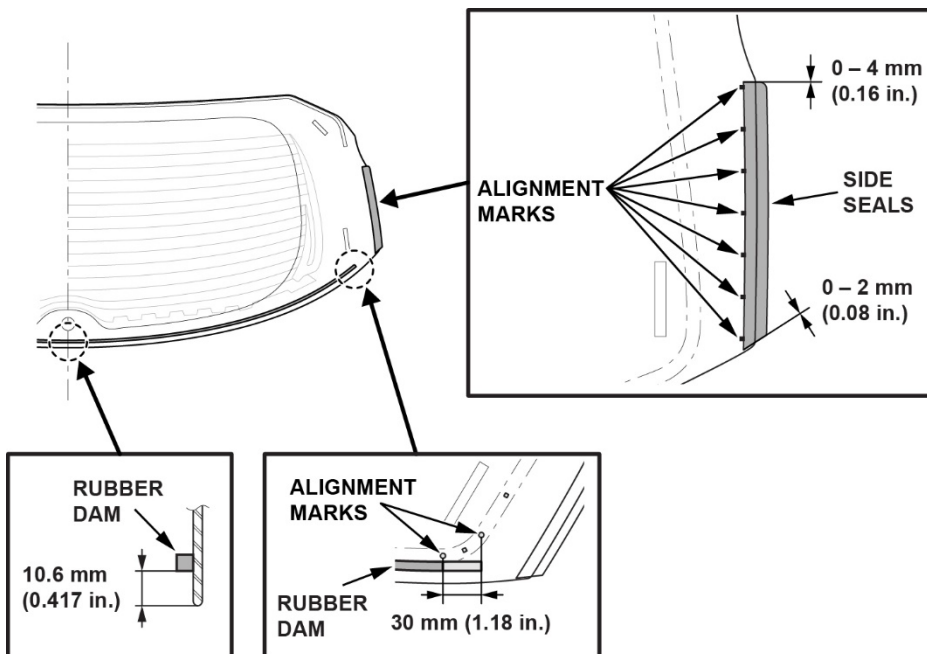
15. Install the rubber dams and side seals with adhesive tape on the inside facing of the rear window.

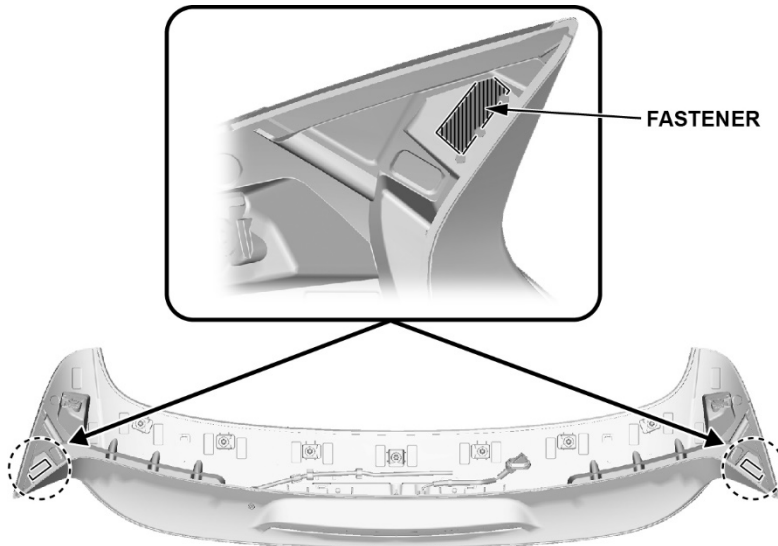
22. Install the remaining parts in reverse order.

- Clean the fastener surface and prevent oil, grease, or water from getting on the surface.
- Inspect the fastener and replace if it is distorted.
- Before installing a new fastener, apply primer to the area where the adhesive tape will be applied.
