STAR ONLINE PUBLICATION

Case Number: S2409000003

Symptom/Vehicle Issue: Engine Oil Leak

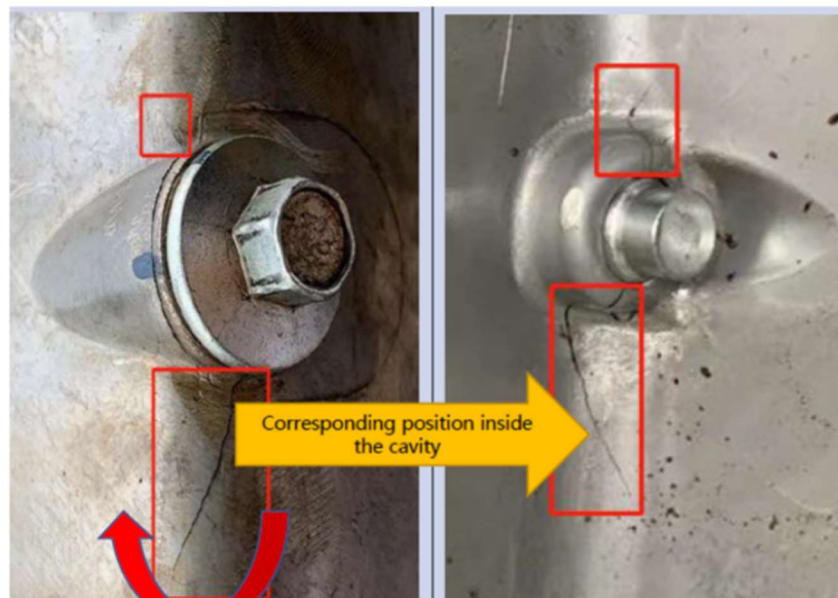
Discussion: Upon inspection, tech may find a crack at the oil pan drain plug area (Fig. 1). Repair as necessary. R&R oil pan according to service information published in Service Library. Oil drain plug should be torqued to 27Nm \pm 3Nm (20Ft/Lbs).

Note: Oil pan drain plug should NEVER be installed with power tools
