| RE: <b>Service Campaign Launch Notification</b><br><b>Replace B-Pillar Certification Label</b><br><b>MY20-24 G-Class (463 platform)</b> | DATE: July 12, 2024 |

# Service Campaign Bulletin

Campaign No. 2024060020, July 2024

## **Replace B-Pillar Certification Label**

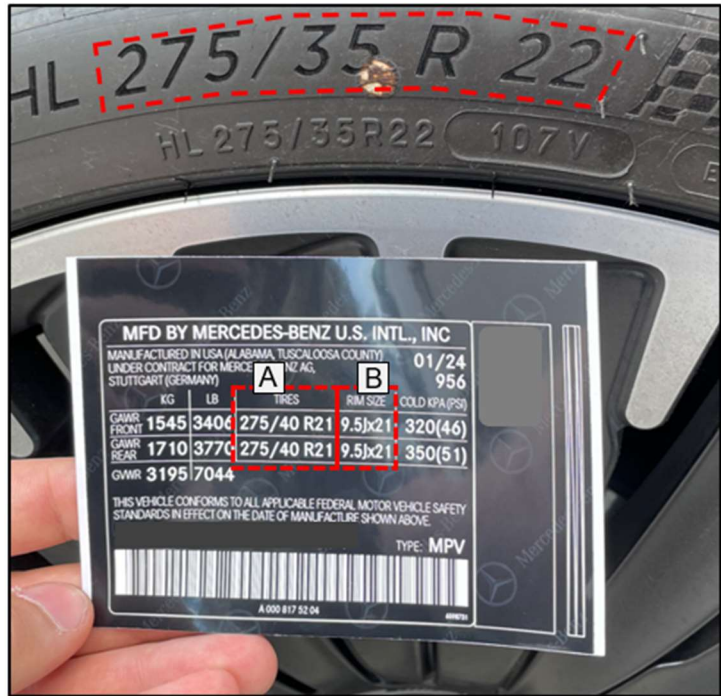
Figure 1

1. Check B-Pillar label TIRES (**Figure 1, A**) and RIM SIZE (**Figure 1, B**) information.

**i** **NOTE:** TIRES and RIM SIZE information must match the tires and rims installed on the vehicle from factory!

- a. If TIRES and/or RIM SIZE information is **INCORRECT** (**Figure 1**), return label to your dealer-facing PDC using the “SCM authorized special return in Paragon”.

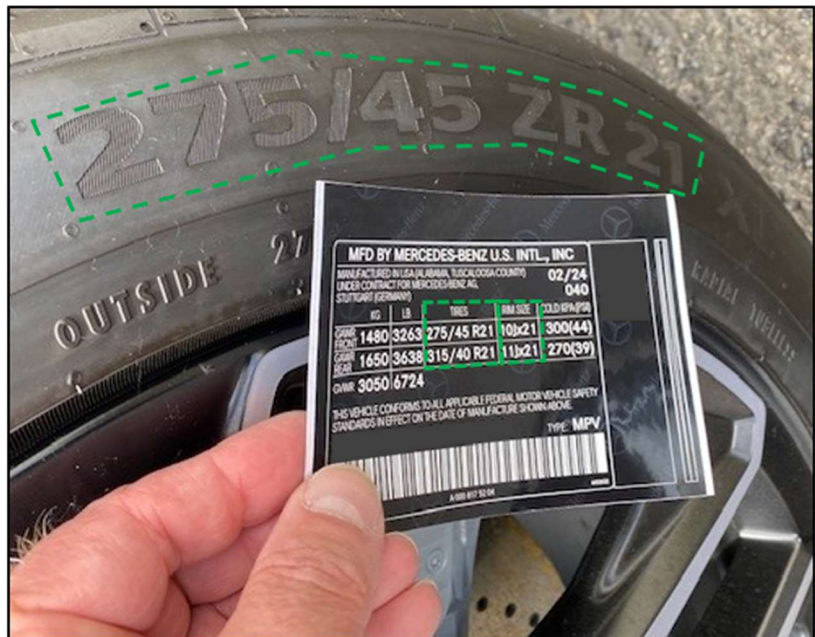
Figure 2

- b. If TIRES and RIM SIZE information is **CORRECT** (**Figure 2**) continue to **Work Procedure**.

**i** **Note:** If the vehicle is equipped with staggered TIRES and RIM SIZE, confirm both front and rear match what is on the vehicle!

1. Replace identification plate on driver's side B-pillar.
  -

Lightly heat identification plate with a commercially available heat gun.
  -

Carefully remove identification plate with a suitable aid.
  -

Clean bonding surface with alcohol based cleaner to remove residual adhesive.
