All Vehicles Equipped with M139: CEL for P012800 - The coolant temperature is below the coolant thermostat specified temperature.

| Topic number | LI20.10-P-076206 |
| Function group | 20.10 - Coolant pump, coolant thermostat |
| Validity | All vehicles with any version of M139 engine |

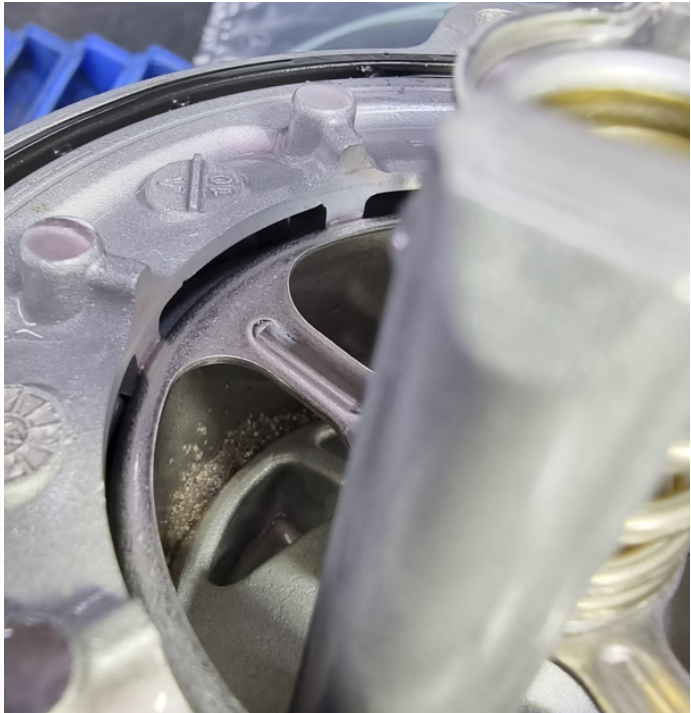
Debris in the coolant system

| Attachments | |
|---|---|
| <a href="#">Debris Aft of Sealing Surface of Thermostat.png</a> | |

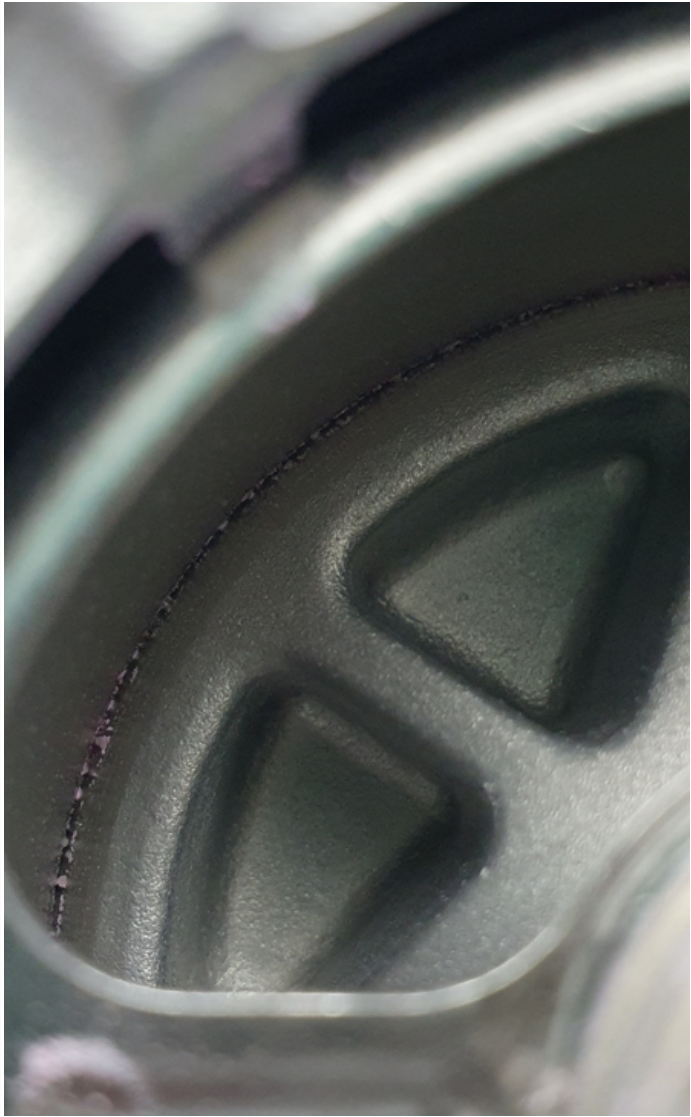
Debris at Interior Sealing Surface of Thermostat.png

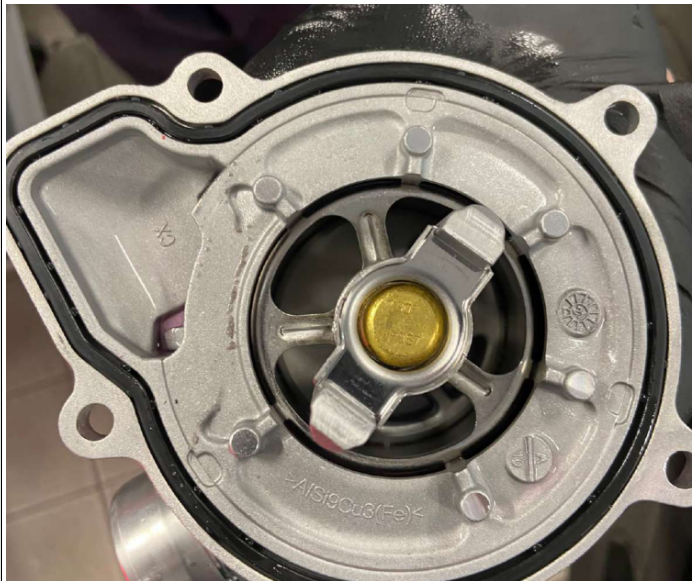
Debris near Mating Surface of Thermostat.png

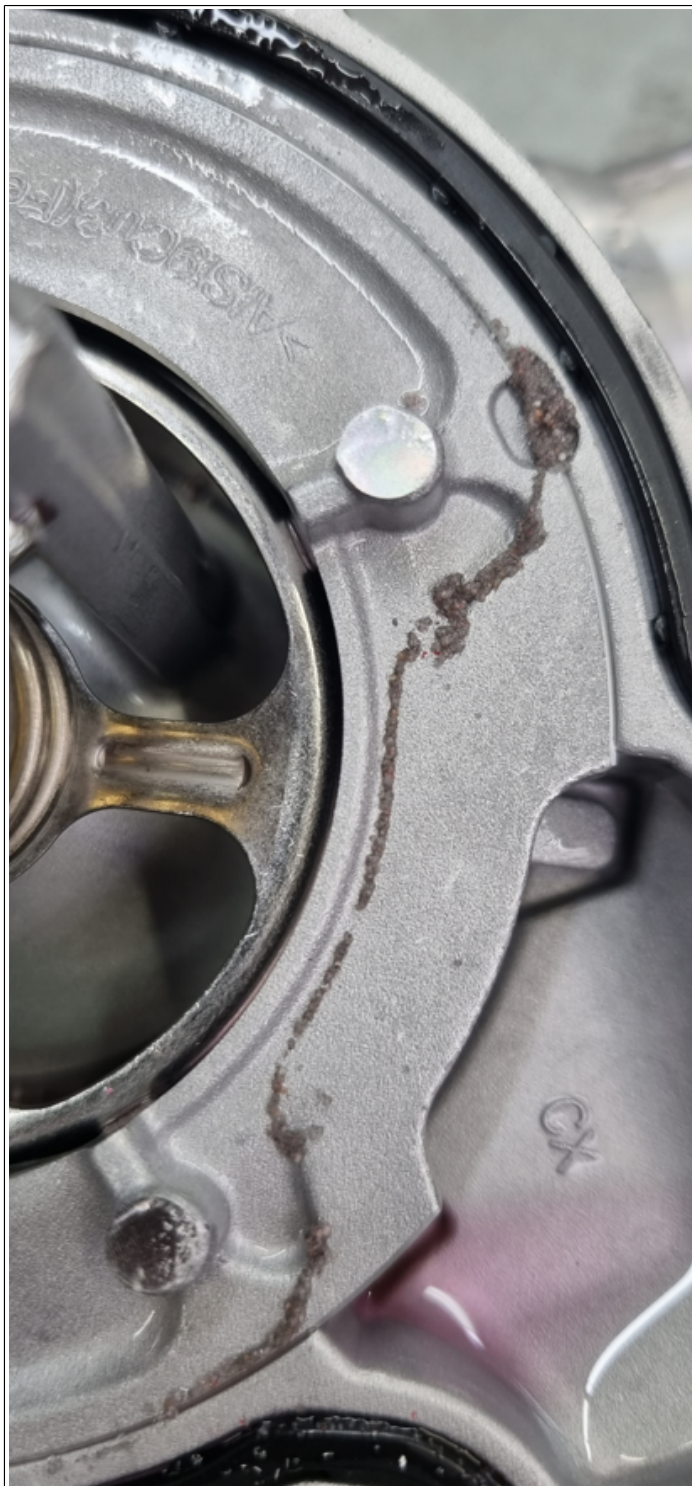
Heavy Debris in Thermostat.png
