| REFERENCE: | TSB: 31-001-24 GROUP: 31 - Collision Bulletins | Date: | July 24, 2024 | REVISION: | 31-001-23 REV. A |
| CUSTOMER SYMPTOM: | Aluminum corrosion or bubbling along the leading edge of hood, hinges or other exterior surface areas of the hinges, doors, fenders, swing gates or liftgates. | | | | |
| CAUSE: | **Corrosion conditions** | | | | |

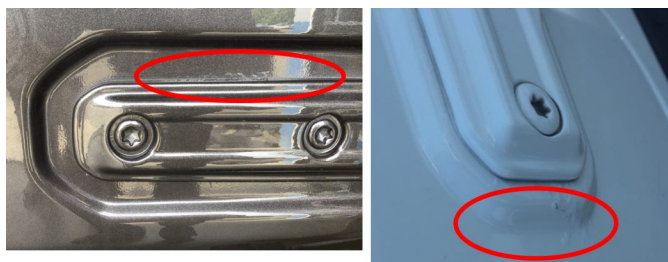
Fig. 2

Aluminum corrosion or bubbling on the doors and/or hinges [Fig. 2](#).

Examples Of Bubbling

Is corrosion evident on the aluminum panel surface [Fig. 2](#) or [Fig. 3](#)?

- YES>>> Consult current warranty policy to determine if digital imaging and/or Regional Office Approval is required before proceeding with repair, Proceed to [Step 1](#) of the diagnosis procedure.
- NO>>> The repair does not apply.

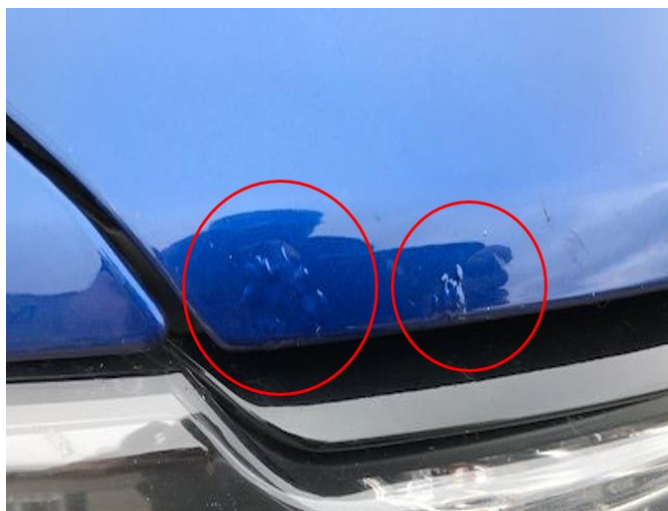
Fig. 3

Aluminum corrosion along the leading edge of hood or other exterior surface areas of the doors, fenders or liftgates [Fig. 2](#) or [Fig. 3](#).

Examples Of Corrosion Along Leading Edges

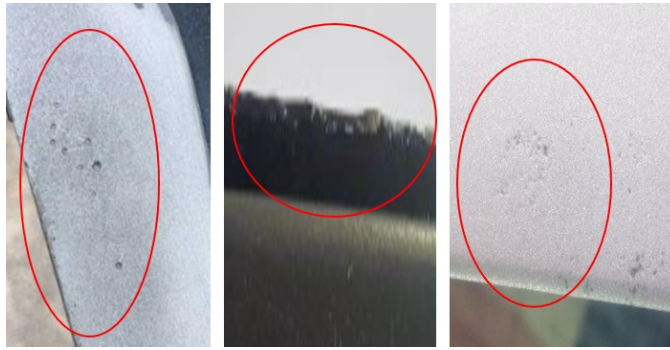
Fig. 4
Corrosion Examples

2. After digital imaging or Regional Office approval and removing the initial blistered paint from the panel surface with 80 grit grinding disc, is severe pitting exhibited that cannot be removed with sandpaper, 3M Clean and Strip Disc or equivalent [Fig. 4](#)?

- YES>>> Replace the panel.
- NO>>> Proceed to [Step 1](#) of the repair procedure.
