**Volvo Chassis - Equipped With A
Cummins CU12 CNG Engine (ONLY)
Displaying/Generating Cummins Code
P2560 Low Engine Coolant Followed By
An Engine Derate When There Is No
Low Coolant Issue**

Valid for Volvo models VNL and VNM, model years 2014 to 2017

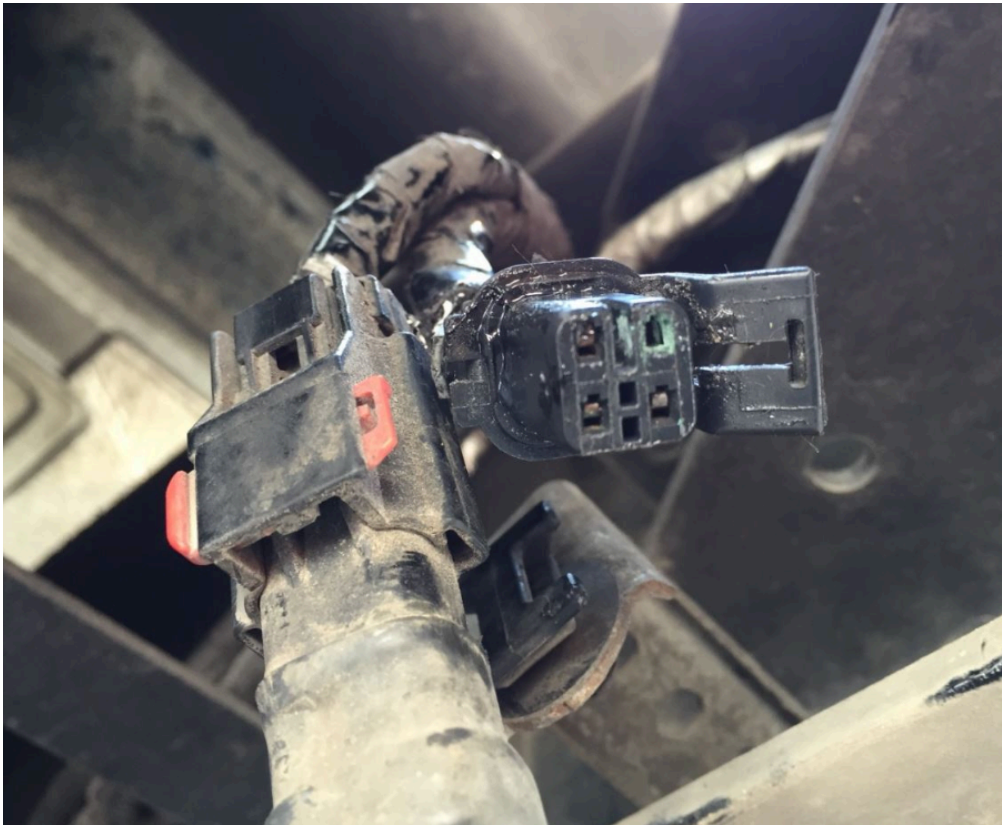
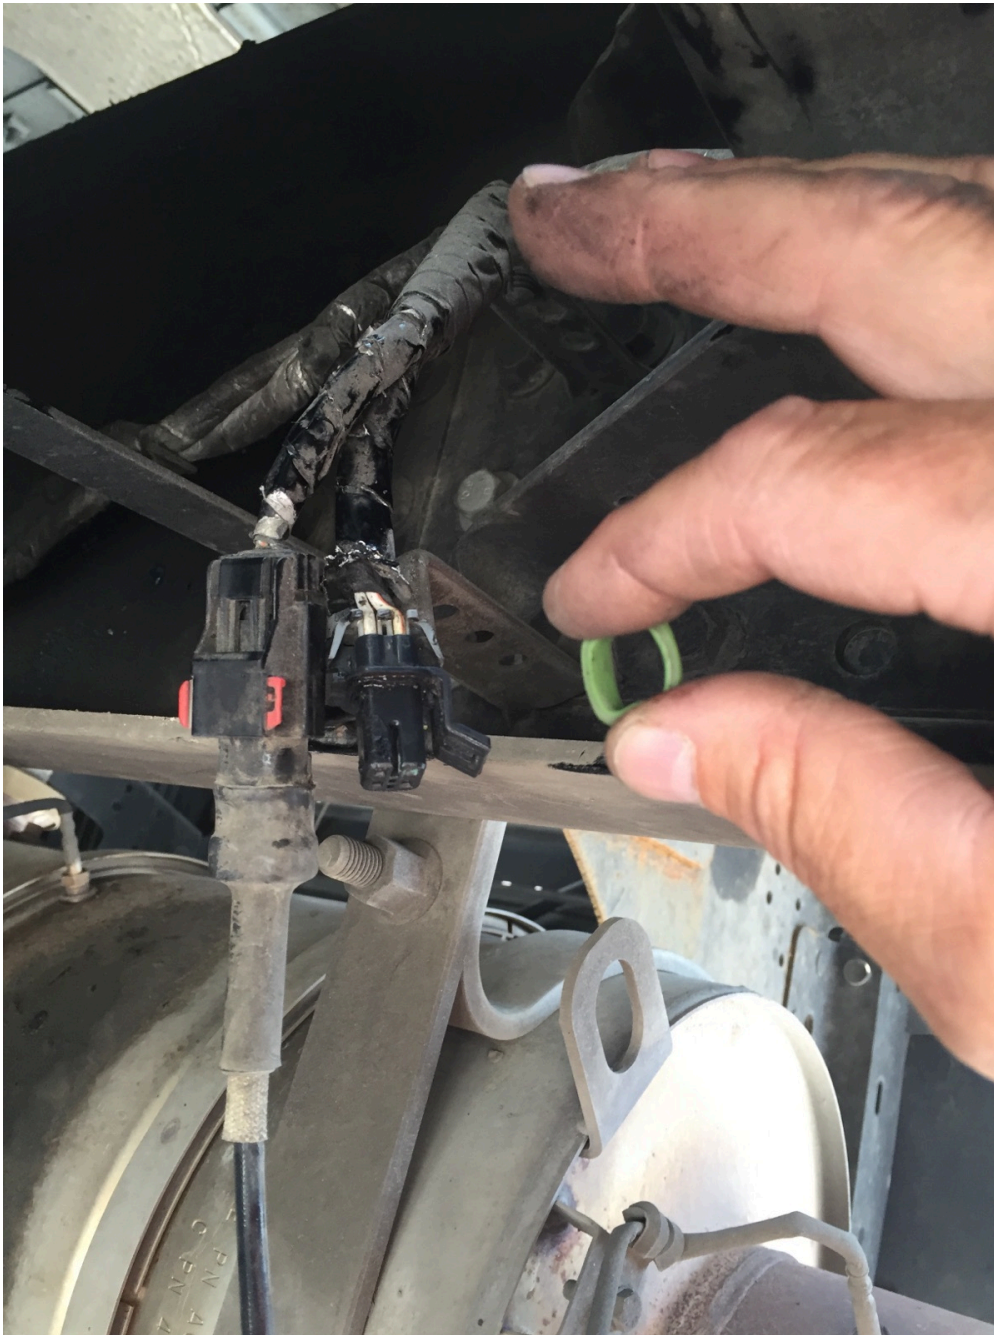
On a Volvo Chassis equipped with a Cummins CU12 CNG Engine that is displaying/generating Cummins Code P2560 Low Engine Coolant and followed by an engine derate when there is actually no low engine coolant issue. It has been confirmed that the possible source could be a corroded Oxygen Sensor circuit at the harness connector pin/socket location causing this issue. The condition of the Oxygen Sensor harness connector pins and sockets need to be inspected to confirm that there is no corrosion or high resistance related issues and that the green connector seal is not missing.

This is important due to the Oxygen Sensor and Low Engine Coolant Sensor using the same circuit and the Low Engine Coolant Sensor, Cummins Code P2560 being the first to be displayed/generated when an Oxygen Sensor circuit resistance issue arises.
