Mack Chassis - Day Cab Glass Breakage

Published 10 July 2024

All Mack day cab trucks, model years 2021 to current.

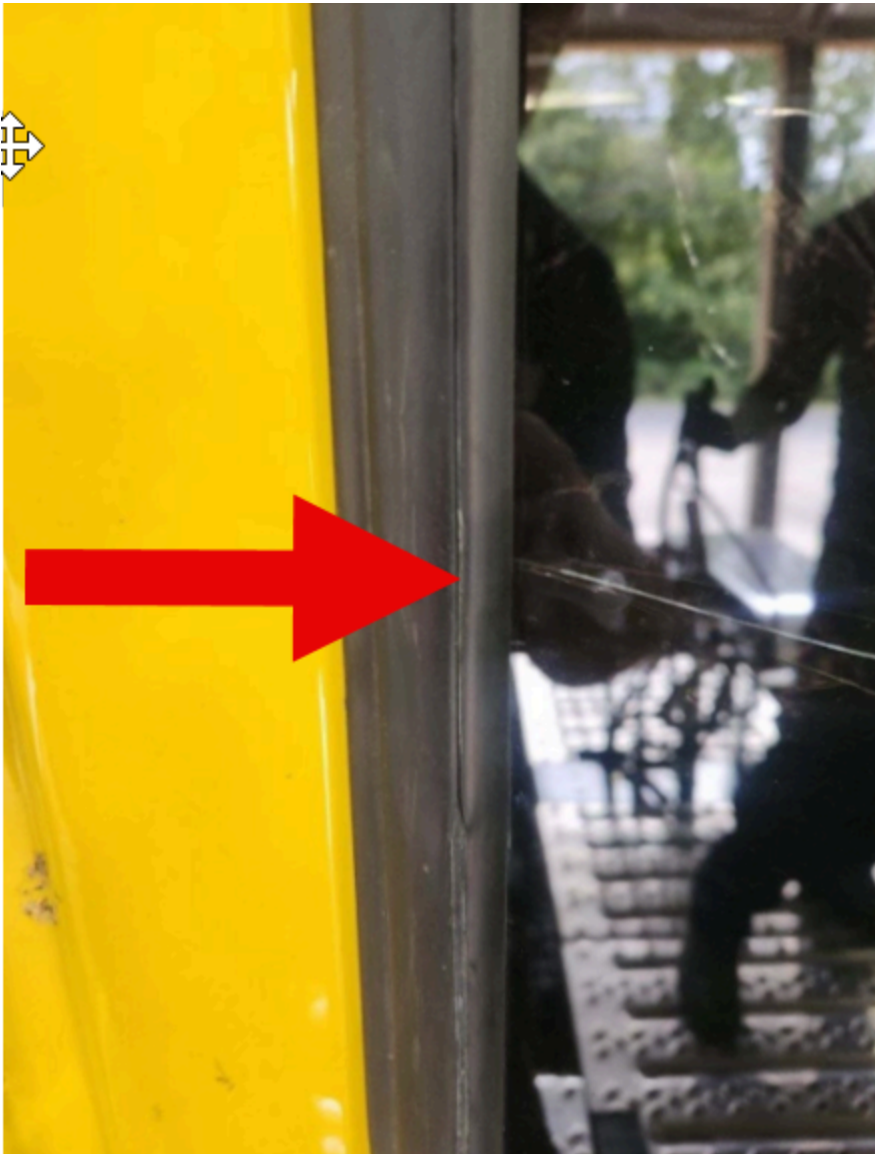
1. Mark on the exterior of the cab the two points at which the glass fractured with tape or paint pen:

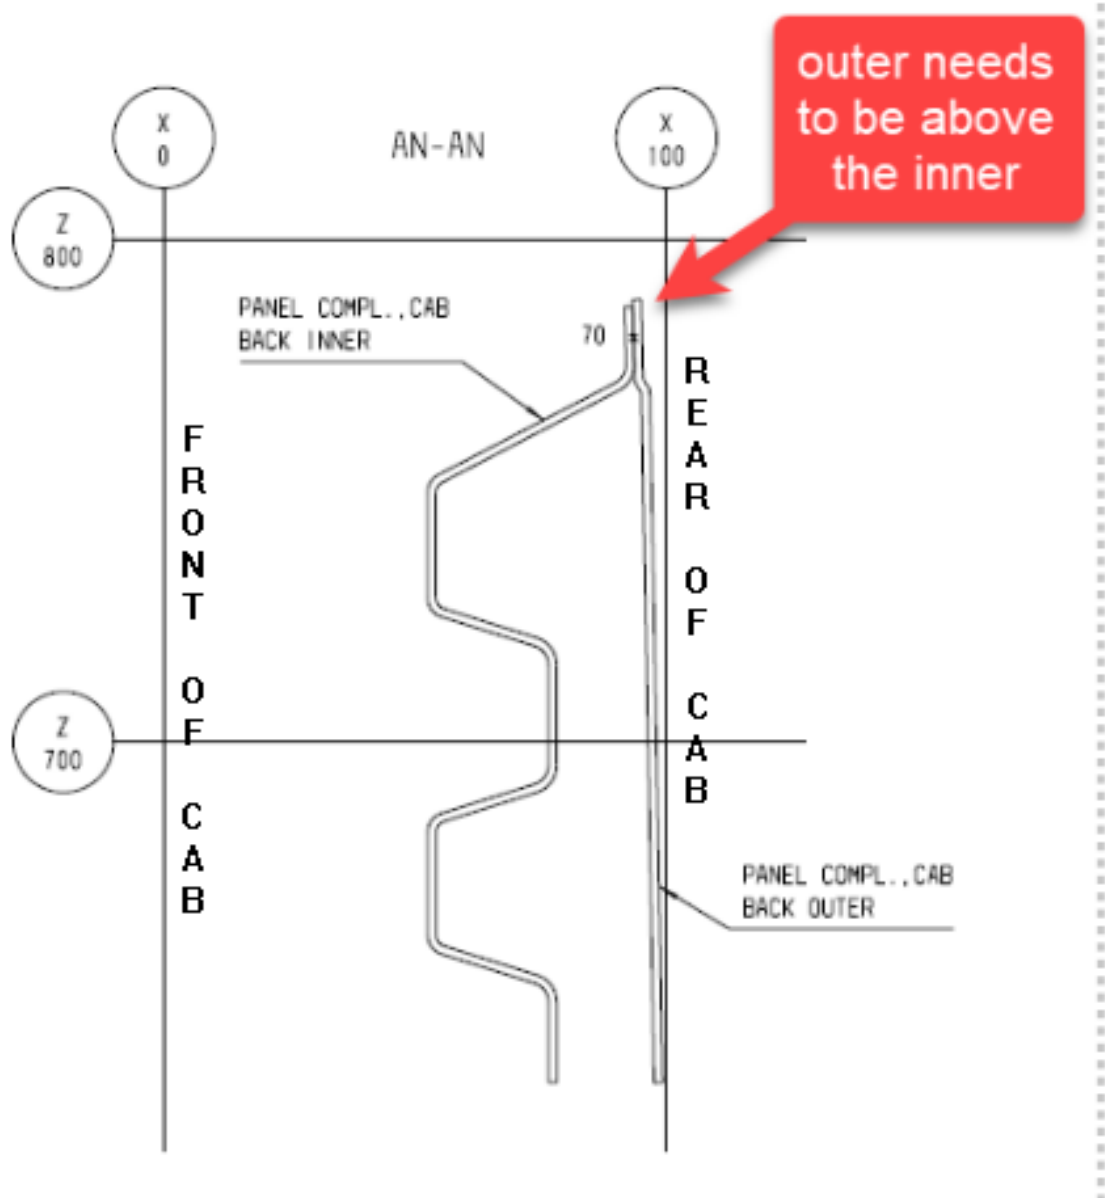
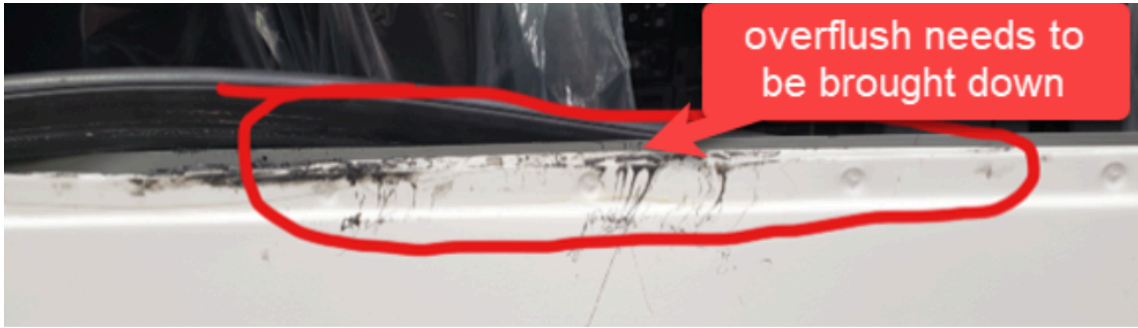
- The outer panel on the back of cab should be slightly higher than the inner panel.
