# TECHNICAL UPDATE: FRONT BRAKE SWITCH CABLE DAMAGE SCRAMBLER 1200 X AND XE PDI

**Models affected:** Scrambler 1200 X and Scrambler 1200 XE

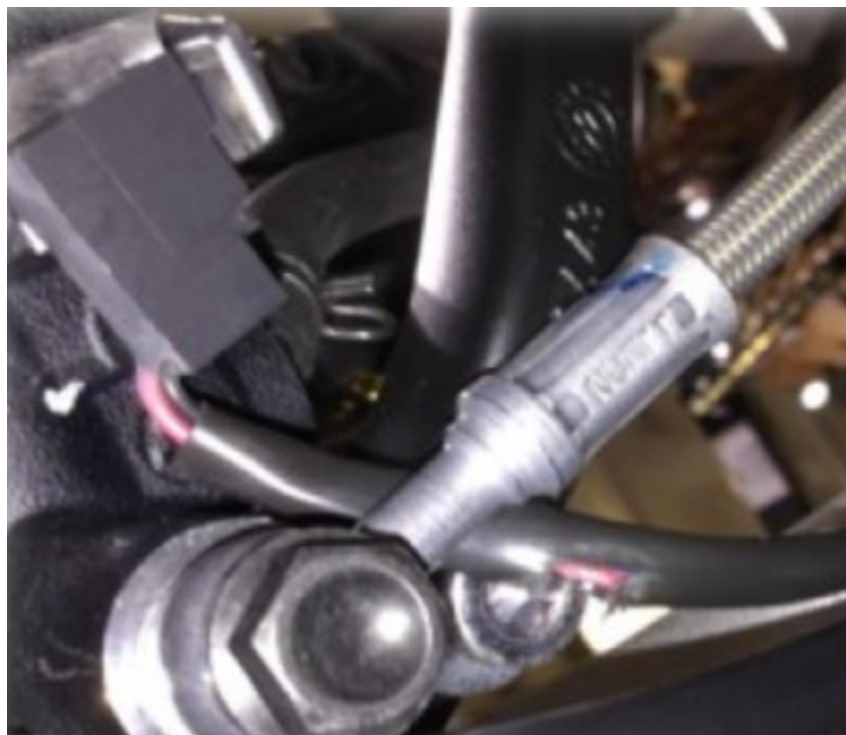
A technical update has been released to cover potential damage to front brake switch cables when mirrors are fitted during PDI.

**What is the nature of concern?** When the mirrors are fitted at PDI, the front brake switch cable can be pinched by the mirror bolt causing damage to the wires.

**What is Triumph doing?** Triumph has carried out an investigation into this concern and has found that the front brake switch wire is being trapped by the mirror bolt fastener when fitted at PDI by dealerships staff.

**What do I need to do?** Dealers are requested to ensure that when fitting the mirrors to these models at PDI, appropriate care is taken not to trap the front brake switch cable. For additional clearance, we suggest unfastening the rubber harness band T3700252 Rubber Band, 88mm, before the mirror bolts are located and fastened. This can then be refastened after the bolts are tightened.
