Rear Wheel Area Screeching or Scraping

Supersedes 24-059, dated June 21, 2024, to revise the information highlighted in **yellow**.

Year	Model	Trim Level	VIN Range
2022– 25	MDX	ALL	ALL

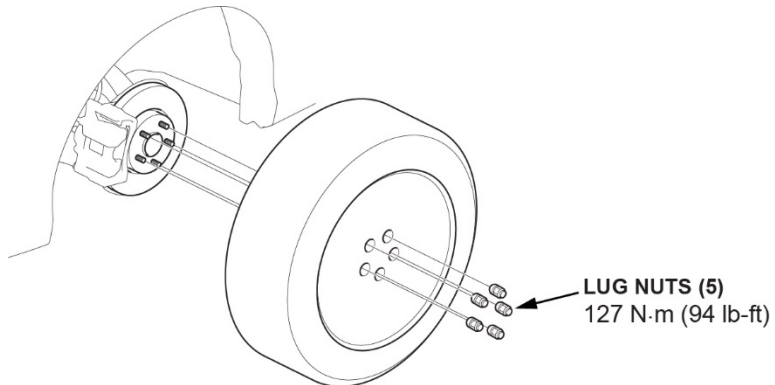
4. Remove both rear wheels.

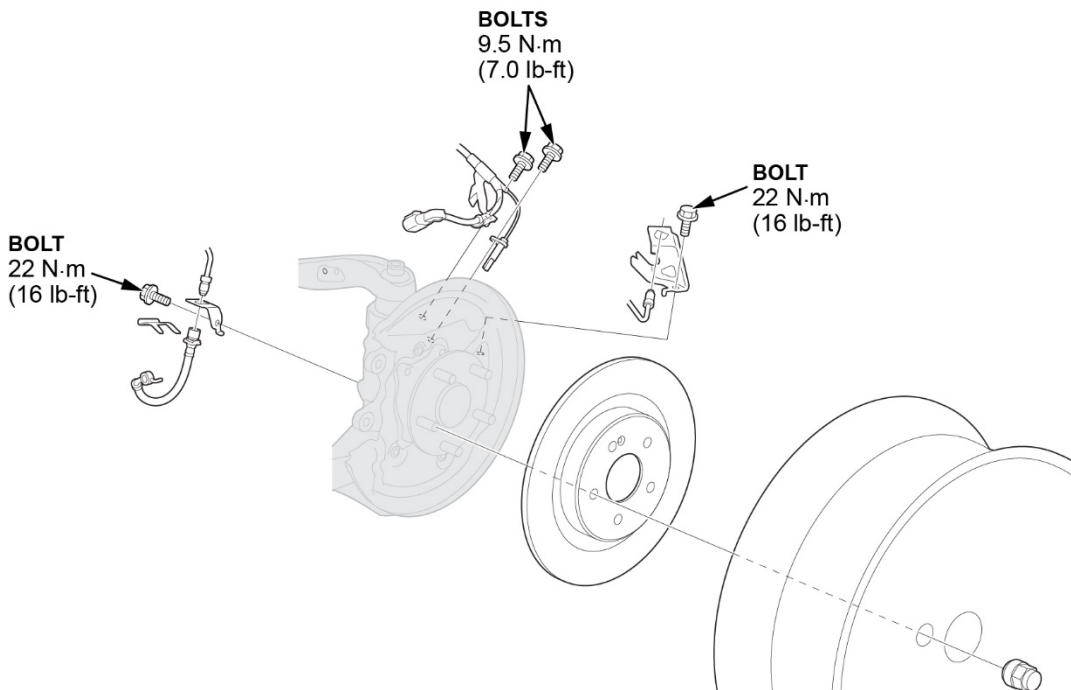
5. Remove the bolts from the rear brake brackets.

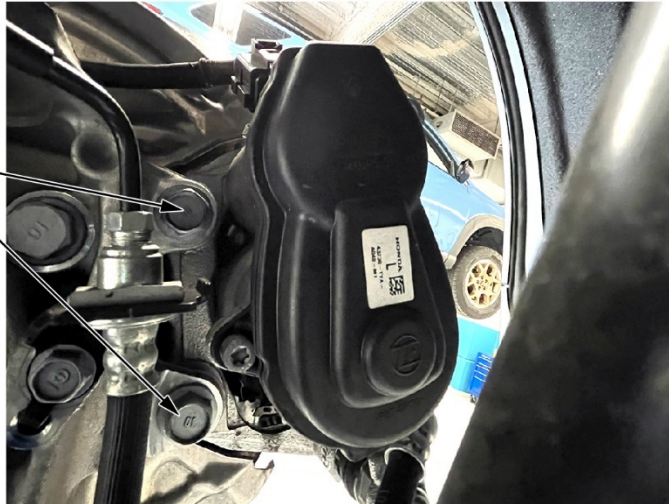
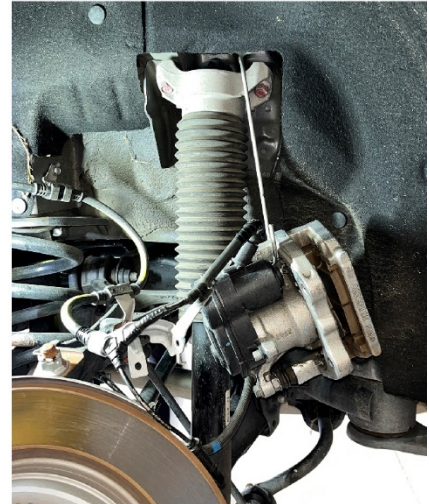
6. Remove the rear caliper and use a short piece of wire to hang the caliper assembly **108 N·m (80 lb-ft)**.

NOTE: To prevent damage **DO NOT** twist the brake hose excessively.

BOLTS
Replace.
