TO: Mercedes-Benz Dealers, General Managers, Sales Managers, Service Managers, Parts Managers	FROM: Anthony Washington, Senior Manager, Regulations and Certifications
<b>Re: Service Campaign Notification</b> <b>Model: Sprinter</b> <b>Model Years 2023-2024</b> <b>Replace Certification Label (reprint)</b>	July, 2024

<b>Campaign No. :</b>	<b>Campaign Desc. :</b>	<b>Replace Certification Label(reprint)</b>
2024070013	VS3RADREK	
This is to notify you of a Service Campaign to Replace Certification Label on approximately and 333 MY 2023-2024 Mercedes-Benz Sprinter Vans. All affected VINs will be flagged as "OPEN" in VMI and cannot be sold until remedied.		
<b>Background</b>		
<b>Issue</b>	Mercedes-Benz AG, the manufacturer of Mercedes-Benz Vans, has determined that on certain Sprinter and Metris vehicles, the B-pillar certification label might not contain information on the vehicle's rim size, tire size, and cold tire inflation pressure required under FMVSS 110 or, as applicable, FMVSS 120. In this case, relevant regulatory requirements might not be met. Mercedes-Benz believes this issue has no impact on vehicle safety. Mercedes-Benz intends to submit a petition to NHTSA for exemption fr

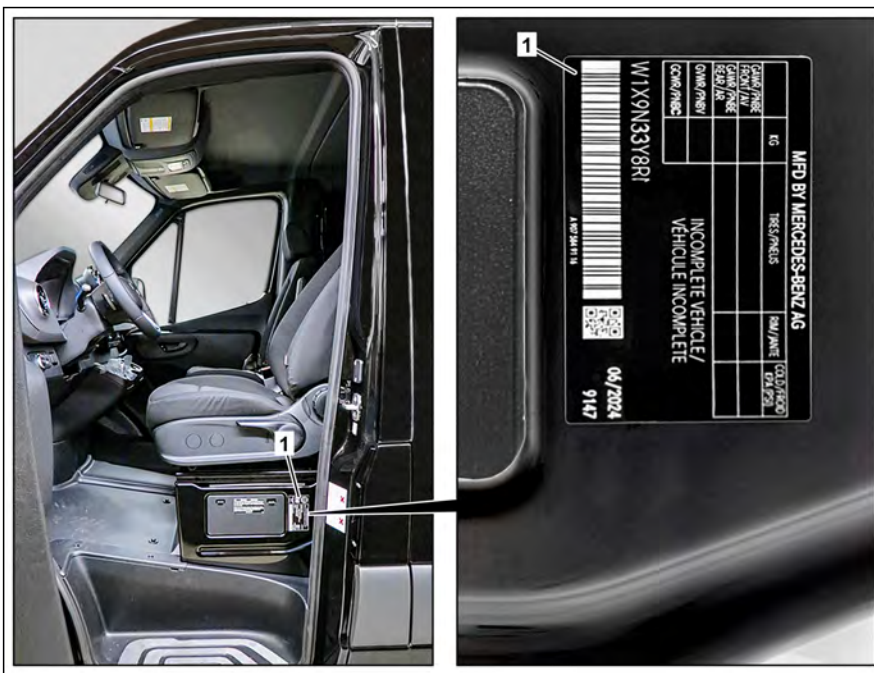
D00.10-A080-76

**Shown on model 907.6, complete vehicle**

1    *Vehicle identification plate*

◀	<b>Check</b>		
1	Check whether the vehicle is affected by the measure.		
	<b>Replace vehicle identification plate (1)</b>		
2 WS	Remove vehicle identification plate (1). 000 588 00 84 00 Heat gun	<p>ⓘ Do not heat seat box under vehicle identification plate (1) too much. Otherwise the paint will be damaged.</p> <p>ⓘ To do so, remove vehicle identification plate (1) using a suitable tool.</p>	WS54.00-P-0049B
3	Attach new vehicle identification plate (1).	<p>ⓘ Bonding surface must be absolutely free of dust and grease. Otherwise, a sufficient degree of adhesion cannot be assured.</p> <p>ⓘ Check whether the newly ordered vehicle identification plate (1) with <b>dealer code: 2-XXXXX</b> on the separating film has been shipped.</p> <p>ⓘ In the case of "incomplete" vehicles (code Z5U), additionally stick the new vehicle identification plate (1) over the old vehicle identification plate (1) in the supplement (3) veh. data USA/CAN A-2023 (IVD User Manual) (see picture 3). Cleaner</p>	BR00.45-Z-1025-04A

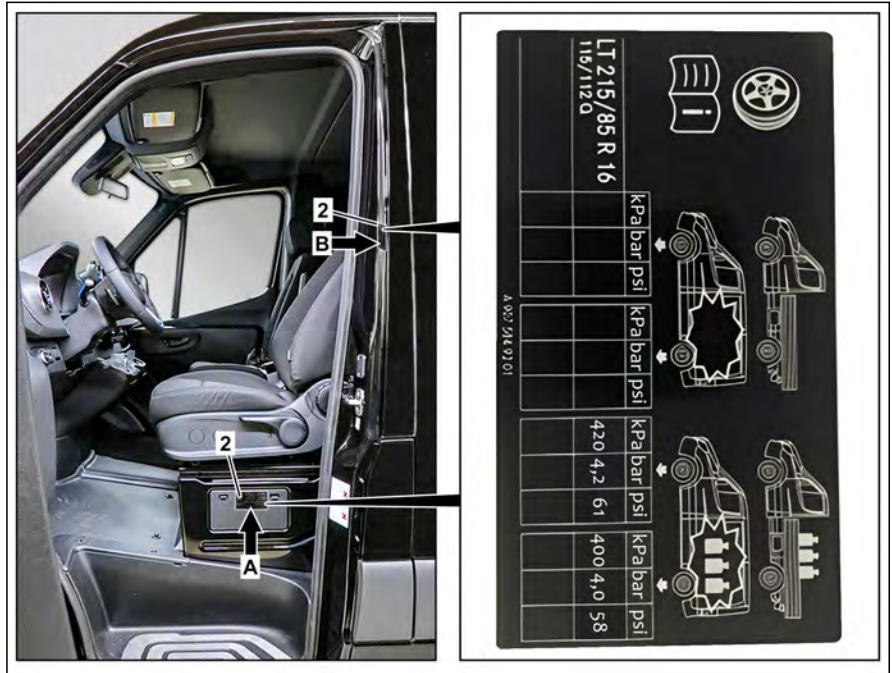
D00.10-A079-76

Shown on model 907.6, complete vehicle

2 Tire pressure table information label

<b>Replace tire pressure table information label (2)</b>		
4 WS	Remove tire pressure table information label (2). 000 588 00 84 00 Heat gun	<p>ⓘ Do not heat the cover on the seat box or the B-pillar under the tire pressure table information label (2) too much. Otherwise the cover or paint will be damaged.</p> <p>ⓘ To do so, remove tire pressure table information label (2) using a suitable tool.</p> <p>ⓘ The tire pressure table information label (2) is attached to the cover on the seat box or to the B-pillar (arrow A).</p>	WS54.00-P-0049B

5	Attach new tire pressure table information label (2) to B-pillar (arrow B).	<p>ⓘ Bonding surface must be absolutely free of dust and grease. Otherwise, a sufficient degree of adhesion cannot be assured.</p> <p>ⓘ The new tire pressure table information label (2) must <b>always</b> be attached to the <b>B-pillar</b> (arrow B). Cleaner</p>	BR00.45-Z-1025-04A
---	---	--	--------------------

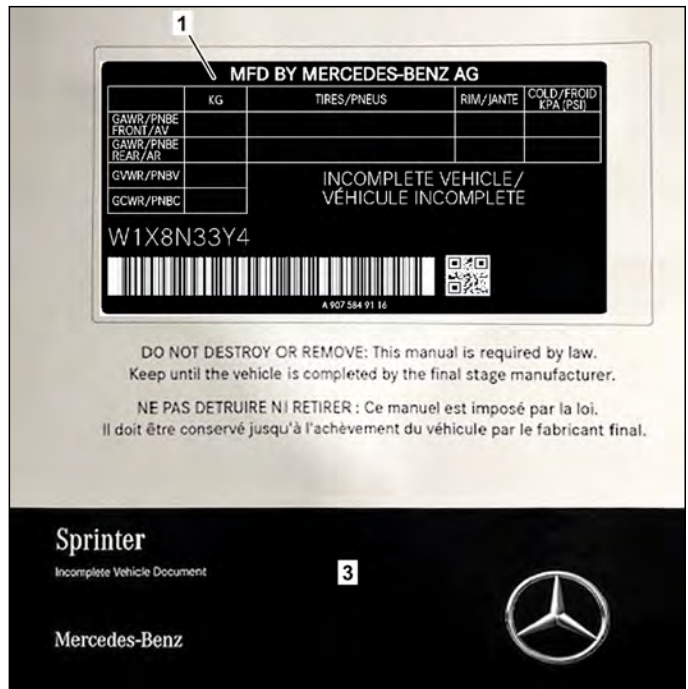
D00.10-A081-82

Shown on supplement for model 907.6, incomplete vehicle

1 Vehicle identification plate

3 Supplementary instructions
