## Front door collides with fender

Topic number	LI72.10-N-077998
Version	1
Function group	72.10 - Front door
Date	7/4/24
Validity	Models 907
Reason for change	Damage code revised Updated from LI72.10-N-071190

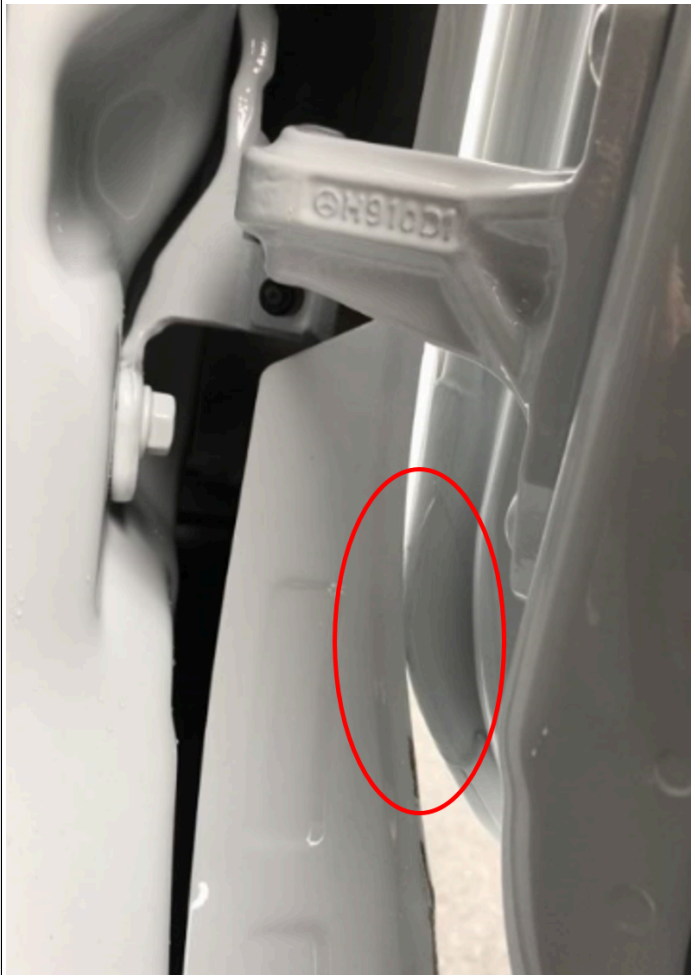
Attachments	
File	Description
<a href="#">01.jpg</a>	Front door collides with fender in area of lower hinge.

Excessive dynamic stress results in permanent deformation of the lower hinge and causes the front door to collide with the fender.

1. Conduct a visual check for cracks on threaded connection of door holder in front door. In the event of damage, please create a TIPS case with informative pictures.
2. Replace lower hinge of front door on affected side of vehicle. (lower hinge will need to be painted)
3. Replace door holder (on both sides) with modified, shortened door holder. If part number A910 720 17 00 is imprinted on the part, then replace this part with the revised, shortened door holder.
4. For a repeat failure on a vehicle that has been previously repaired with the updated parts, Please create a TIPS case

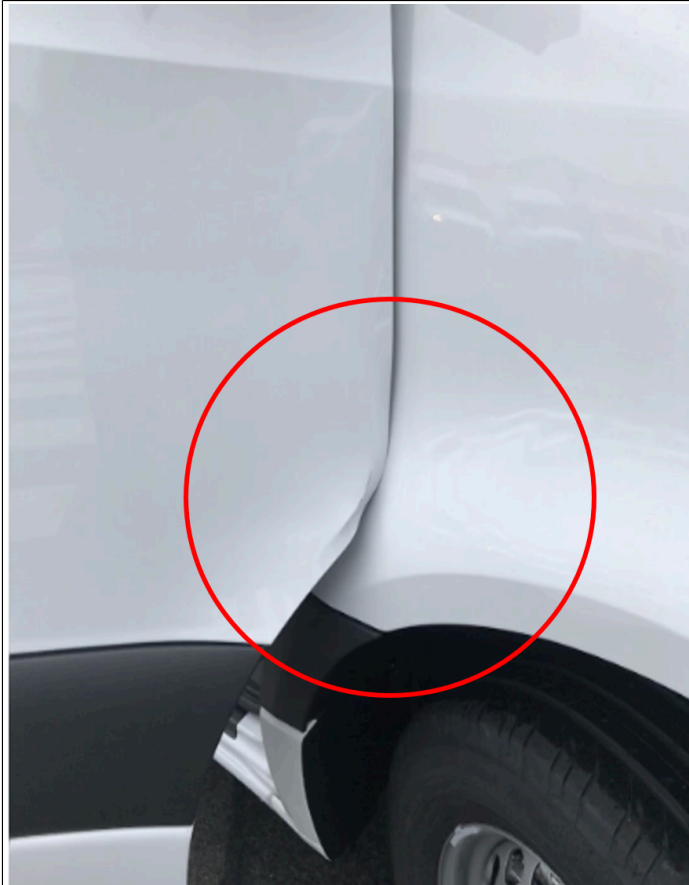
<a href="#">02.jpg</a>	Body damage on the front door and fender.

Damaged body components will need to be repaired or replaced by a MB certified collision center.

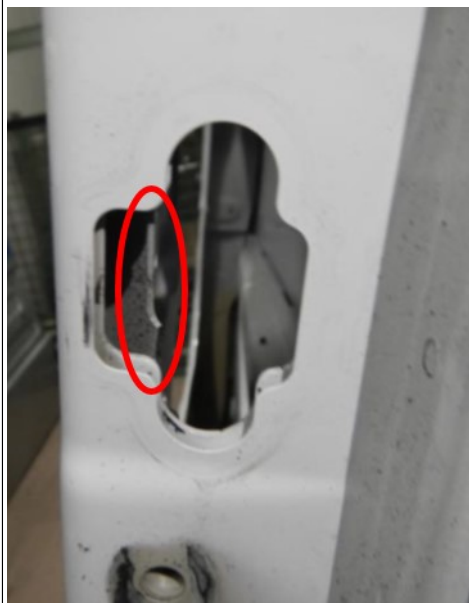
03.jpg

Crack on threaded connection in door

This can result in damage to the door holder and the front door at the threaded connection of the door holder.

Note: The modified, shortened door holder reduces the opening angle of the door by approx. 6°. The contact surface in the door has been enlarged.
