Service Alert

Subject: DOOR GARNISH GAP	Service Alert No.: SA-044/24
	Last Issued : 07/25/2024

2025 CX-70
2024-2025 CX-90

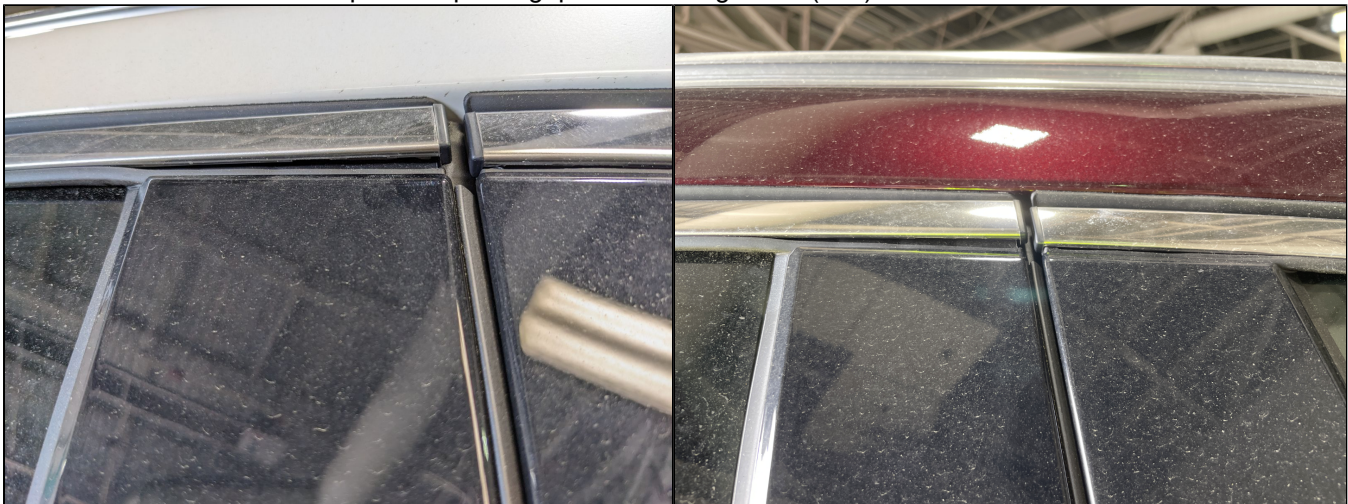
Some customers or dealerships will report a gap at the door garnish (trim).

Customers having this concern should have their vehicle repaired using the following repair procedure.

1. Verify the customer concern,
2. Replace the rear glass run channel on the affected door(s) using the LEFT FRONT DOOR GLASS RUN-CHANNEL REMOVAL/INSTALLATION, RIGHT FRONT DOOR GLASS RUN-CHANNEL REMOVAL/INSTALLATION, or REAR DOOR GLASS RUN-CHANNEL REMOVAL/INSTALLATION procedure.

3. Verify the repair.
