Rear Wheel Area Screeching or Scraping

Supersedes 24-059, dated June 21, 2024, to revise the information highlighted in **yellow**.

Year	Model	Trim Level	VIN Range
2023– 25	Pilot	ALL	ALL

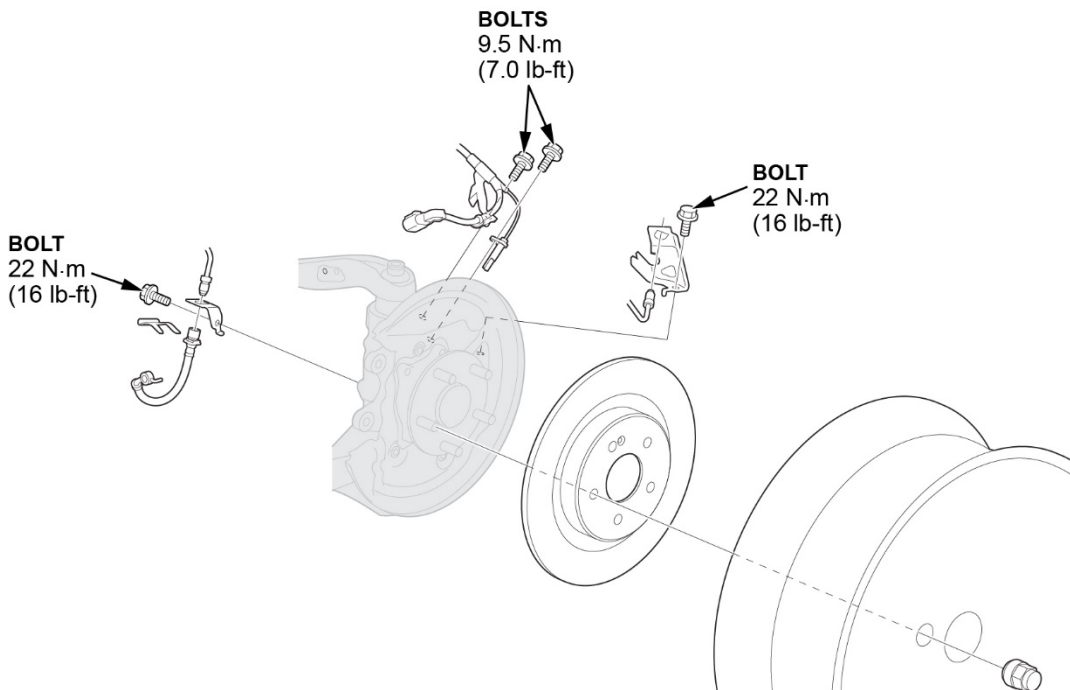
5. Remove the bolts from the rear brake brackets.

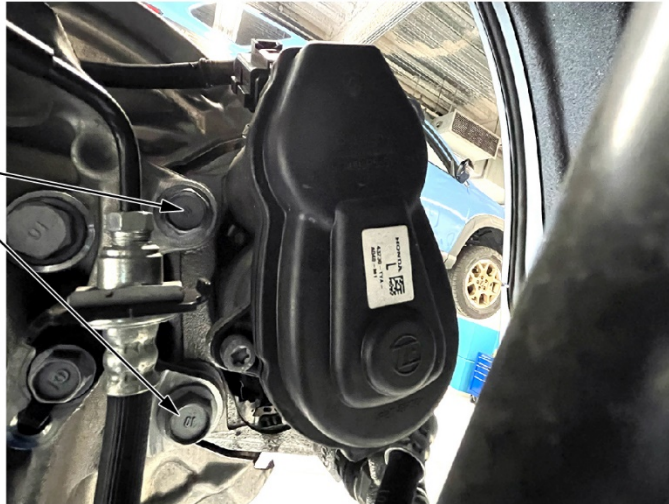
6. Remove the rear caliper and use a short piece of wire to hang the caliper assembly **108 N·m (80 lb-ft)**.

NOTE: To prevent damage **DO NOT** twist the brake hose excessively.

BOLTS
Replace.

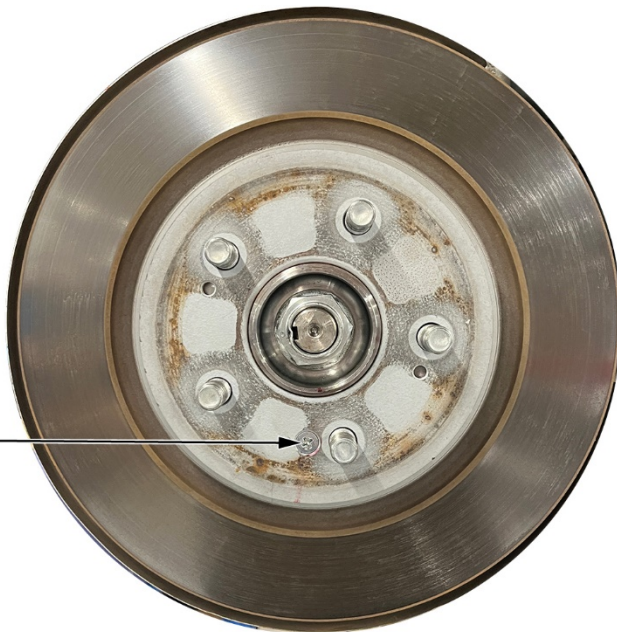
7. Remove the screw holding the rear disc, then remove the rear disc **9.5 N·m (7 lb-ft)**.

SCREW
