WRB2 - Replacing Oil Note Sticker (Workshop Campaign)

Vehicle Type: **718 Cayman GT4 RS (982) / 718 Spyder RS (982)
911 GT3 RS (991) / 911 Speedster (991)
911 GT3 (992) / 911 GT3 RS (992) / 911 S/T (992)**

Concerns: **Oil note sticker**

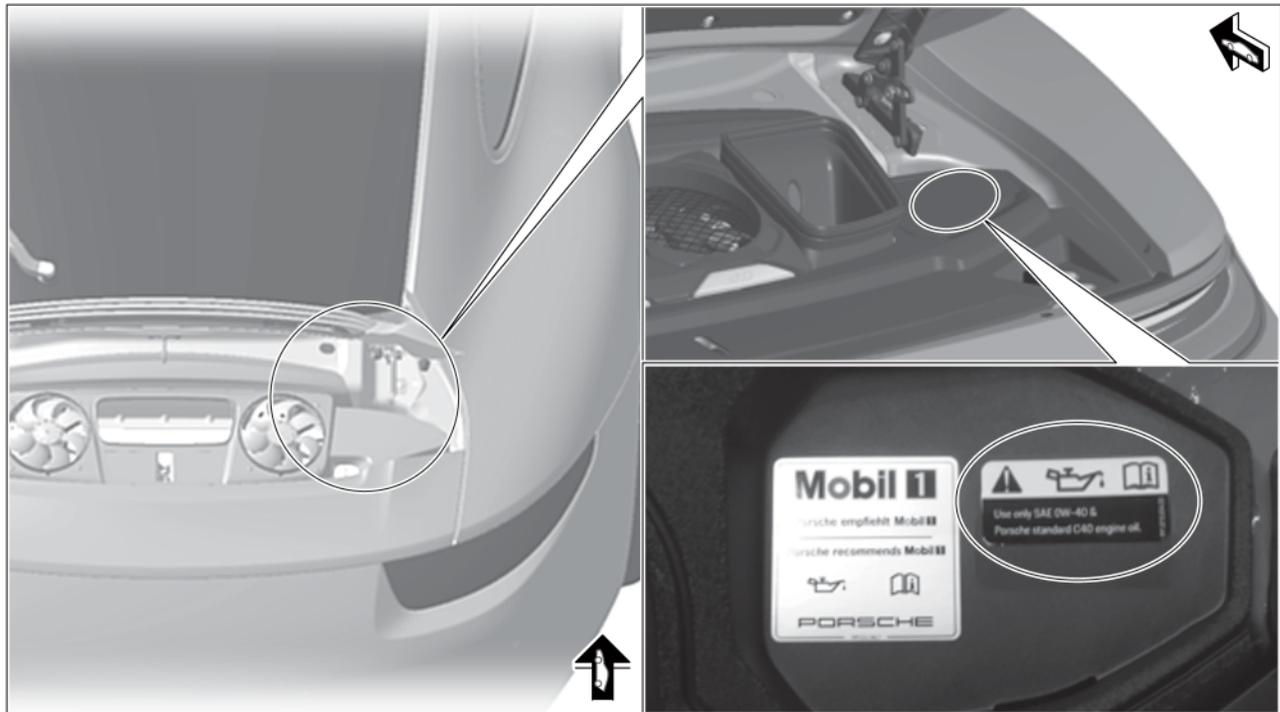
The oil warning sticker on all affected vehicles is located directly near the oil filler neck.

Sample illustration on the 911 GT3 RS (991)

Work Procedure: 1 Open the rear lid or service flap.

2 Locate the sticker.

3 Carefully heat the affixed sticker with a hot air gun.

4 Carefully remove the sticker. Heat the sticker multiple times using the hot air gun if necessary. Remove sticker residue and clean bonding surfaces using a suitable cleaning agent (e.g., isopropanol).

- 5 Destroy and dispose of the old sticker.
- 6 Affix the new sticker at the same position and with the same text alignment as the original sticker.
- 7 Close the rear lid or service flap.
- 8 Enter the campaign in the Warranty and Maintenance logbook.
