# Technical Service Bulletin

## 13 Starter/generator drive belt is noisy or came off.

13 24 25 2061461/10 July 16, 2024. Supersedes Technical Service Bulletin Group 13 number 24-24 dated March 8, 2024 for reasons listed below.

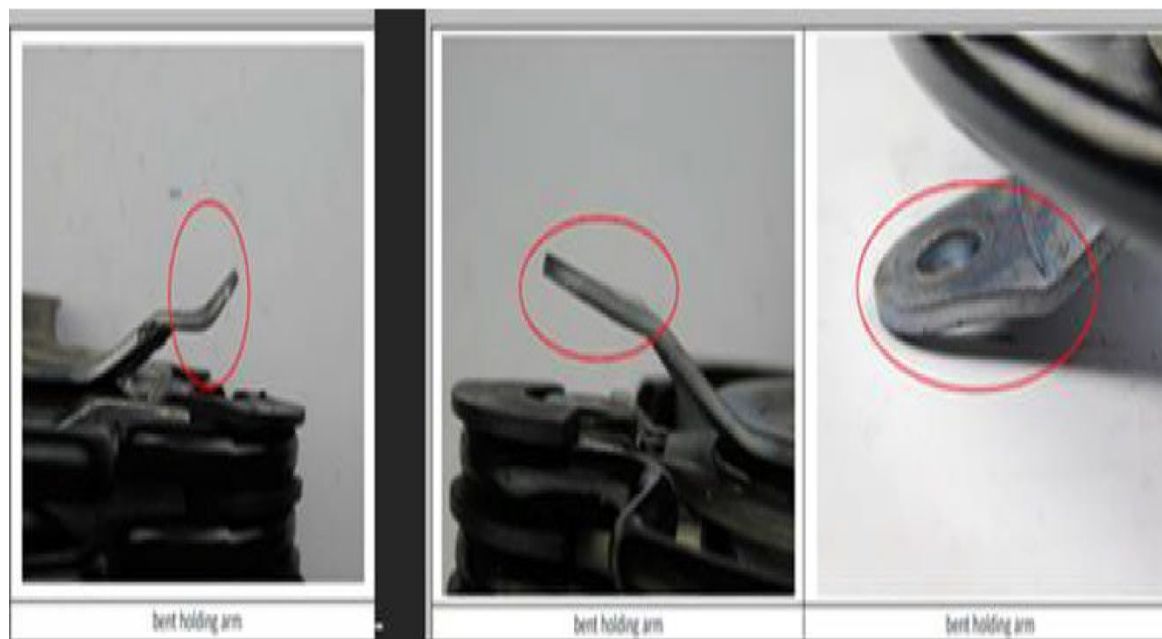
Figure 3. Examples of damaged parts.

**Please ensure that the belt tensioner (including the retaining tab) is not damaged during removal. Damage to the component would make analyzing the parts impossible. In such cases, we may charge back the damaged parts.**
