## 94 Third brake light inoperative. DTC B12C615

90 24 12 2074275/1 July 5, 2024.

Model(s)	Year	VIN Range	Vehicle-Specific Equipment
e-tron GT, and RS e-tron GT	2022 - 2024	All	Not Applicable

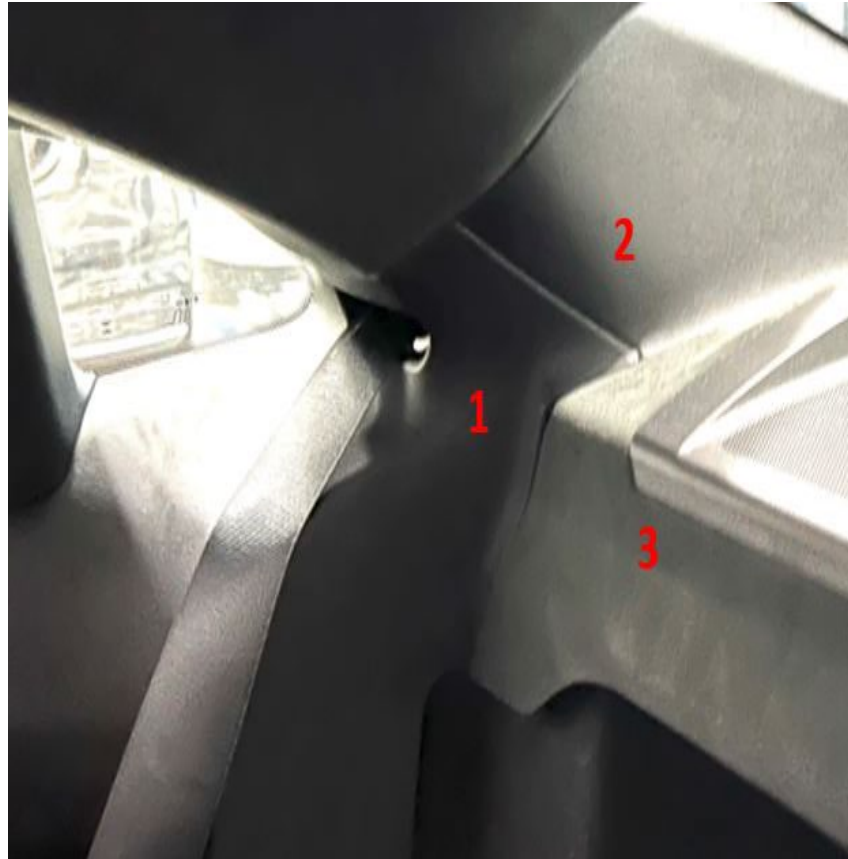
*Figure 1: Trim to remove.*

Remove the seat belt feeder trim, C-pillar trim and rear shelf as indicated by position 1,2 and 3 in Figure 1.

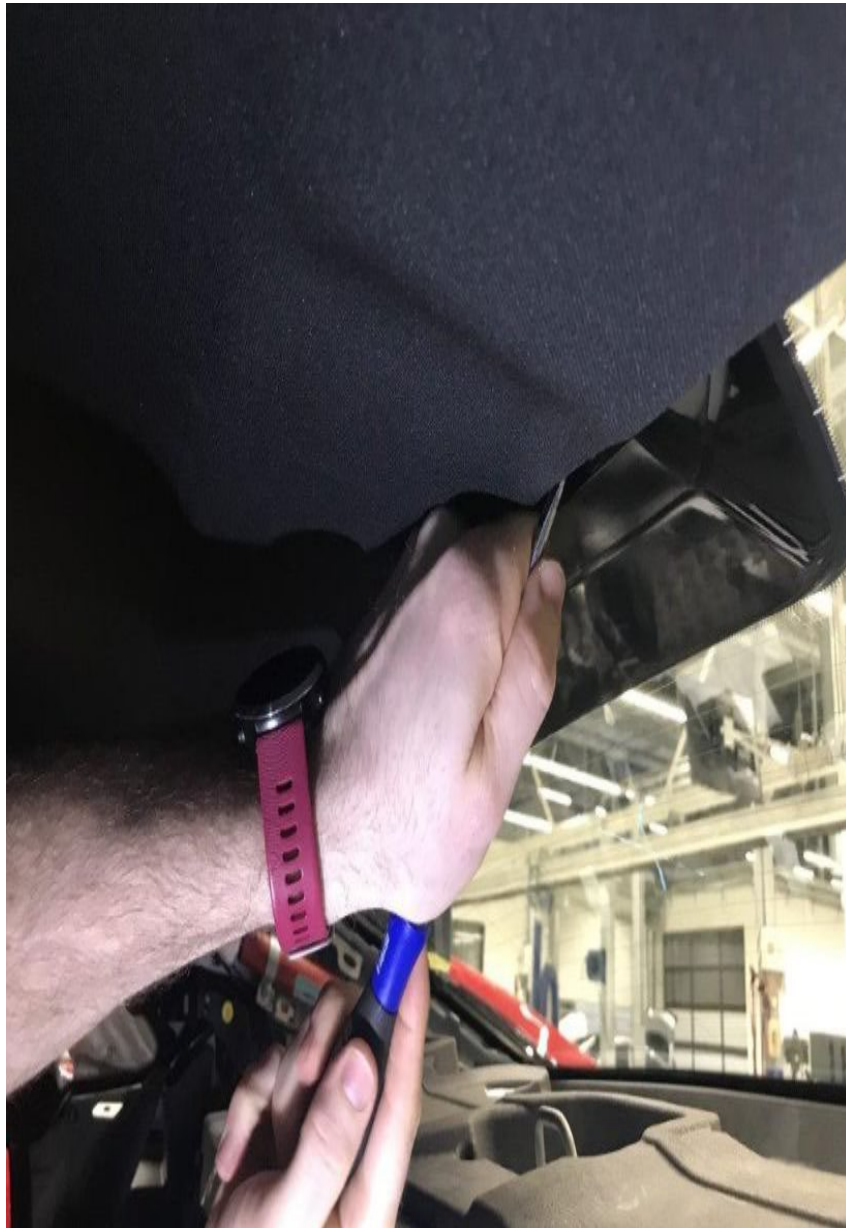
*Figure 2: Remove 3<sup>d</sup> brake light.*

Remove the 3rd brake light  
and unplug the lamp.

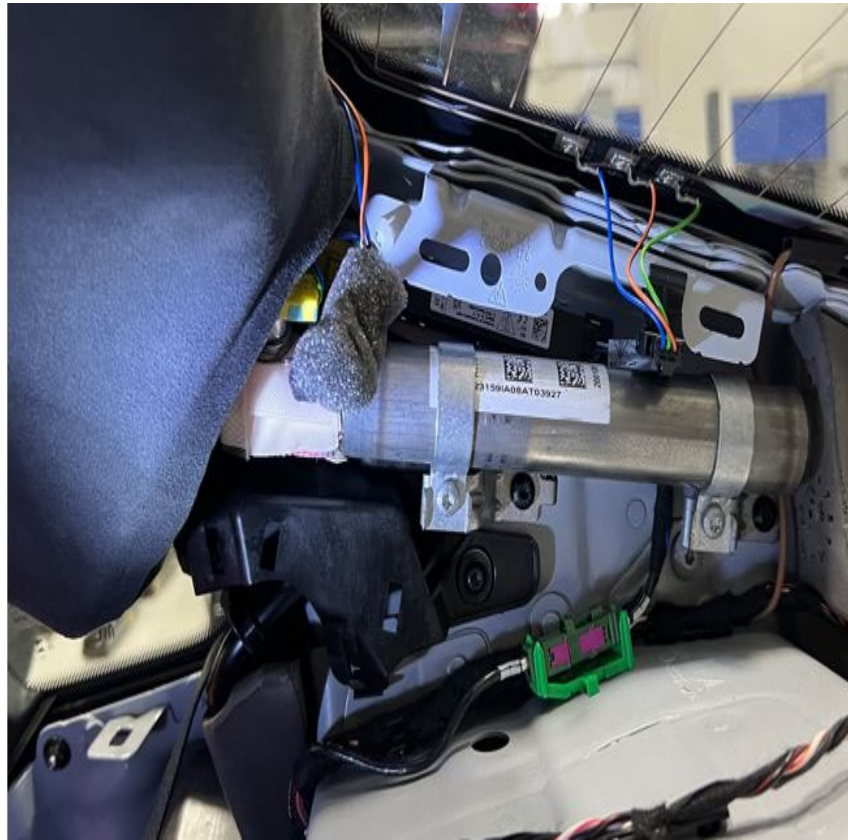
*Figure 3: Access the 3<sup>d</sup> brake light connector.*

Pull the foam insulated connector for the 3<sup>rd</sup> brake light circuit from behind the C-pillar.

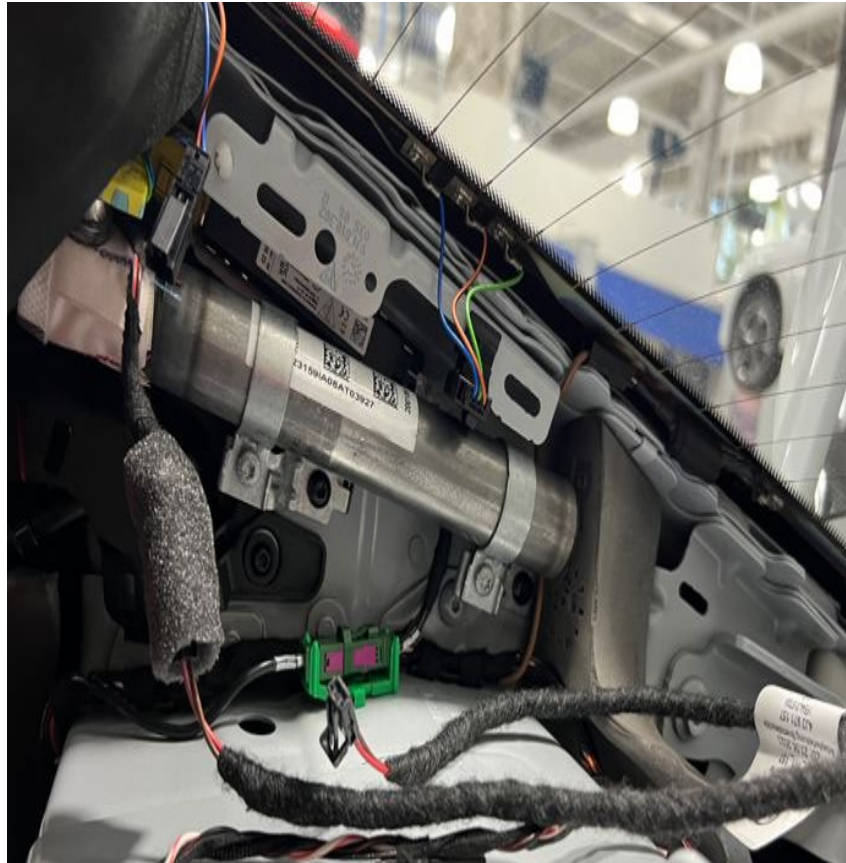
*Figure 4: Install adapter harness.*

Separate the connection and insert **4J3 971 157** into the vehicle side of the wire harness only.

In this step the wires leading to the welded points on the glass will remain unused.

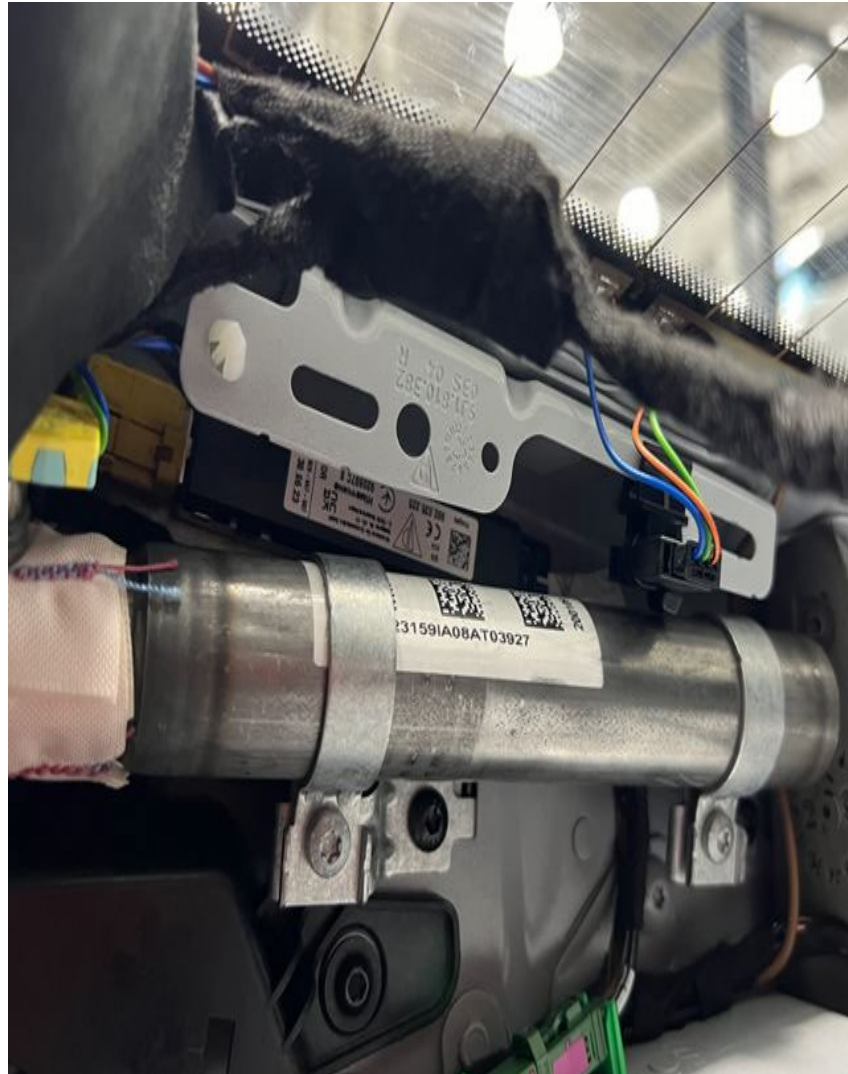
*Figure 5: Insulate connector and harness.*

Wrap the unused connector end from the glass to the new harness.

Insulate as needed to prevent noise and future chaffing.

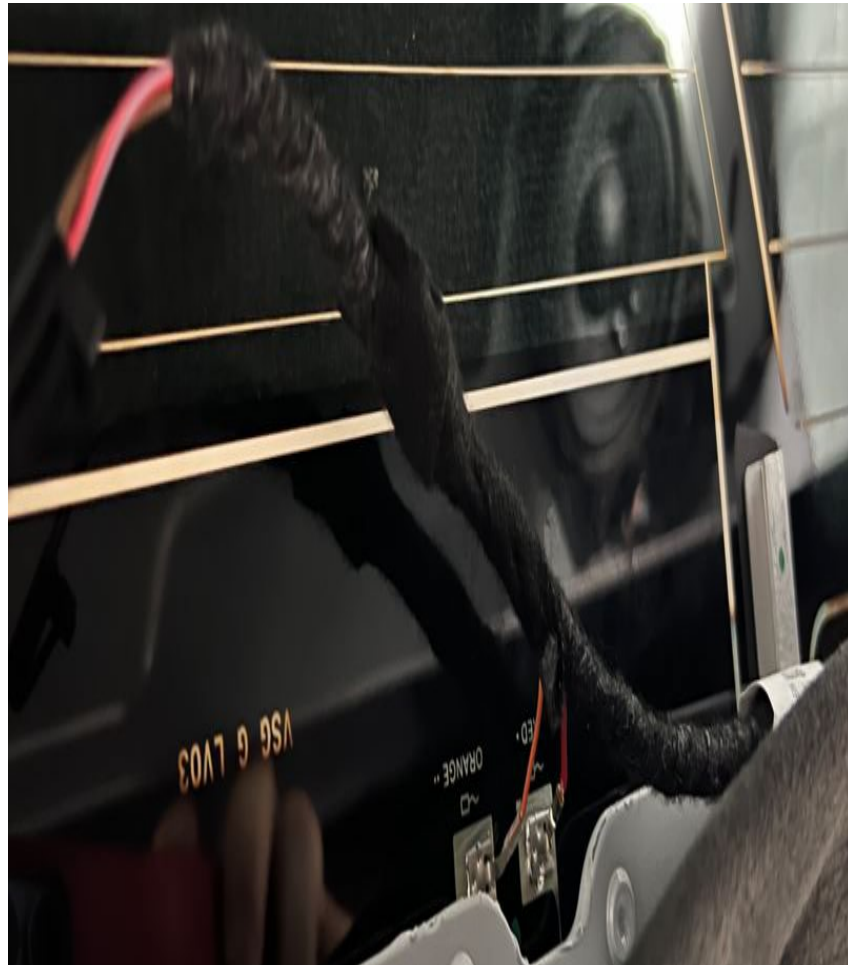
*Figure 6: Insulate connector and harness.*

Loosely route the replacement harness **4J3 971 157** along the space between the headliner and glass.

Wrap the old connector end for the 3<sup>rd</sup> brake lamp to the new harness approx.. 90mm behind the new harness connector.

**Ensure enough length of the new harness is available to facilitate installation/removal of the 3<sup>rd</sup> brake lamp.**

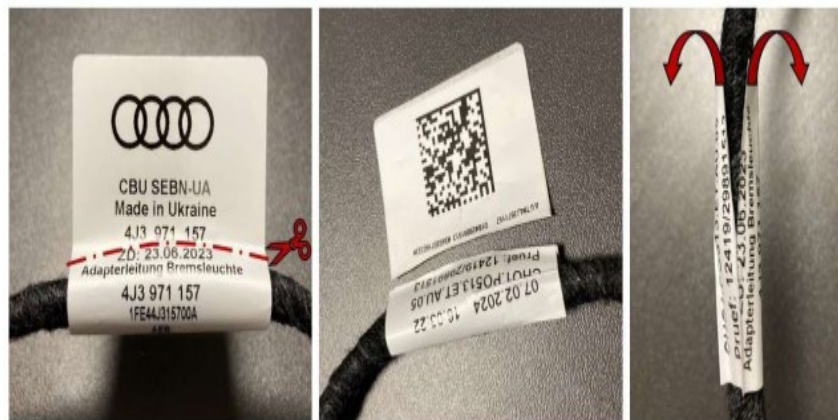
*Figure 7: Remove label.*

Remove the label on the new harness to reduce risk of noise.

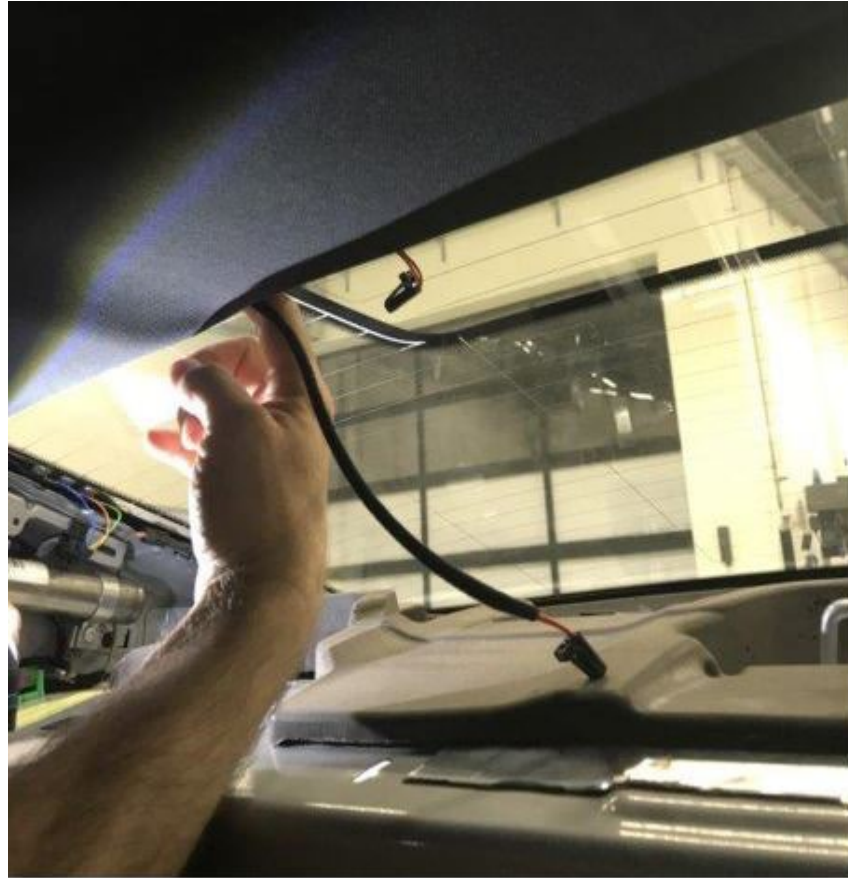
*Figure 8: Route adapter harness.*

Insert the new harness **4J3 971 157** into the space between headliner and metal flange of the body.

Connect the new harness to the 3<sup>rd</sup> brake lamp.

Position/secure harness as needed to prevent noise and protrusion from behind the headliner.

Re-assemble the vehicle in reverse sequence according to Workshop Manual.
