# Technical Service Bulletin

**93 Q4 e-tron cannot be charged - connector does not lock/unlock - charge connector lock, blocked  
P1CF400 in DA 00C6**

93 24 74 2074617/1 July 19, 2024.

Model(s)	Year	VIN Range	Vehicle-Specific Equipment
Q4 e-tron, and Q4 Sportback e- tron	2022 – 2025	All	Not Applicable

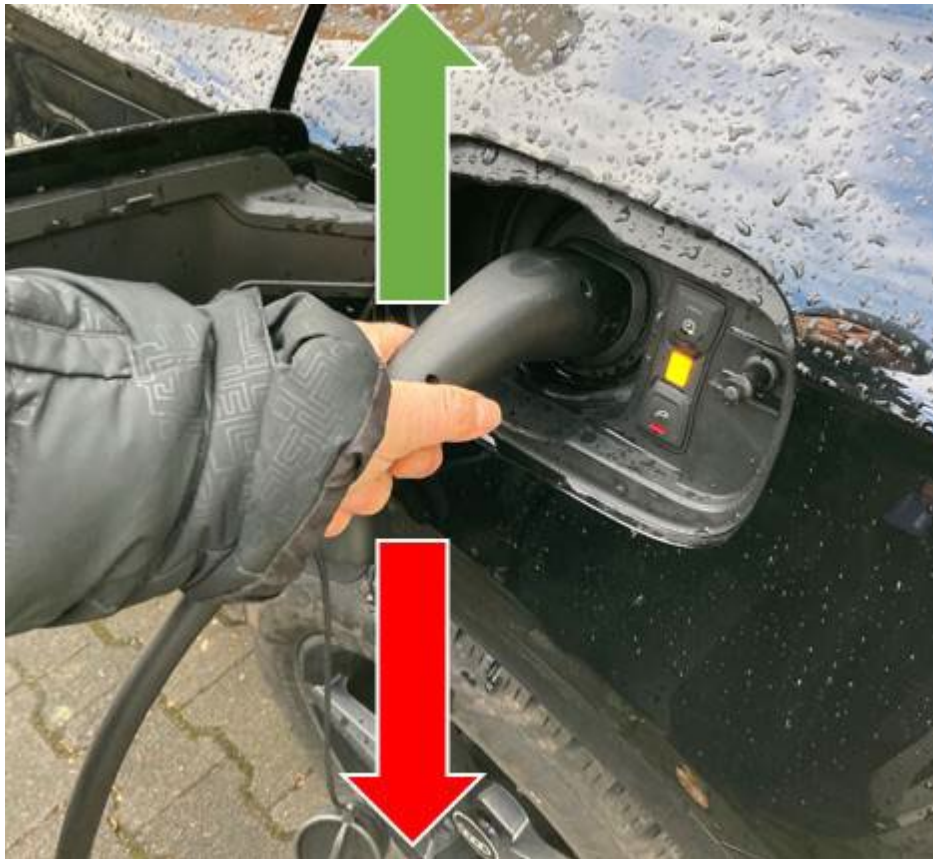
(Example image from a Q5 PHEV)

Charging connector lock OK if connector is lifted during locking procedure.

Charging connector lock not OK if pushed downwards during locking procedure.

Please inform the customer that lifting the charging connector slightly immediately after plugging it in until it is locked causes the pin to enter the charging connector without any problems.

This will prevent the connector from dropping (see example image from Q5 PHEV).
