| <br><b>Technical Service Bulletin</b> | <b>GROUP</b><br>EV SYSTEM | <b>NUMBER</b><br>24-EV-004G |
| <b>SUBJECT:</b> ICCU SPECIAL SERVICE INSTRUCTIONS | | |

**Description:** This bulletin provides important special service instructions to properly repair a vehicle that has been diagnosed to require an Integrated Charge Control Unit (ICCU) replacement, such as required for DTC P1A9096 DC to DC related charging concern or for inoperative AC charging.

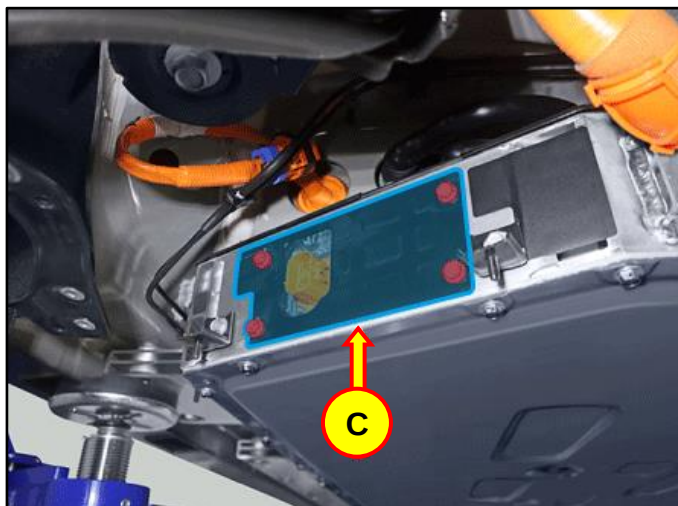
3. Remove the ICCU high-voltage connector assembly cover (C).

**Tightening Torque:**

| lb-ft | 7.4 |
| lb-in | 88.5 |
| N.m | 10.0 |

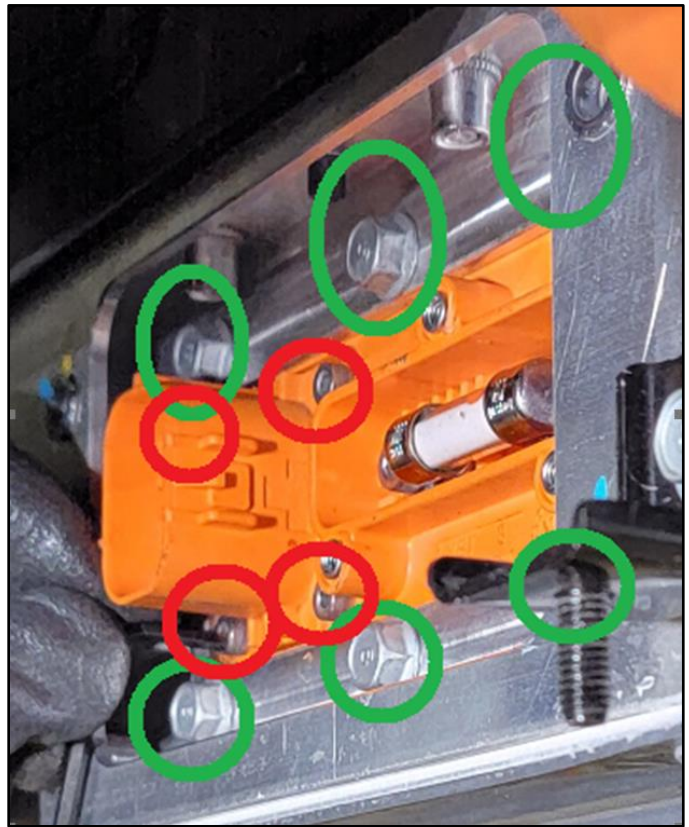
**SPECIAL INSTRUCTION:** Only applies when ICCU Fuse rear nut(s) falls back into the battery.

1. Remove:
  - 6 qty. 10mm bolts (circled in Green),
  - 4 qty. bolts by Allen wrench (circled in Red).
2. Push in bottom area. Pull out top area.
3. Reach in and grab the nut behind the plate on the bottom surface.
4. Hold the nut at the back side.
5. Install the fuse bolt at the place that the nut had dropped.
6. Install all the other bolts in reverse order of removal.
7. Install the rest of the fuse bolts.

**NOTE:** Contact Techline if the above procedure did not resolve a dropped nut problem.
