# TECHNICAL SERVICE BULLETIN

Technical Service Bulletin: 51-1798

The Magic Chef refrigerator may not have the proper vents cut out inside the refrigerator potentially causing cooling issues.

# Adding Vents to 12 Volt Refrigerator

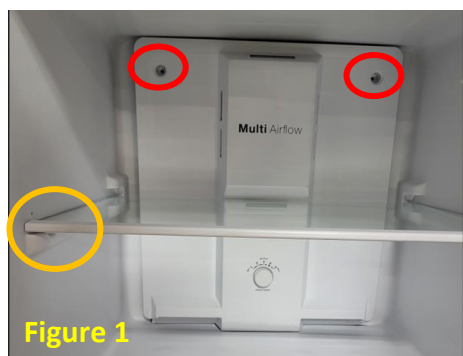
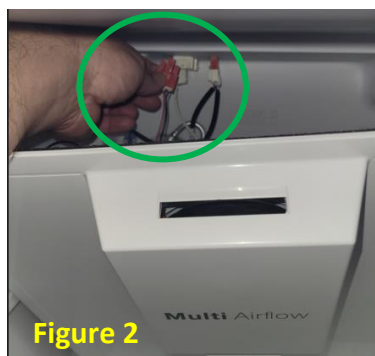
1. Open the freezer door and remove the screw for the shelf (*Figure 1 in Orange*) and then remove the shelf. You will then remove the 2 screws (*Figure 1 in Red*) on the back wall and remove the Fan/Vent Assembly gently from the back wall. As you remove the assembly, you will need to disconnect the wire with the red connector (*Figure 2 in Green*).

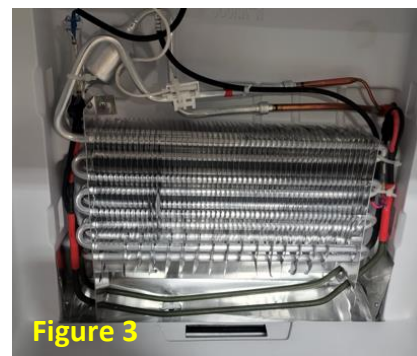
2. Check evaporator (*Figure 3*) to make sure the freezer is completely defrosted. (*This step could take up to 12 hours if ice is present*). If no ice is present, proceed to the next step.

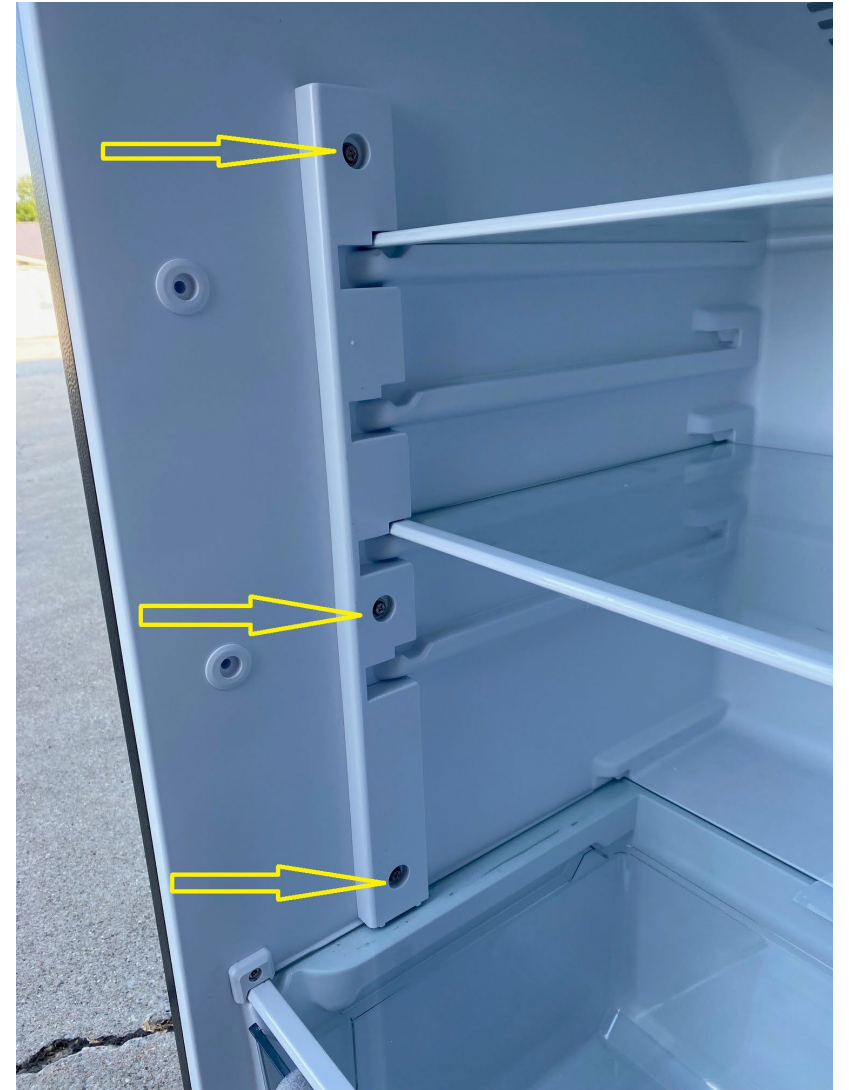
Remove (3) 5/16" bolts from the shelf locking bracket and remove shelf(s)

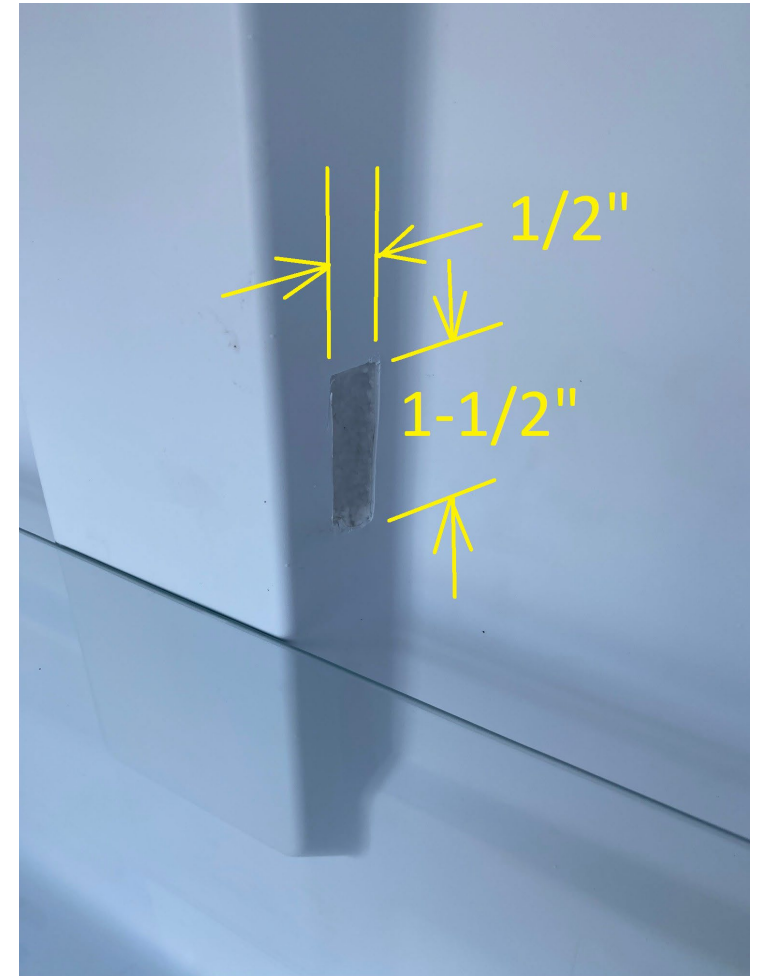
# Side Vent Installation

- Vent hole size is  $\frac{1}{2}$ " x  $1\frac{1}{2}$ ".
- Using light pressure, press utility knife through the right side of the duct that runs down the center of the refrigerator compartment.
- Make sure interior duct foam is cut out for airflow to pass thru.

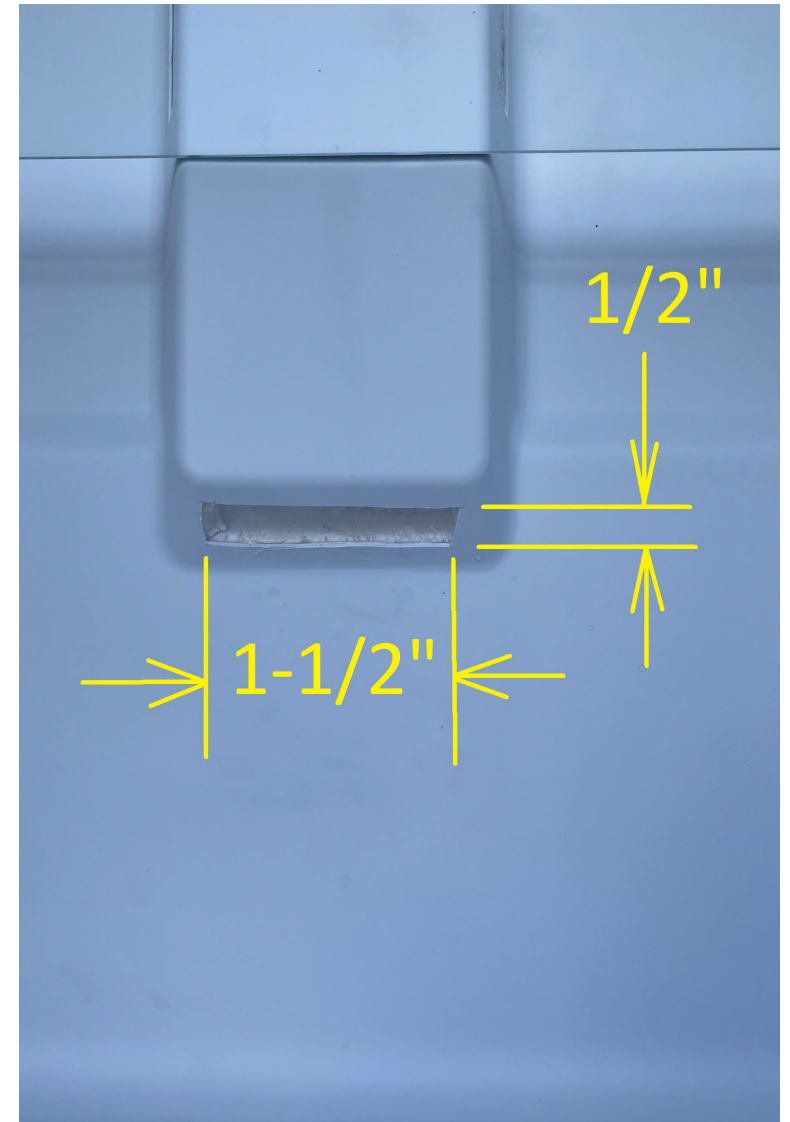
## Lower Vent Installation

- Vent hole size is  $\frac{1}{2}$ " x  $2\text{-}\frac{1}{4}$ ".
- Using light pressure, press utility knife through the lower side of the duct that runs down the center of the refrigerator compartment.
- Make sure interior duct foam is cut out for airflow to pass thru.
