Technical Service Bulletin

GROUP CAMPAIGN	NUMBER 24-01-066H
DATE AUGUST 2024	MODEL(S) SANTA FE HYBRID (MX5A HEV)

SUBJECT: COOLANT RESERVOIR LEAK INSPECTION AND REPLACEMENT
(SERVICE CAMPAIGN TCB)

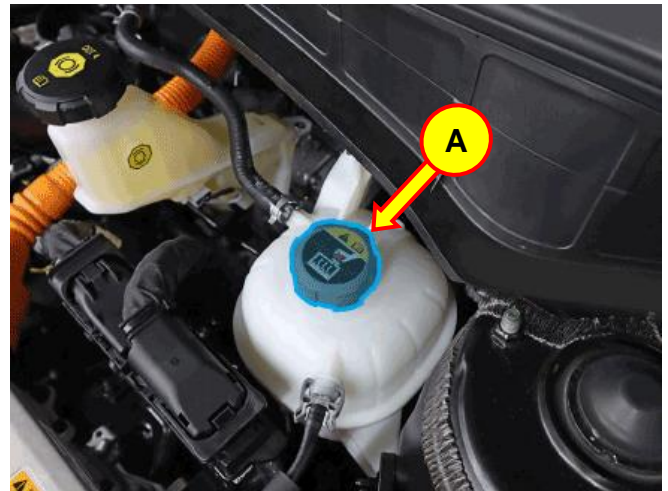
1. Remove the coolant reservoir tank cap (A).

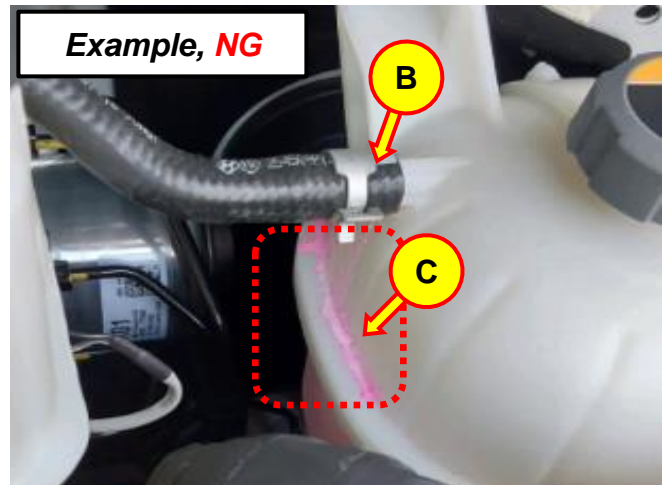
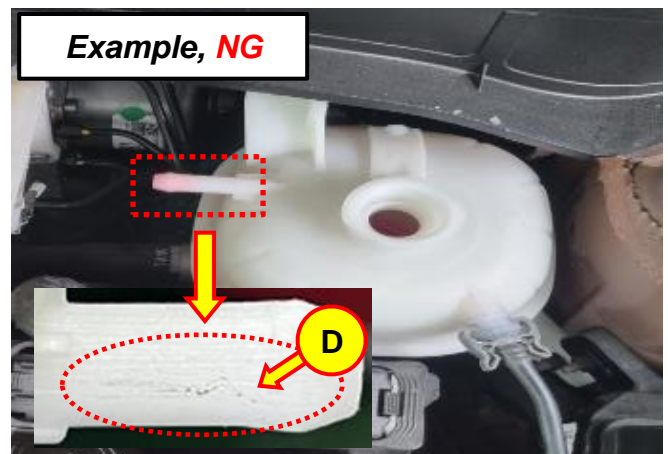
2. Remove the reservoir tank hose (B) and check for any burrs, cracks, or coolant leaks (C) located at the tank flange (D).

- If there is **NO** coolant leak, crack, or burr, then **STOP**. Do not continue with this service procedure in this TSB. Use OP Code **40D097R2** to finish the inspection procedure.
 - **Take a picture of the tank showing no coolant leaks / cracks / burrs as indicated in step 3b.**
 - **Reinstall all parts in reverse order.**
- If a coolant leaking condition is found at any of the indicated areas, then follow step 3a to take a STUI photo and replace the coolant reservoir tank in Section B. An additional photo will be required in Section B.
 - **Be sure to inspect for cracks and/or burrs at multiple locations along the flange (90°/180°/270°)**

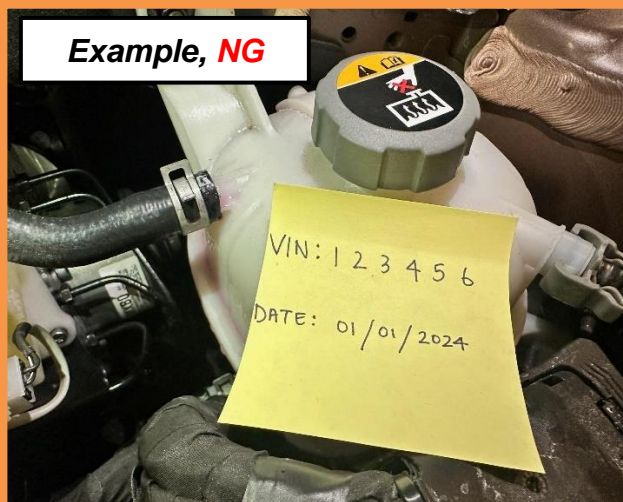
Example, NG

- 3a. Document the coolant leaking, crack, or burr condition at the coolant reservoir tank and/or tank flange using STUI prior to reservoir replacement.

Using STUI, take a photo any burrs, cracks, or coolant leaks located at the tank flange with the last 6 digits of the VIN and the date of repair on a piece of paper.

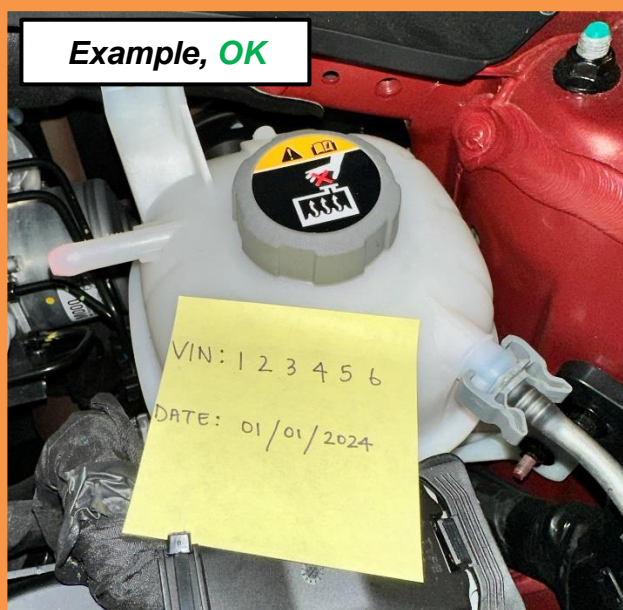
Example, OK

- 3b. Document the coolant reservoir showing no coolant leaks / cracks / burrs.

Using STUI, take a photo of the tank flange with the reservoir tank hose disconnected and the last 6 digits of the VIN and date of inspection on a piece of paper.

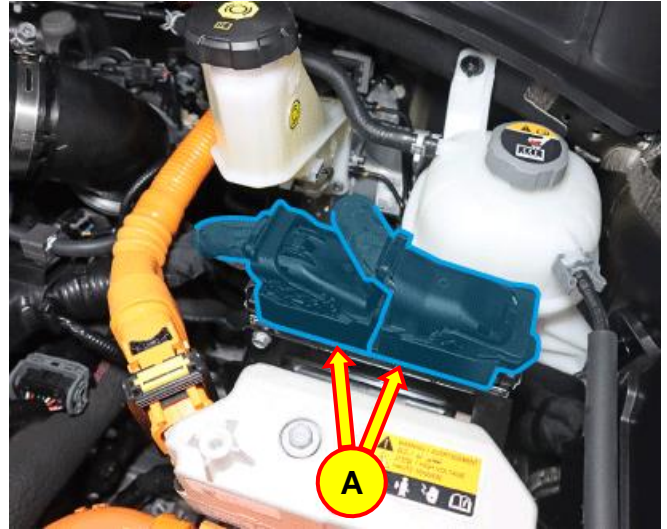
1. Disconnect the negative battery terminal, engine control module connectors (A) and remove the engine control module (ECM).

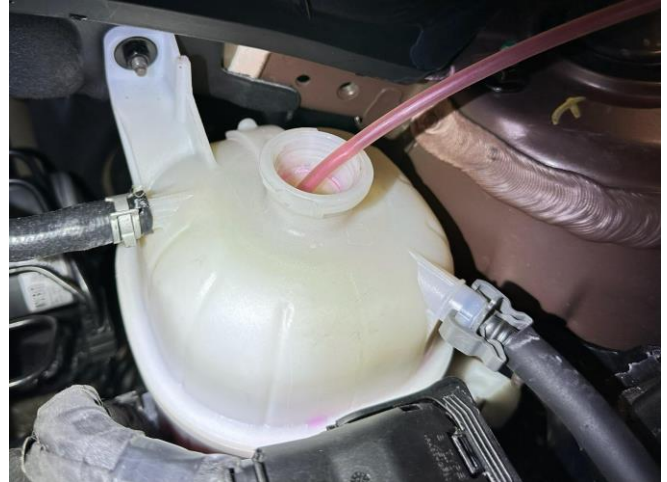
2. Using an evacuation tool, remove the coolant from the reservoir.

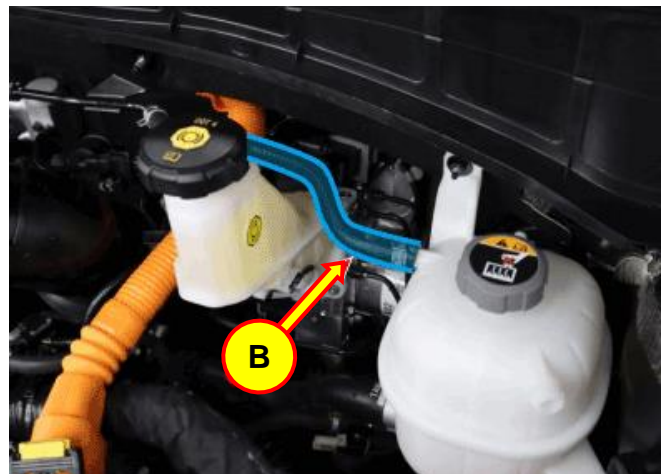
3. Remove the reservoir tank hose (B).

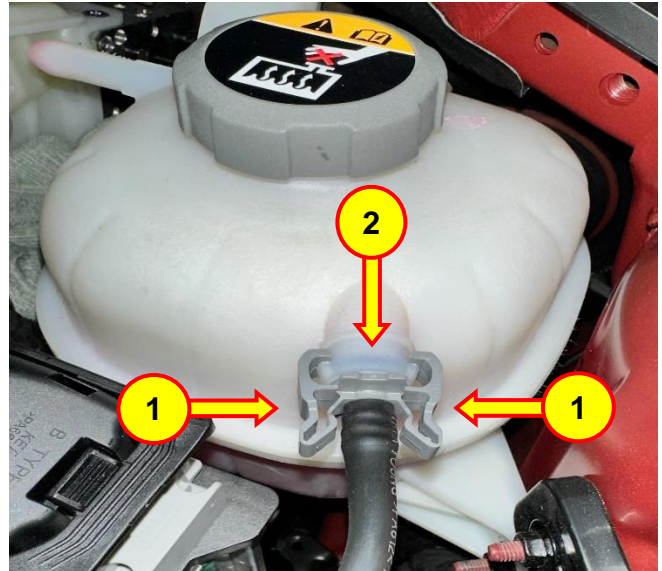
4. Remove the degassing hose from the reservoir tank.

When disconnecting the degassing hose, separate in the order shown to the right.

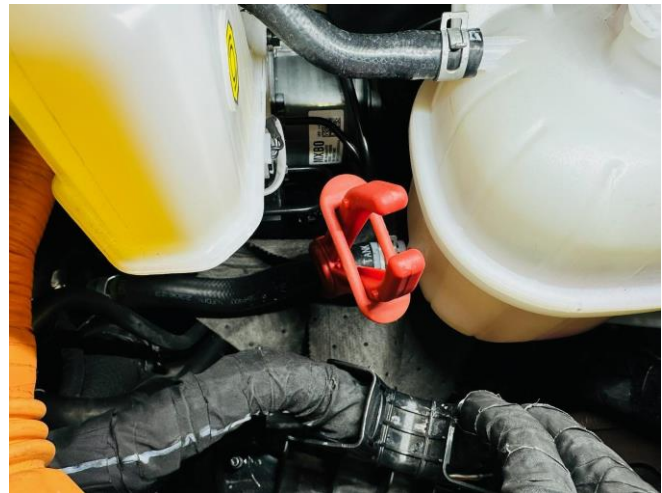
5. Remove the lower cooling hose from the reservoir tank, remove the two fasteners holding the coolant tank reservoir, and remove the coolant tank reservoir.

- Place a hose pinch clamp plier on the lower hose before removing to prevent excess coolant loss.
- Place an absorbent mat underneath the coolant tank reservoir to capture any coolant that may escape.

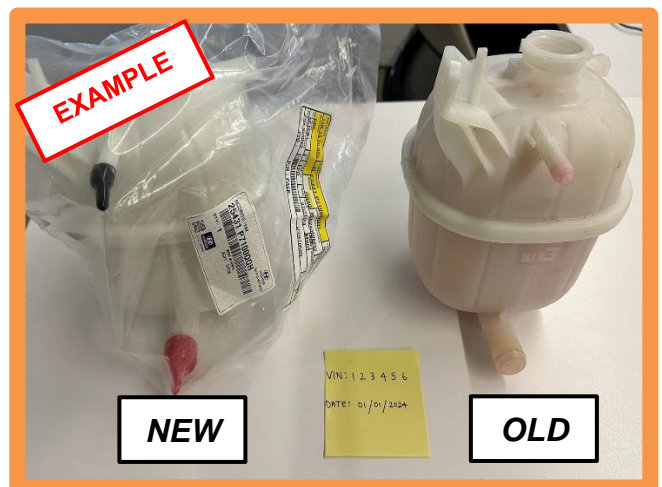
Using STUI, take a clear photo of the OLD part removed next to the NEW part in the bag with the 'QQH' label showing with the last 6 digits of the VIN and the date of repair on a piece of paper.

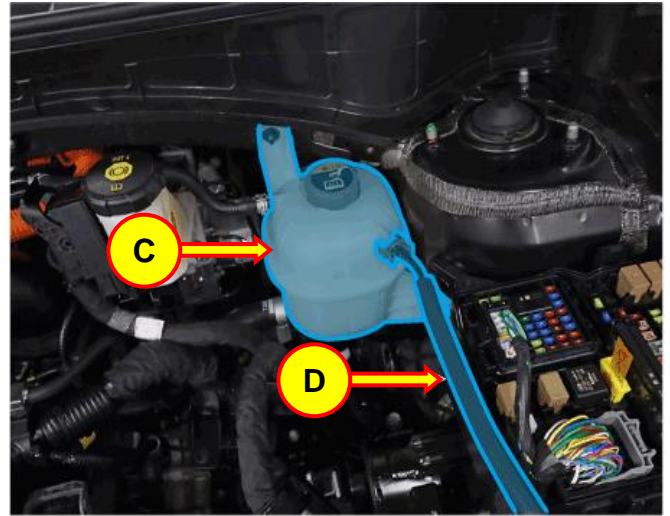
7. Install the new coolant reservoir tank in the reverse order of removal along with other disconnected or removed components (C & D).

Re-use the old coolant reservoir tank cap, hoses, and hose clamps.

lb-ft	7.3
lb-in	87.0
N.m	9.8

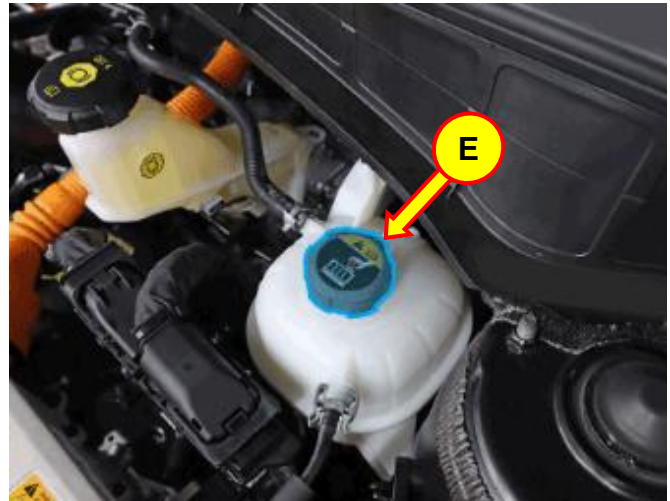
8. Fill the coolant reservoir tank with coolant (E) as needed.

Be sure to follow the Integrated Thermal Module Coolant Filling Mode procedure. Failure to do so may result in air pockets and overheating of engine.
