## EPS Sticking and Slipping

Supersedes 24-095 dated July 25, 2024, to revise the information highlighted in yellow.

Year	Model	Trim Level	VIN Range
2022–24	Civic	ALL	ALL

Redistribute grease to the worm gear, and replace the end cap, spring, and spring seat in the EPS gearbox assembly.

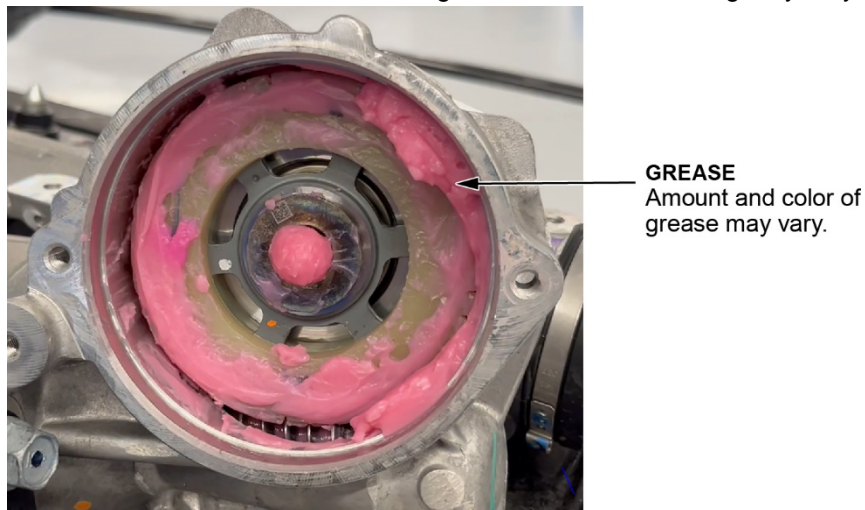
3. Remove the cover.

NOTE: The amount and color of the grease inside the housing may vary from vehicle to vehicle.

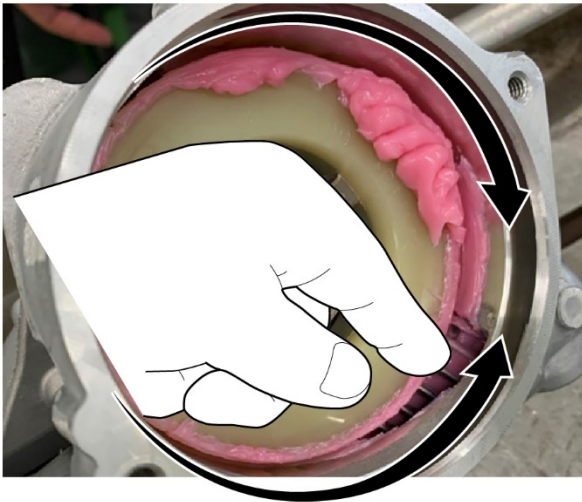
**BEFORE**

- **Do not** add any additional grease.
  - Save a small amount of grease to be used in **Steps 8 and 9**.
1. While wearing clean gloves, start at the top and run your finger along the nylon gear and aluminum housing while directing the excess grease to the metal worm gear at the lower area of the housing.
  2. Once the excess grease is moved to the lower area of the nylon gear, pack the grease into the worm gear location until the grease fills the gap where the worm gear mates with the nylon gear.

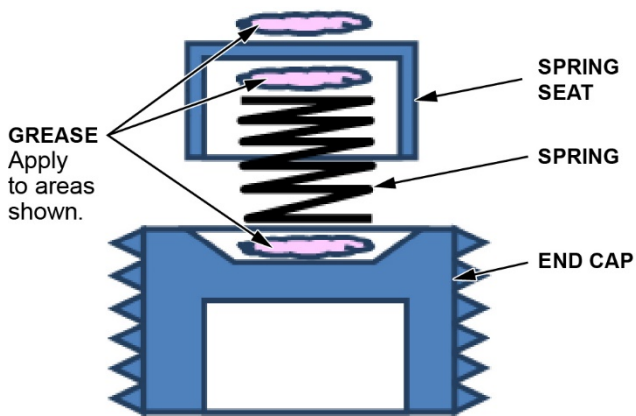
8. **Using the extra grease from the previous step**, apply grease between the new replacement end cap, spring, spring seat, and also on top of the spring seat. Protect the assembly from potential contamination by setting it aside in a safe place.

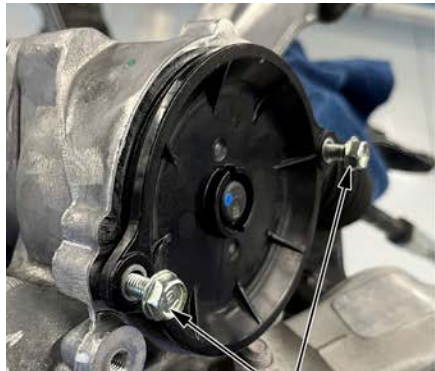
**BOLTS**  
Loosely install.

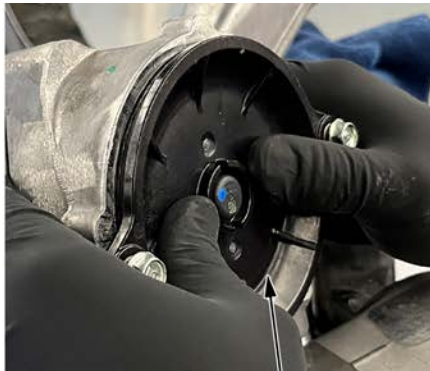
**COVER**  
Gently press.

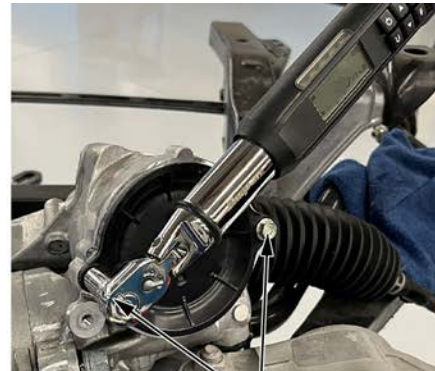
**TORQUE BOLTS**  
8 N·m (6 lb-ft)

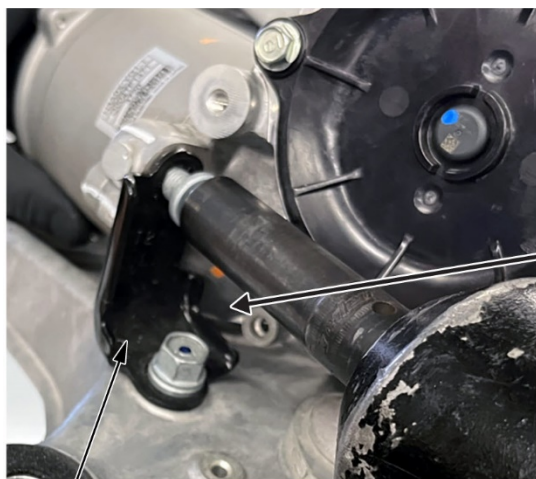
**EPS BRACKET**

13. Remove the EPS bracket.

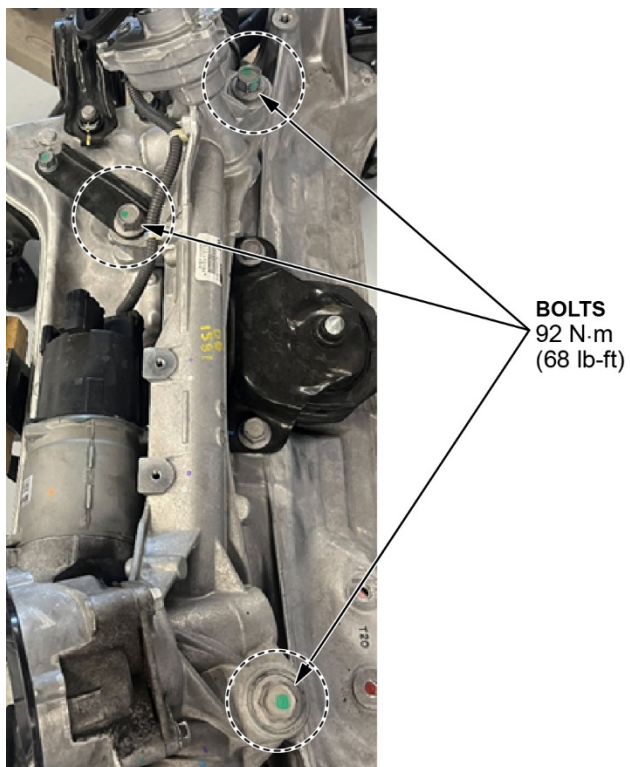
14. Remove the EPS gearbox from the subframe.

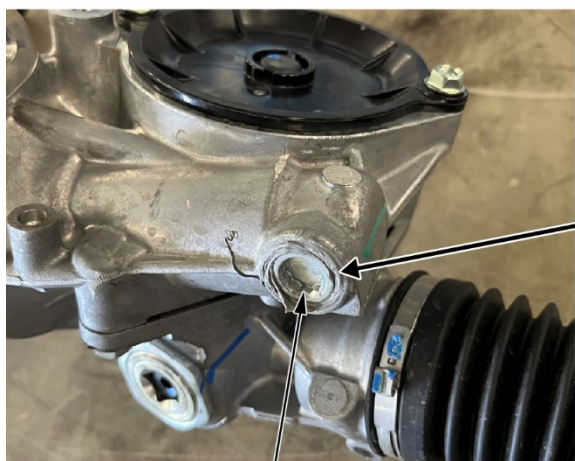
**BEFORE**

15. Using a wire brush, clean off the exposed sealant around the end cap. Then, use a rag (with brake cleaner) to wipe away any residual loose material.

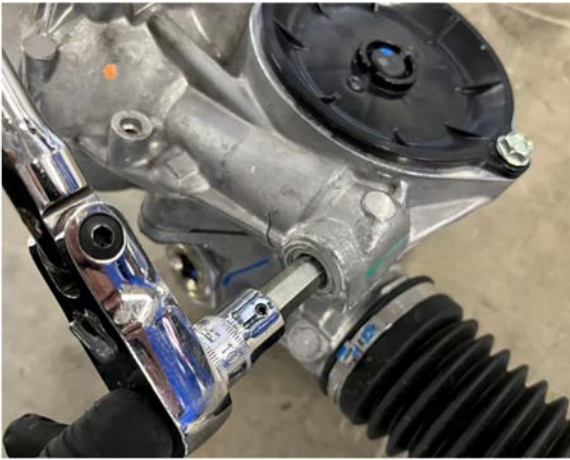
16. With a **10 mm** hex socket bit, remove the end cap on the EPS gearbox.

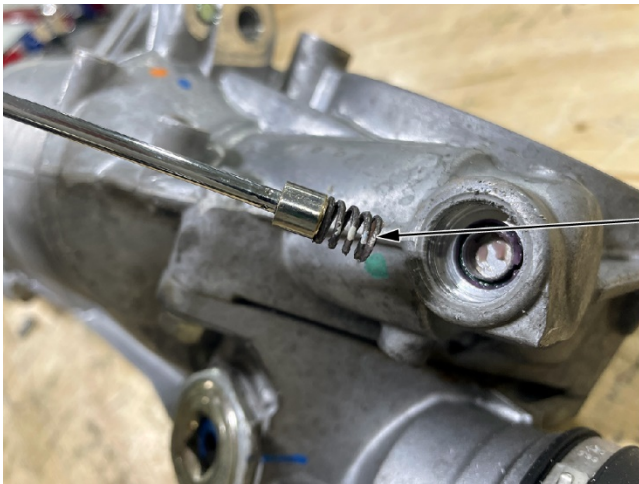
17. Using a magnet tool, remove the spring from the EPS gearbox and **immediately discard upon removal**.

SPRING  
Discard.

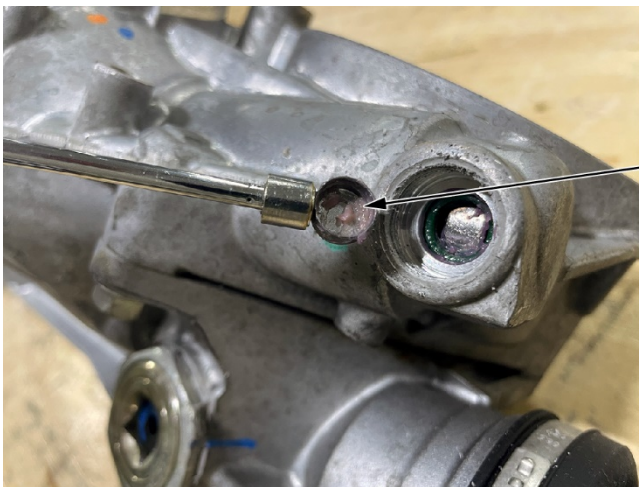
18. Using a magnet tool, remove the spring seat from the EPS gearbox and **immediately discard upon removal**.

SPRING SEAT  
Discard.

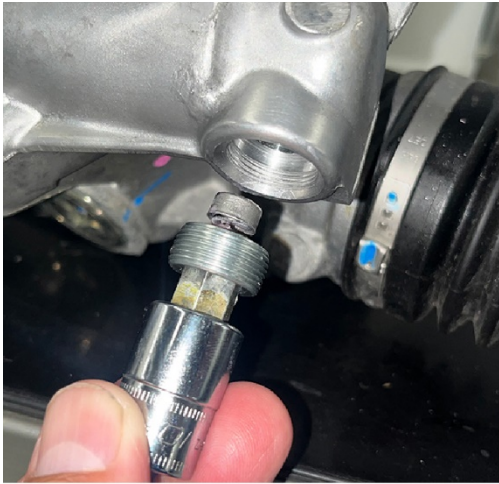
19. With the new spring seat, spring, and end cap held together by the grease, install the pieces together into the EPS gearbox, then tighten the end cap until **4 mm** of threads remain exposed.

NOTE: To keep the parts from falling off the hex socket bit while installing, rotate the EPS housing until the hole is facing downward, then install the spring seat, spring, and end cap up into the hole.

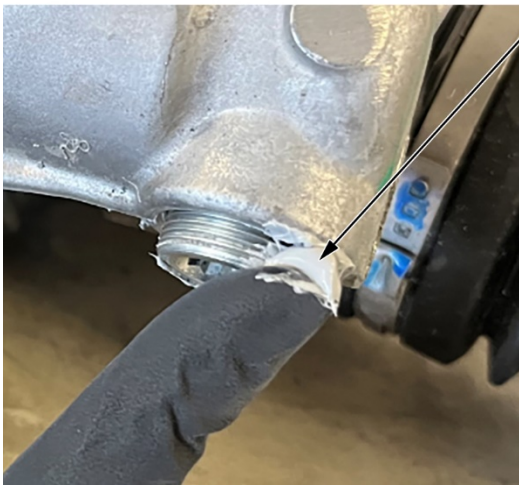
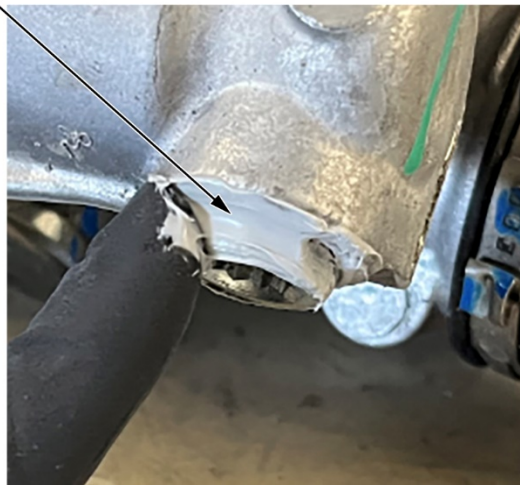
HONDABOND

20. Before torquing, apply Hondabond sealant to the exposed threads of the end cap.

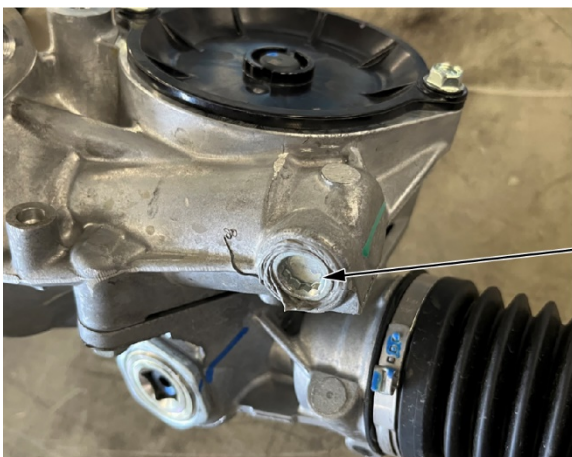
21. Torque the end cap to **12 N·m (9 lb-ft)**, then wipe off all excess Hondabond.

END CAP  
12 N·m (9 lb-ft)
