August 6, 2024

Version 4

A/C Compressor Shaft Seal Leak

AFFECTED VEHICLES

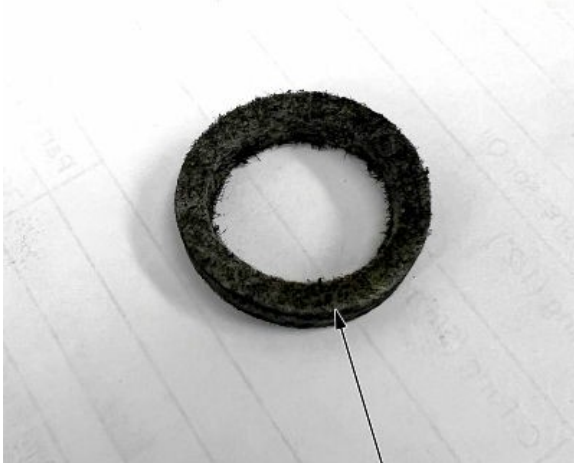
6. Remove the felt washer from the compressor and gently place it on a clean sheet of paper.

NOTE: If oil transfers from the felt washer to the paper after **10 seconds**, proceed to the repair procedure. If not, continue to the next step.

Observe for excess oil.

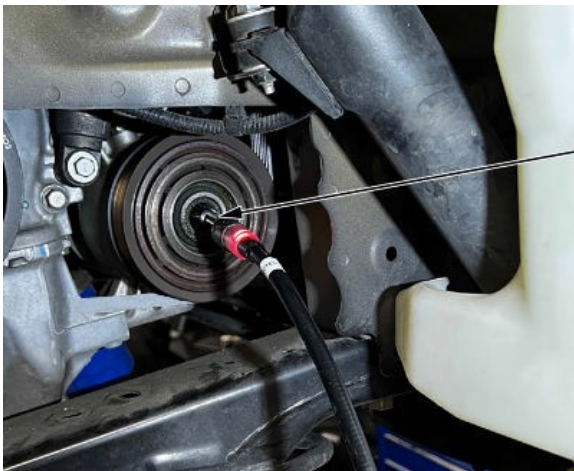
7. Using a calibrated leak detector, check for a leak.

- Use a leak detector for at least **5 minutes** around the snout of the compressor.
- An A/C compressor that has not been engaged will yield better results. The longer the A/C compressor has not been run, the better chance you will have at detecting a leak.
- A higher engine temperature produces more accurate results.
- If a leak is detected, proceed to the repair procedure.

SNOUT OF
COMPRESSOR

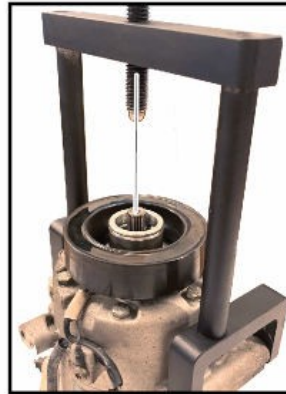
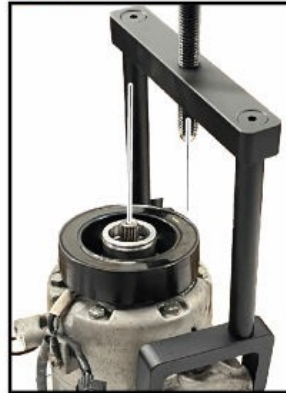
19. Place the press tool onto the A/C compressor and insert the holding pins (2). Make sure the press tool installs where the press shaft should align with compressor shaft. The press tool will only align correctly in one orientation. The pins must go all the way through.

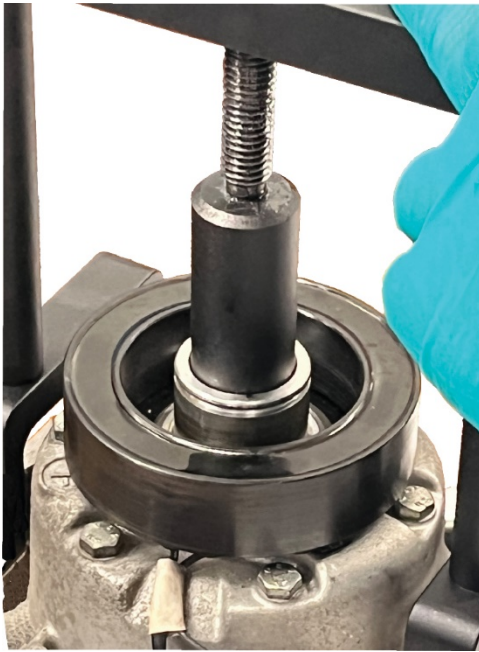
22. Tighten the press until there is no clearance, then **3/4 turn (270°)**.

- The purpose of this step is to break the compressor shaft seal loose.
- Turning the handle more than **3/4 turn (270 degrees)** can damage the tool and seal making it difficult to remove the compressor shaft seal.

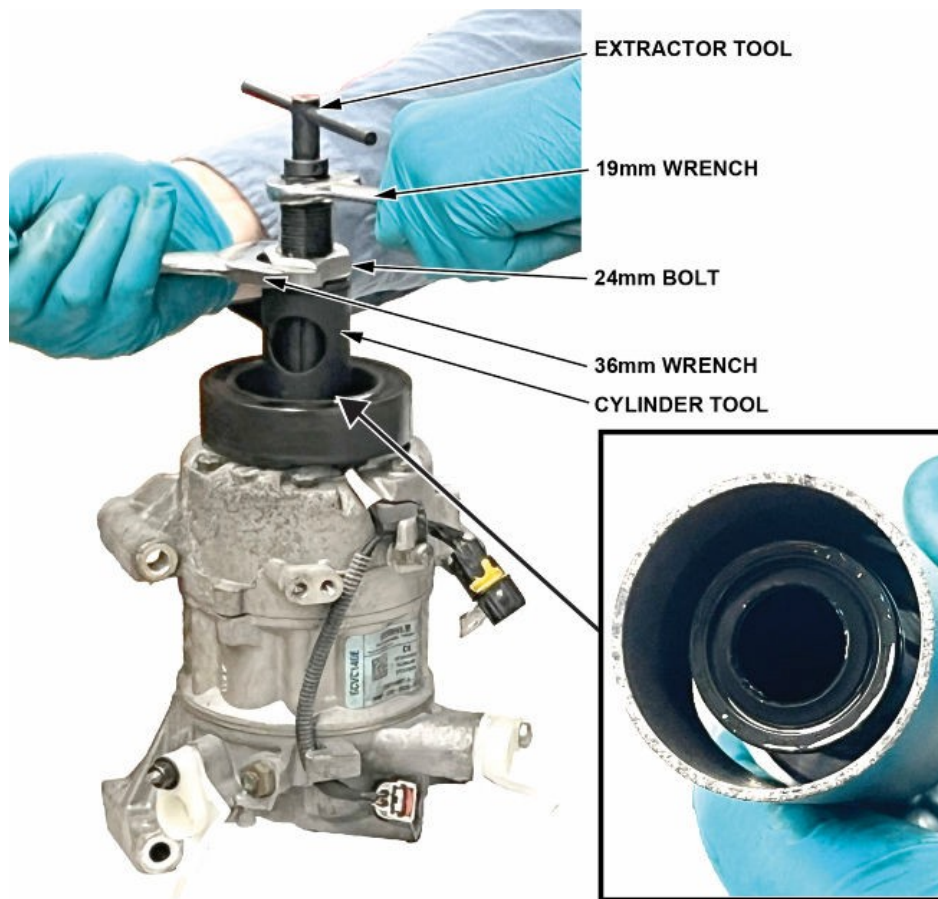
28. With the **19 mm** wrench in place, lower the **24 mm** nut down until it reaches the cylinder. Slowly and carefully adjust until the extractor tool comes out freely with the seal.

- Resistance will be felt while lowering **24 mm** nut and will cease once the seal is extracted.
- If the seal does not come out on the first step, repeat the process starting at step 13.

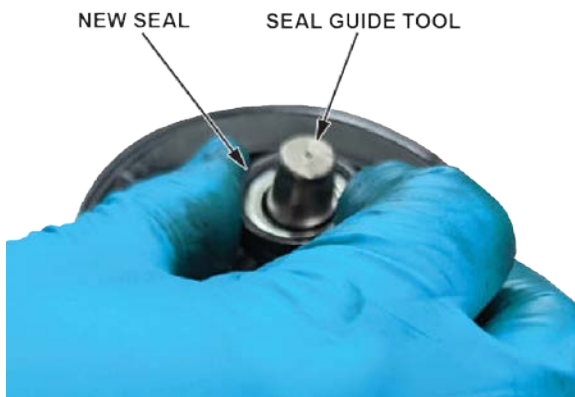
33. Insert the new seal onto the seal guide tool.

NOTE: The seal is directional and must be placed with the metal side upward.

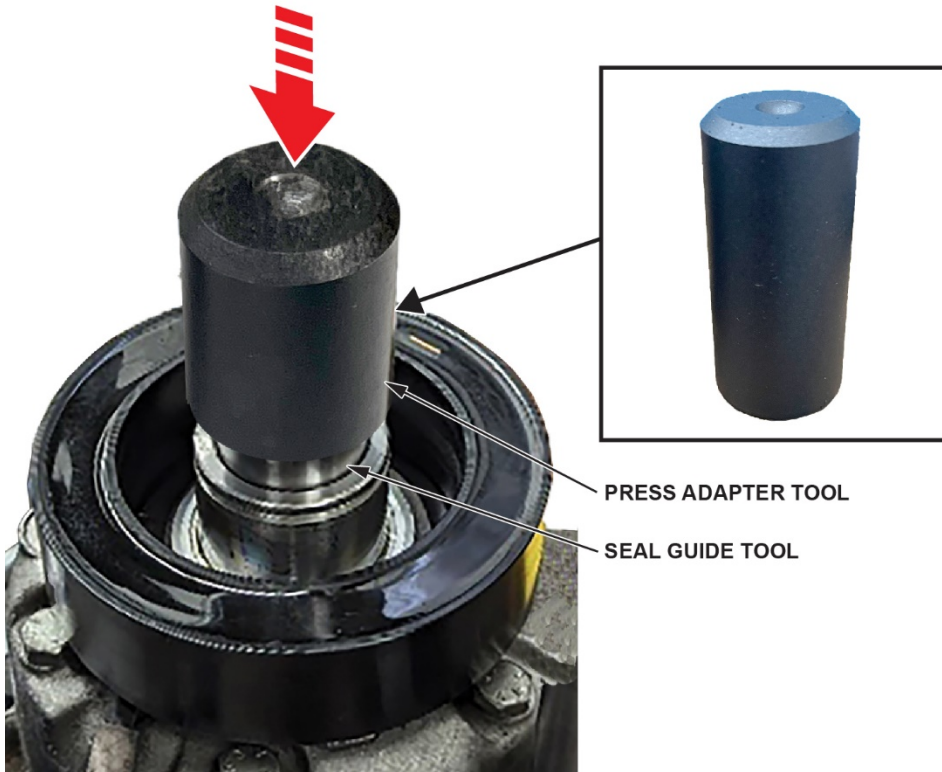
34. Insert the press adapter tool over the seal guide. By hand, press down to seat the new seal about **5 mm** below the top edge of the bore and remove the press adapter.

Push down.

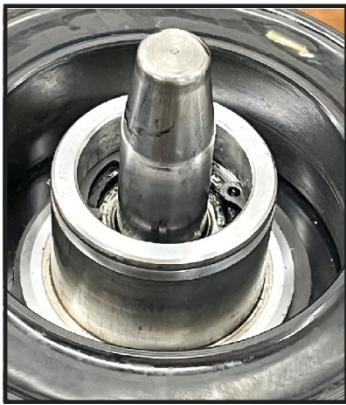
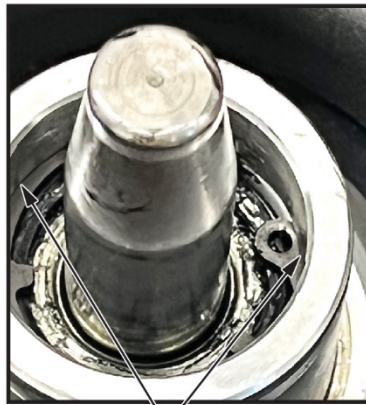
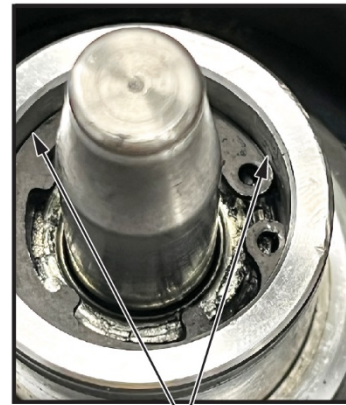
35. Insert the new seal C-ring with the teeth's rounded side pointing down into the bore.

GOOD

NO GOOD

C-RING SET IN GROOVE

C-RING NOT SET IN GROOVE
