## EPS Sticking and Slipping

Supersedes 24-037, dated July 25, 2024, to revise the information highlighted in **yellow**.

Year	Model	Trim Level	VIN Range
2023–24	Integra	ALL	ALL

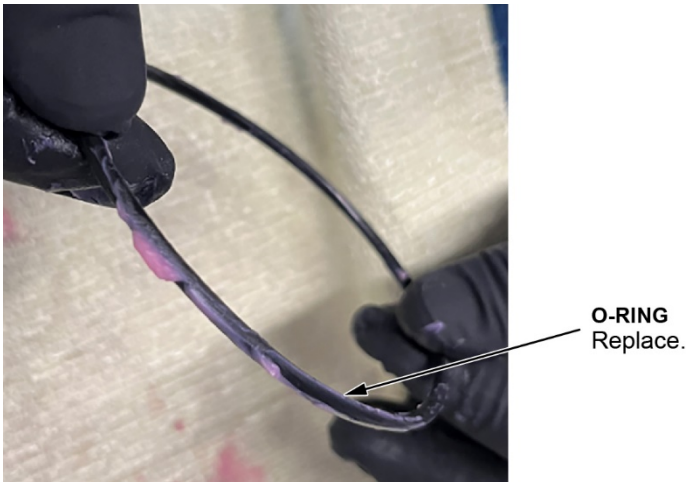
9. Apply grease to the new O-ring.

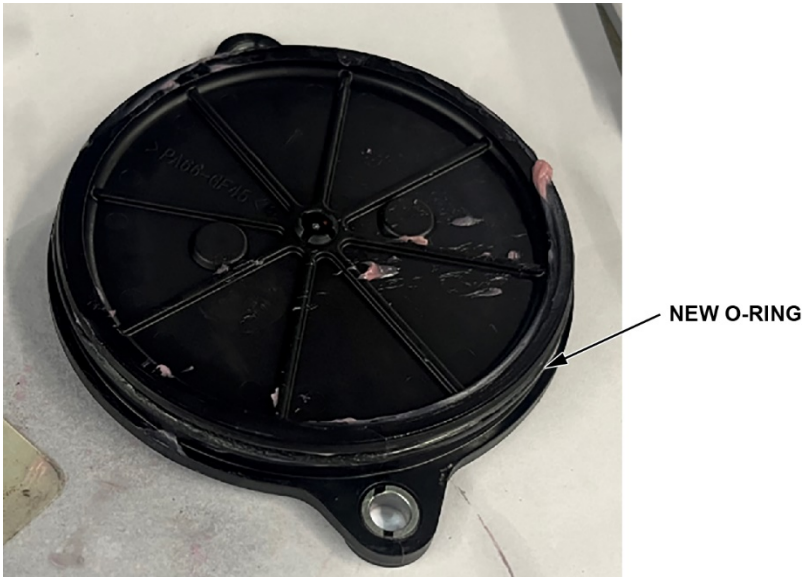
10. Install the new greased O-ring onto the cover.

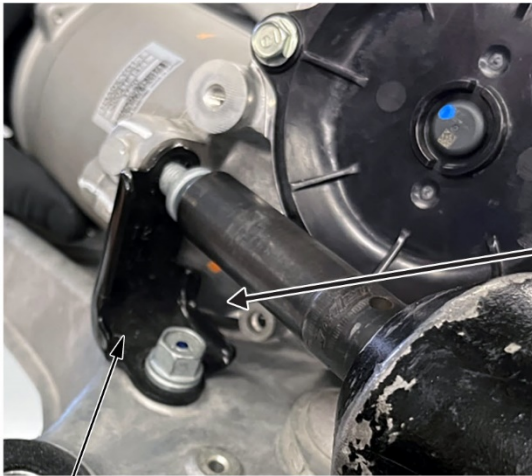
**EPS BRACKET**

13. Remove the EPS bracket.

**BOLTS (2)**  
44 N·m (32 lb-ft)

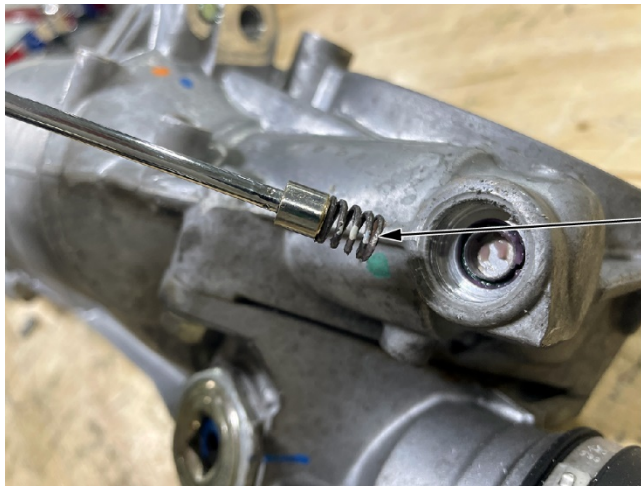
17. Using a magnet tool, remove the spring from the EPS gearbox and **immediately discard upon removal**.  
NOTE: Be careful not to get contamination in the opening.

**SPRING**  
Discard.

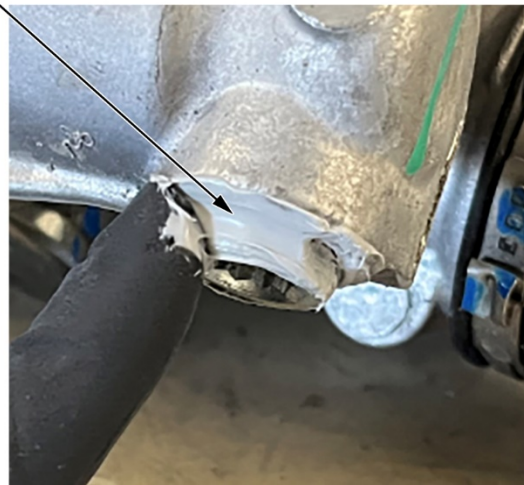
HONDABOND

20. Before torquing, apply Hondabond sealant to the exposed threads of the end cover plug.
