## PIT6057A Power Swing Gate will not power open or unlatch and only move 1-2 mm

Brand:	Model:	Model Years:	VIN:		Engine:	Transmissions:
			from	to		
GMC	HUMMER EV SUV	2024	All	All	All	All

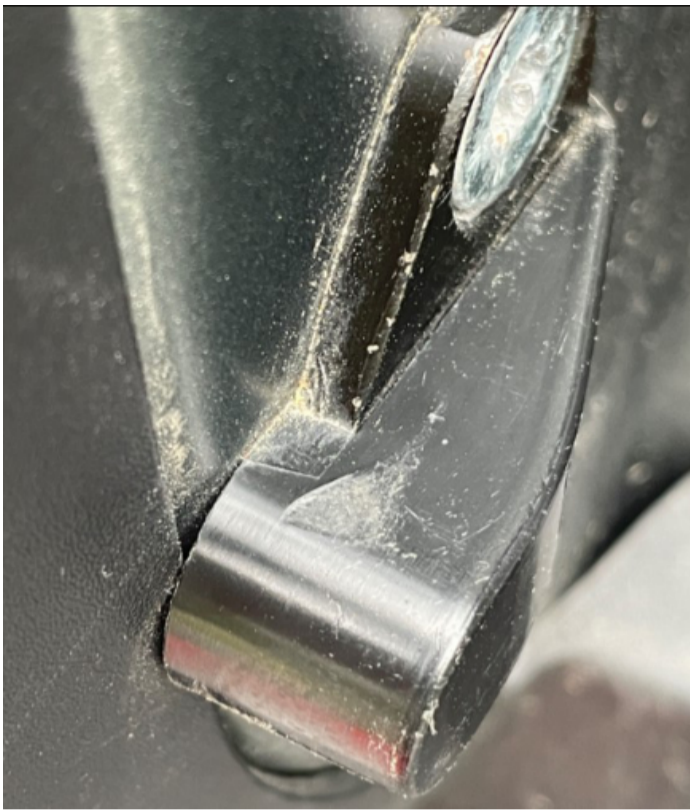
If you experience this concern, Inspect the swing gate guide wedge or the swing gate receiver for signs of scraping or rubbing ( See photo examples below)

Top side of Lower Wedge above

To correct this concern, Start by opening the swing gate. To open the swing gate, grab the spare tire and pull the door open while pressing the unlock button. Once the door is open, slightly loosen the rear door guide wedge bolts on the body ( See Document ID: 6379244 in SI ). Push the close button and let the door auto close.

The wedge will self-align. Check that the lower wedge is centered in the wedge receiver. Open and close the door to verify proper operation. Torque the T40 wedge bolts to 22 Nm (16 lb. ft.)

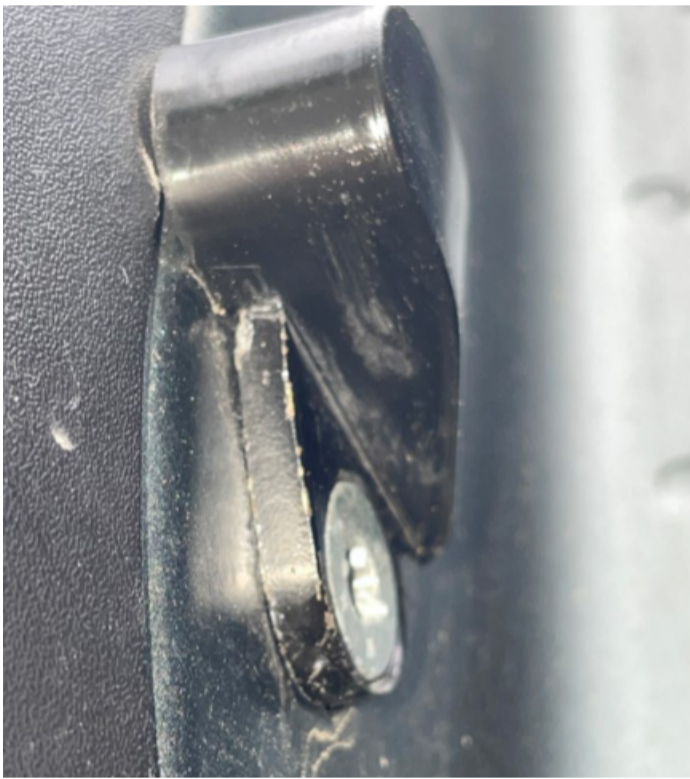
Bottom side of lower wedge above

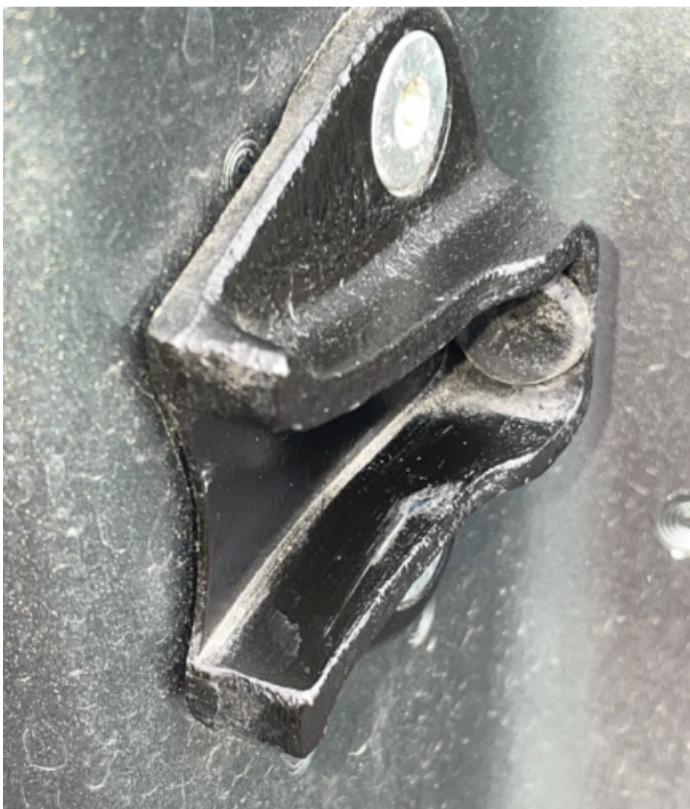
## Wedge receiver above

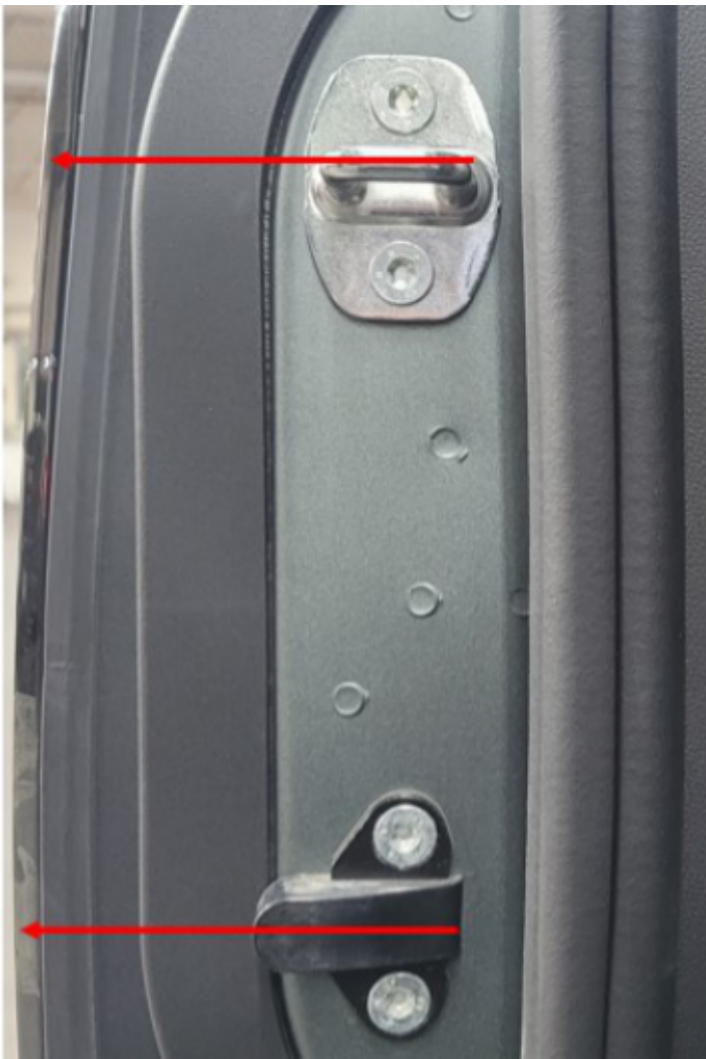
Next, make sure the striker and the lower wedge are parallel with each other, along with proper alignment of the wedge receiver.

If after aligning the wedge, the gate still has a issues opening automatically, work through the striker alignment procedure which can be found under Document id: 5830237 In SI.

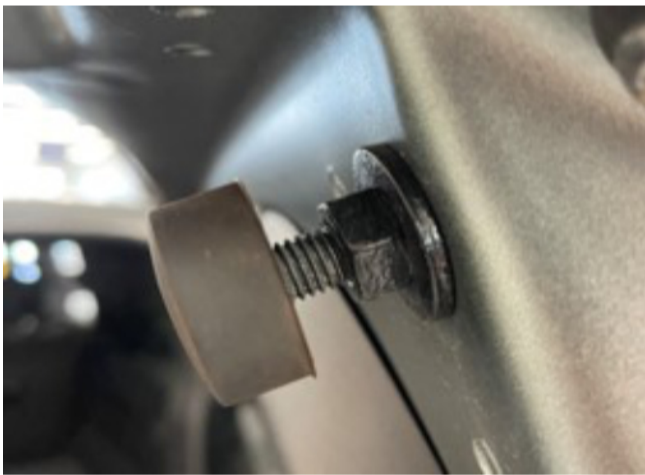
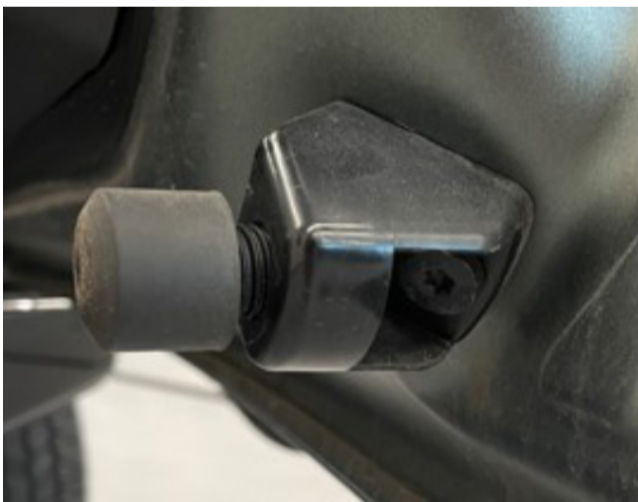
Lastly, check the position of the swing gate bumpers. Adjust them so they are just touching the body.
