## STAR ONLINE PUBLICATION

**Case Number:** S2023000024 Rev. C

**Symptom/Vehicle Issue:** Water Leak Rear Of Cab Rear Seat Or Headliner

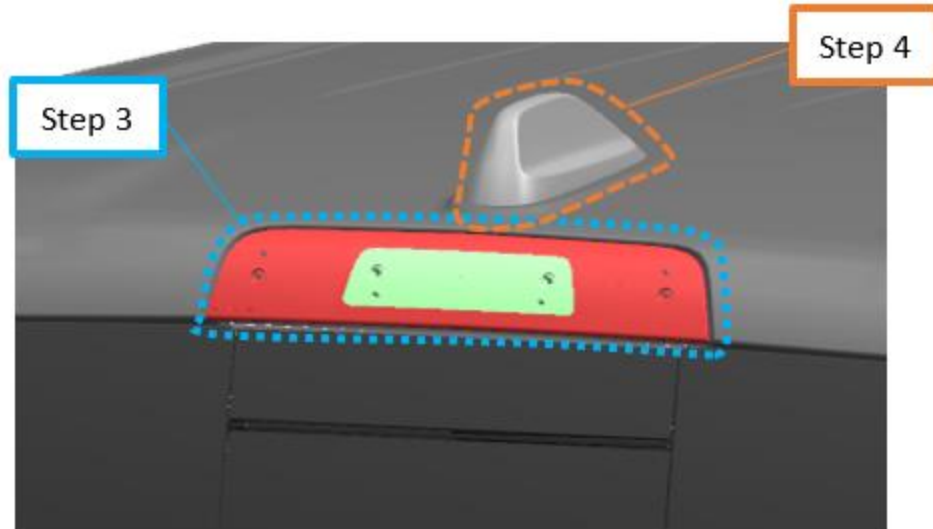
- Step 4: Move water hose around roof antenna. Check roof interior for leaks. Verify foam seal under antenna is in good condition. Verify antenna is torqued to spec

**IF Step 1 or Step 2 yields leaks:** Remove and reseal the backlite and ensure correct urethane seal.

**IF Step 3 yields leaks:** There are 2 different procedures. Note which bulb style you are working on. LED or Incandescent. Always refer to STAR Parts for up to date parts information

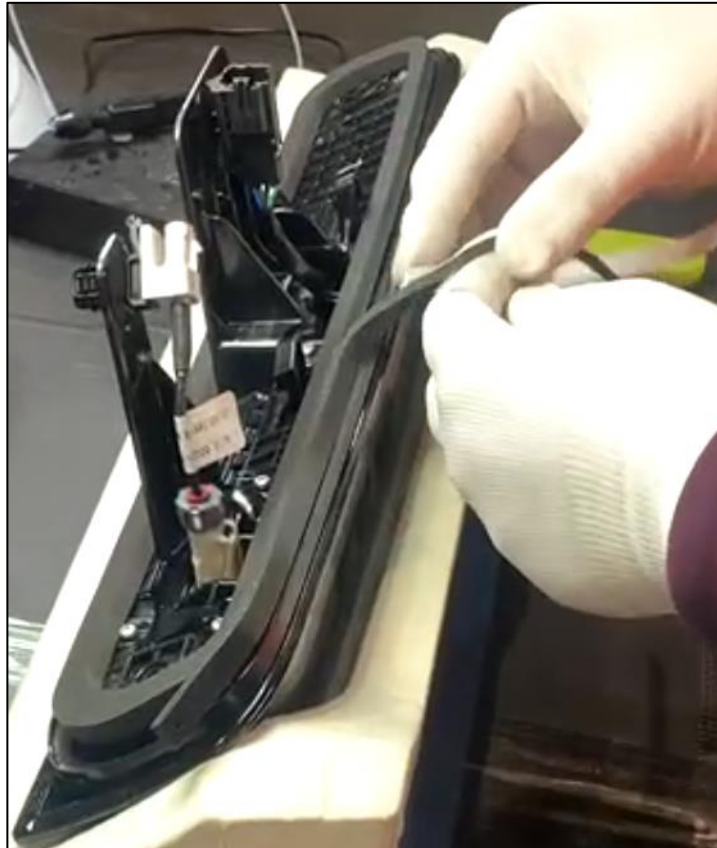
Apply the secondary gasket directly onto the main gasket of the CHMSL. The secondary gasket should be at the top of the part when installed. Remove the adhesive backing from the secondary gasket as you go. You may want to use a ruler or credit card to lightly press the secondary gasket onto the main gasket.

Order a replacement LED CHMSL (Part Number 68444540AB) and order a secondary gasket (Part Number 68545973AA).

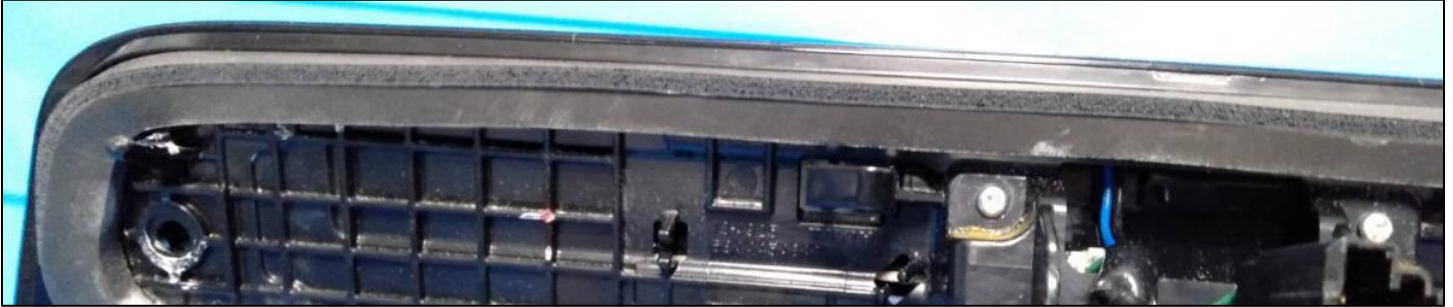
Final result should look like the image below:

Check: once the CHMSL is installed onto the vehicle there should be no gasket visible from the top or the sides.

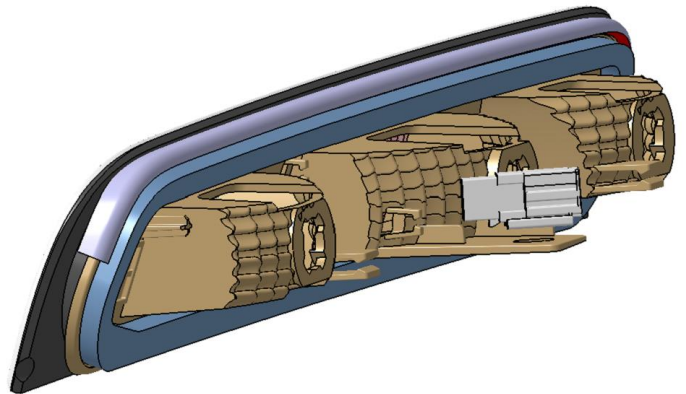
Apply the secondary gasket onto the plastic above the main gasket; the secondary gasket and main gasket will not touch. The secondary gasket should be at the top of the part when installed.

Order a replacement Incandescent Bulb CHMSL (Part Number 68298380AE) and a secondary gasket (Part Number 68545973AA).

**Note:** part numbers 68298380AF and 68298380AG will already have the secondary gasket applied and you won't have to order the part separately.

Check: once the CHMSL is installed onto the vehicle there should be no gasket visible from the top or the sides.
