REFERENCE:	TSB: 08-183-24 GROUP: 08 - Electrical	Date:	August 13, 2024	REVISION:	-
VEHICLES AFFECTED:	2023 - 2024 (BV) Jeep Renegade This bulletin applies to vehicles built on or after August 01, 2023 (MDH 0801XX) and on or before January 19, 2024 (MDH 0119XX).			MARKET APPLICABILITY:	
				<input type="checkbox"/> NA	<input type="checkbox"/> MEA
				<input type="checkbox"/> SA	<input checked="" type="checkbox"/> IAP
				<input type="checkbox"/> EE	<input type="checkbox"/> CH
CUSTOMER SYMPTOM:	Customers may comment on the following:				
	<ul style="list-style-type: none"> Center High Mounted Stop Lamp (CHMSL) holding water. 				
CAUSE:	Manufacturing issue

This bulletin involves testing and possibly replacing the CHMSL if water is present inside.

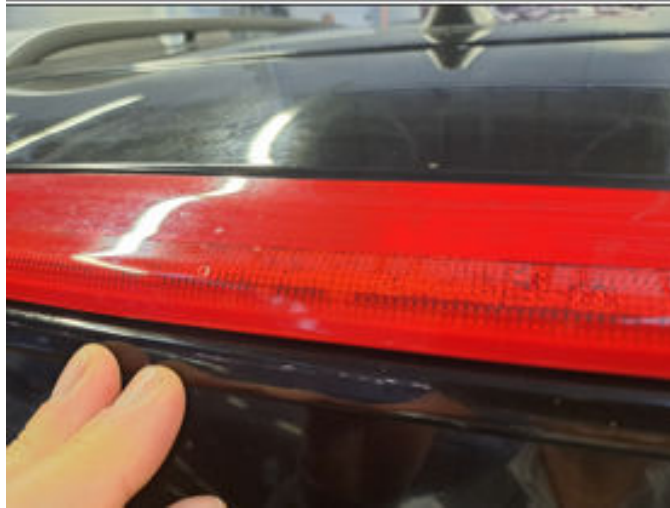
1. Inspect if there is any water in the CHMSL assembly [Fig. 1](#).

Fig. 1
Water Inside Lamp

2. Set the water jet to 120 BAR / (1740 PSI).
3. Position yourself at a distance greater than 40cm (16 inches).
4. Make six passes from right to left for 10 seconds.
5. Dry the CHMSL with compressed air and check for the presence of water inside the assembly.
6. Is water found in the CHMSL assembly?
 - YES>>> Proceed to [Step 7](#).
 - NO>>> This RSU does not apply. Use Inspect LOP (08-50-88-95) to close this active RSU.
7. Replace the CHMSL assembly. Refer to the detailed service procedures available in DealerCONNECT/ Service Library under: 08 - Electrical / 8L - Lamps and Lighting / Lamps/Lighting - Exterior / Lamp, Center High Mounted Stop / Removal and Installation.
