GROUP	MODEL
Service Campaign	2013-2016MY Optima Hybrid (TF HEV)
NUMBER	DATE
SC269 (Rev 1, 08/15/2024)	July 2023

HIGH-VOLTAGE BATTERY SAFETY PLUG FUSE INSPECTION AND REPLACEMENT (SC269)

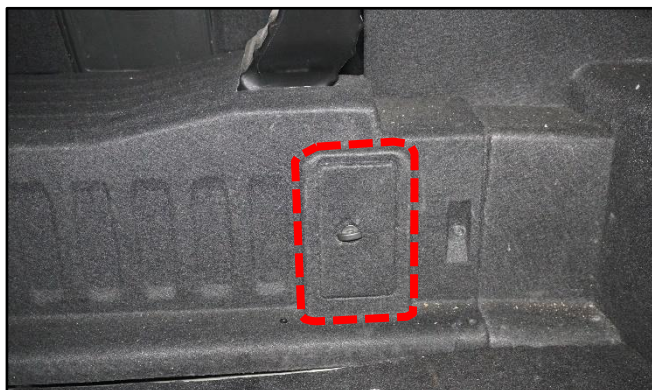
2. Open the High Voltage Battery (HVB) safety plug service cover in the rear cargo area.

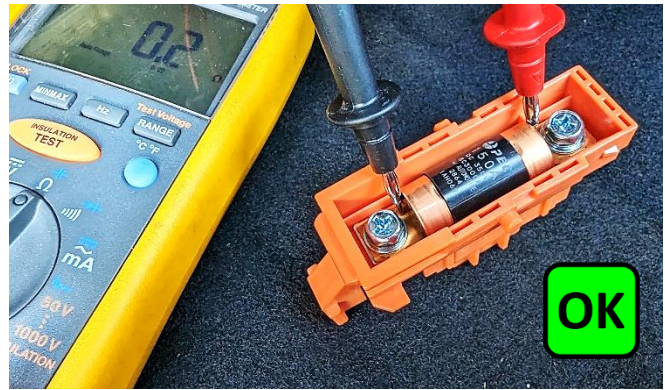
5. Using a multimeter, measure the HV main fuse resistance (in Ohms).

- Resistance is 1Ω or less (OK), proceed to step 6.
- Resistance is over 1Ω (NG), replace the HV main fuse with a new 150A fuse, then proceed to step 7.
