**Volvo Car USA LLC**
**Technical Journal**

Technical Journal Title <b>Coolant Pump Dry Coolant Mix Residue</b>		Ref. No. <b>TJ 36923.4.0</b>	
Issuer (Dept.) <b>Technical Service</b>		Issue Date <b>6/10/24</b>	Status Date <b>6/19/24</b>
Car Market <b>United States and Canada</b>	Partner <b>3 US 7510 Volvo Car USA</b>	Function Group <b>2621</b>	
Function Description <b>Coolant pump, complete</b>		Page <b>Page 1 of 3</b>

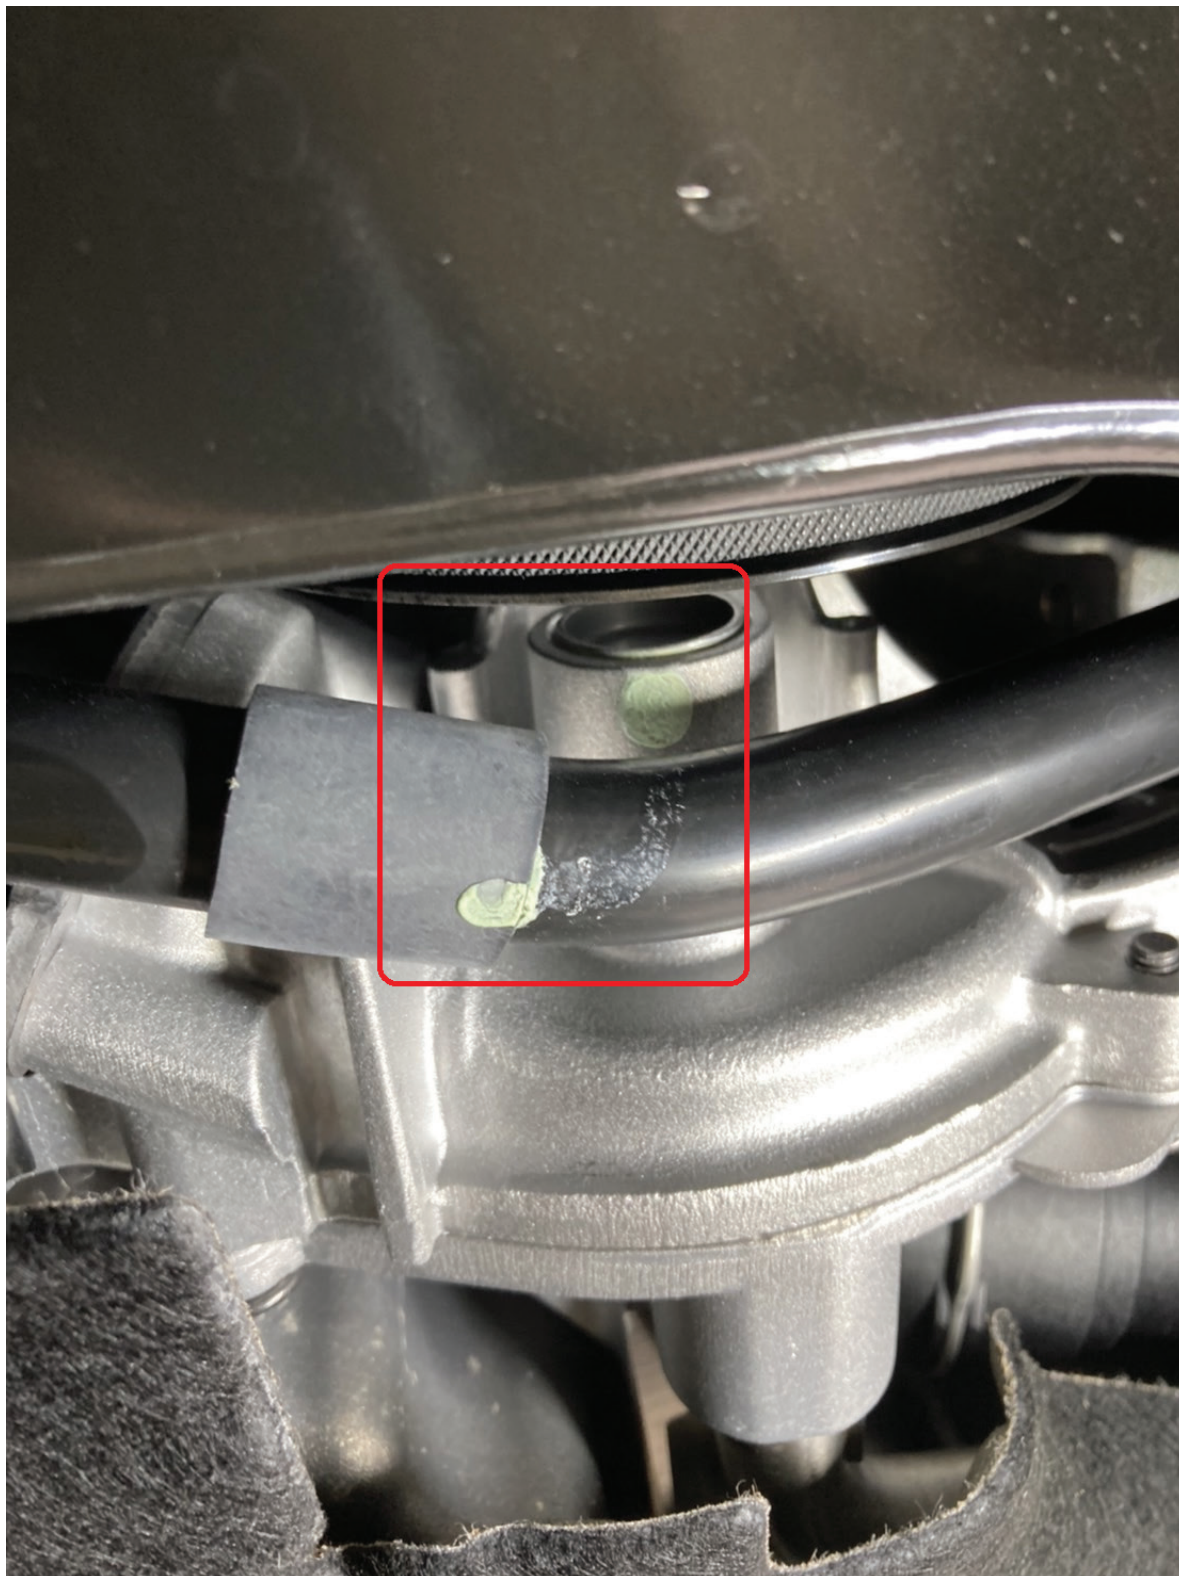
File Name	File Size
TJ_36923_1.png	2.0621 MB

If the coolant pump has a small sign of dry green/white coolant mix (see example in attached picture *TJ\_36923\_1*) without a DTC set, follow advice under "Service".

If the coolant pump has a small sign of dry green/white coolant mix **but no other symptoms** (e.g., warning message(s), visible coolant leakage under the vehicle), this is considered OK, do not replace any parts.
