Title:	Side Roll Protection (SRP) Resistor Leg Locations

Number:	SB_702	Release Date:	07/23/2024	
Revision Number:	Not Applicable	Revision Date:	Not Applicable	
Chassis Type:	Custom Chassis			
Component Description:	Unused legs of SRP harness w/ resistors			
Tools:	Multimeter

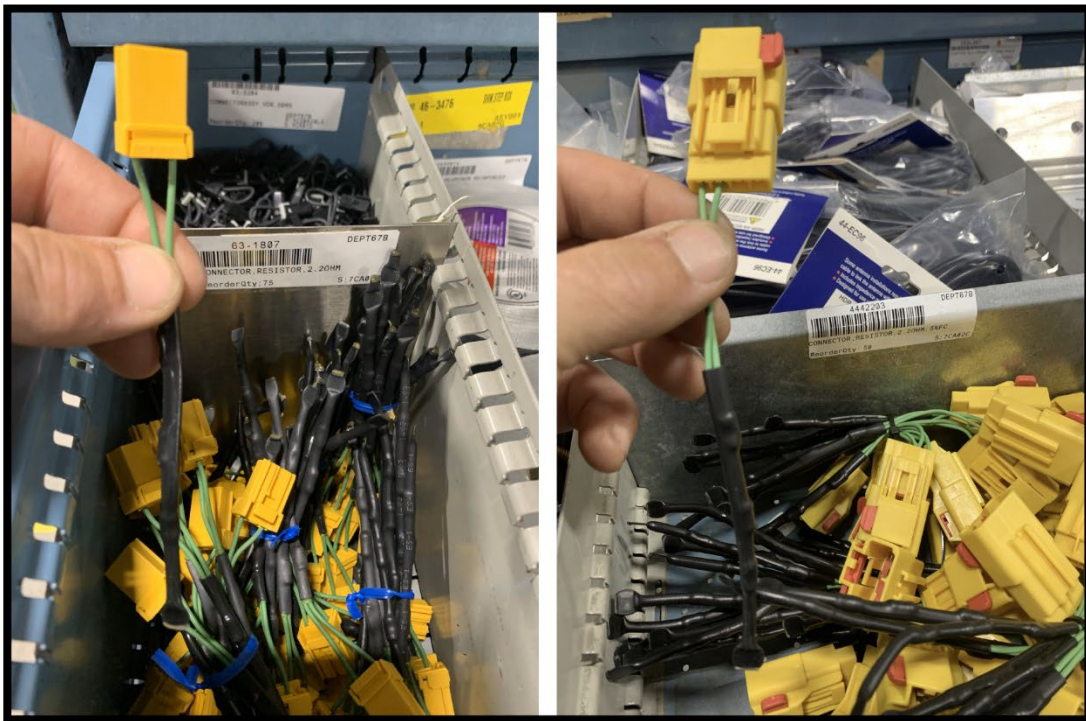
NOTE: Resistor style has changed. Resistors with the black loop are discontinued and, upon failure, should be replaced with PNs: 63-1807 and 4442203.

New Resistors

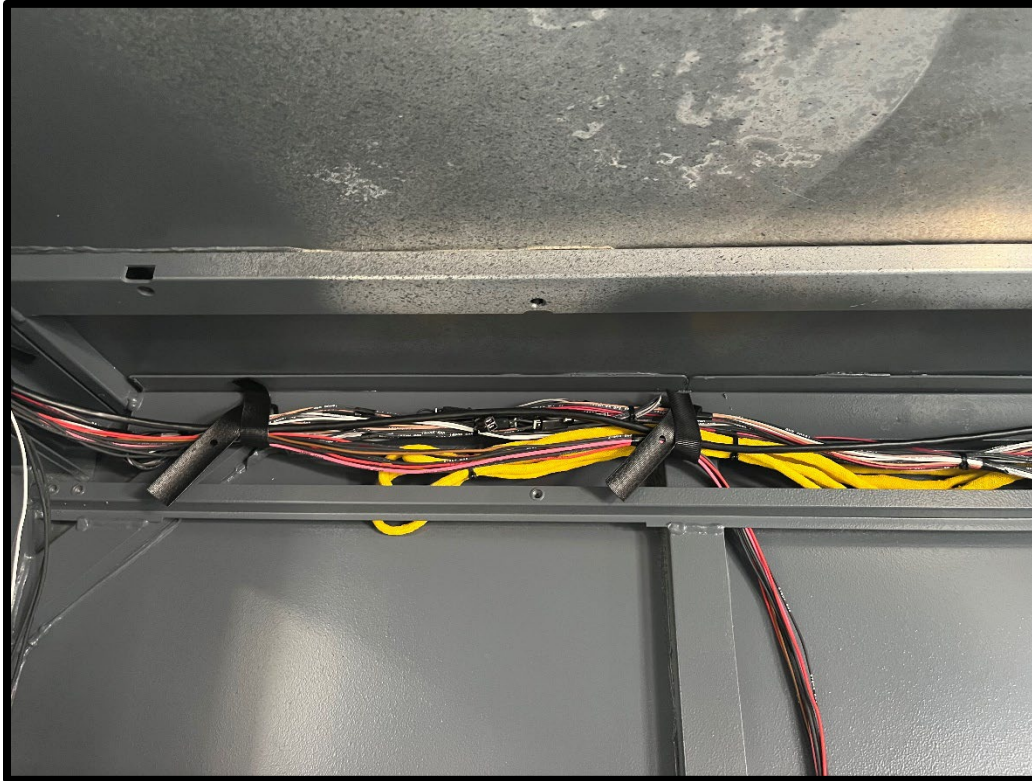
Crew Cab Upper Left Corner

Remove necessary cover panels as required to gain access to unused SRP legs containing resistors.

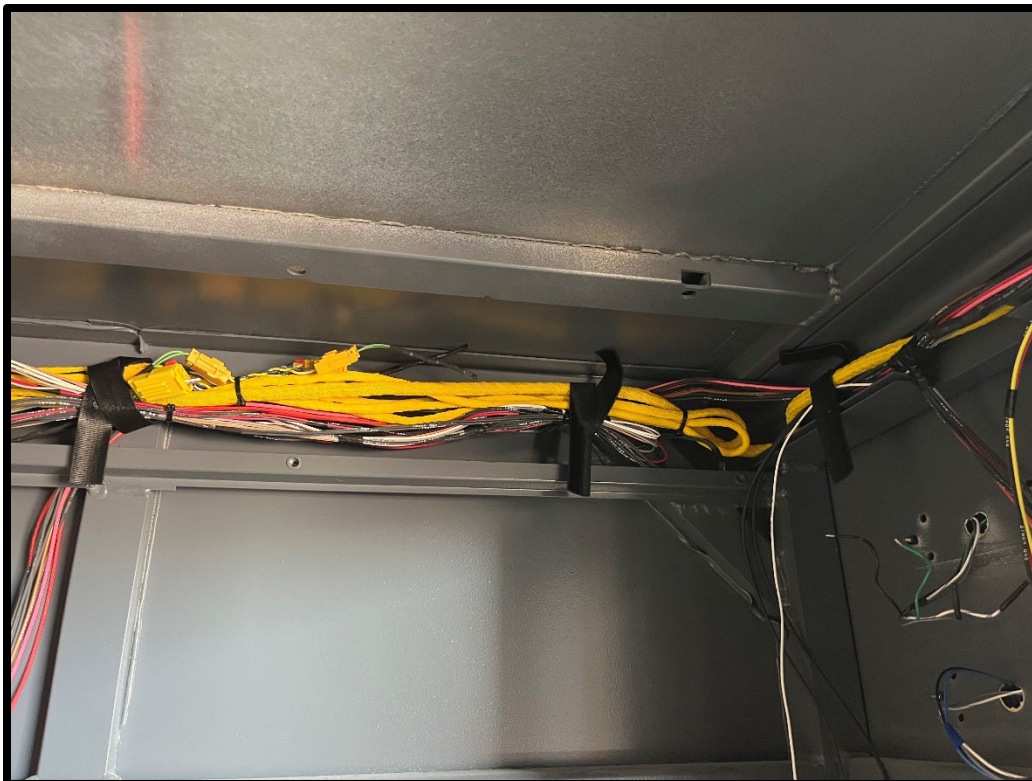
Crew Cab Upper Right Corner

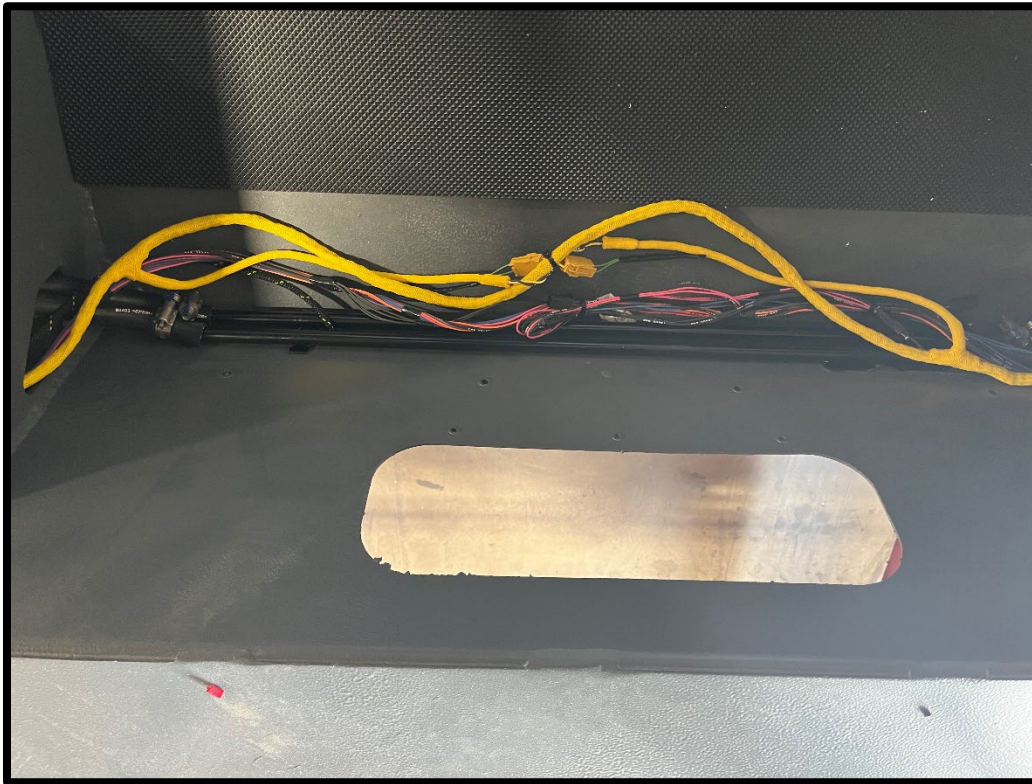
Cover between Rear Facing Heaters
