# Service Bulletin

Bulletin No.: 00-06-01-012N

- Subject:** Use of Surface Conditioning Disks When Cleaning Gasket Sealing Surfaces and/or Reused Parts
- Models:** 2025 and Prior GM Passenger Cars and Trucks including Silverado 4500HD, 5500HD and 6500HD (Excluding Chevrolet Medium Duty Low Cab Forward Equipped with Diesel Engine).
- Attention:** This bulletin also applies to any of the above models that may be North America Export vehicles.

### The Use of Surface Conditioning Disks

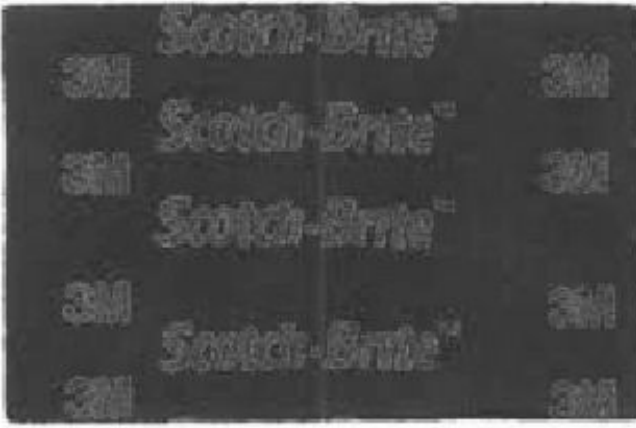
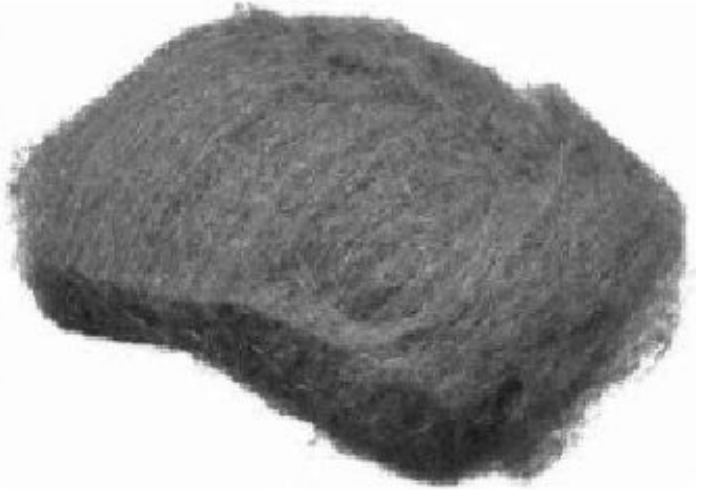
2726943

The use of an abrasive hand pads and/or steel wool can also create imperfections in the metal and therefore are not recommended for use when cleaning surfaces.

General Motors recommends the use of a razor blade or plastic gasket scraper to clean the gasket surface on components that are to be reused. When cleaning gasket surfaces, please note the following:

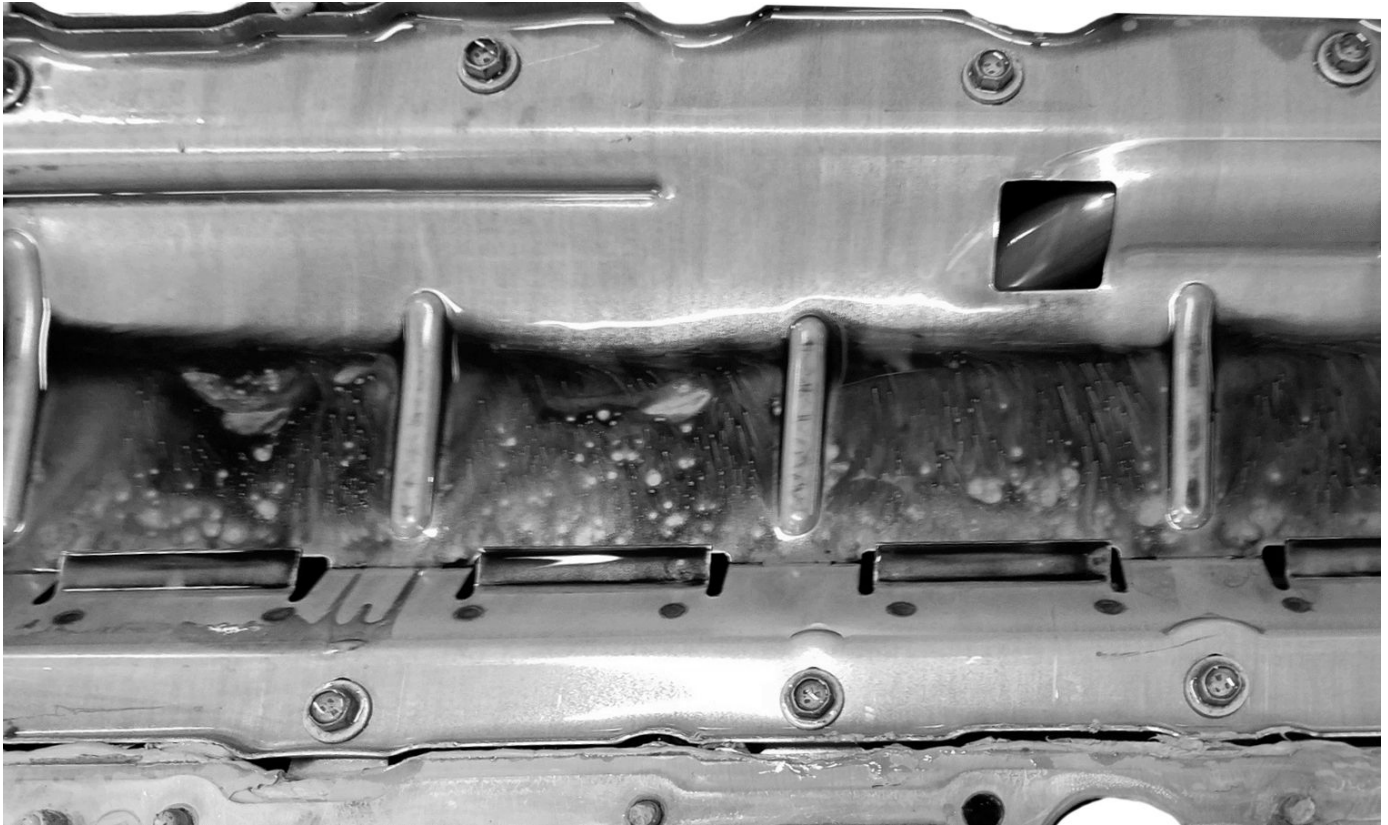
4788796

Surface conditioning disks may grind the component material and imbed it into the disk. This can result when more aggressive grinding of the gasket surface takes place.

The crankshaft deflector in the picture above has debris that was left behind from the abrasive cleaning methods. Once the debris has gotten here, it can be distributed to any surface in the engine.

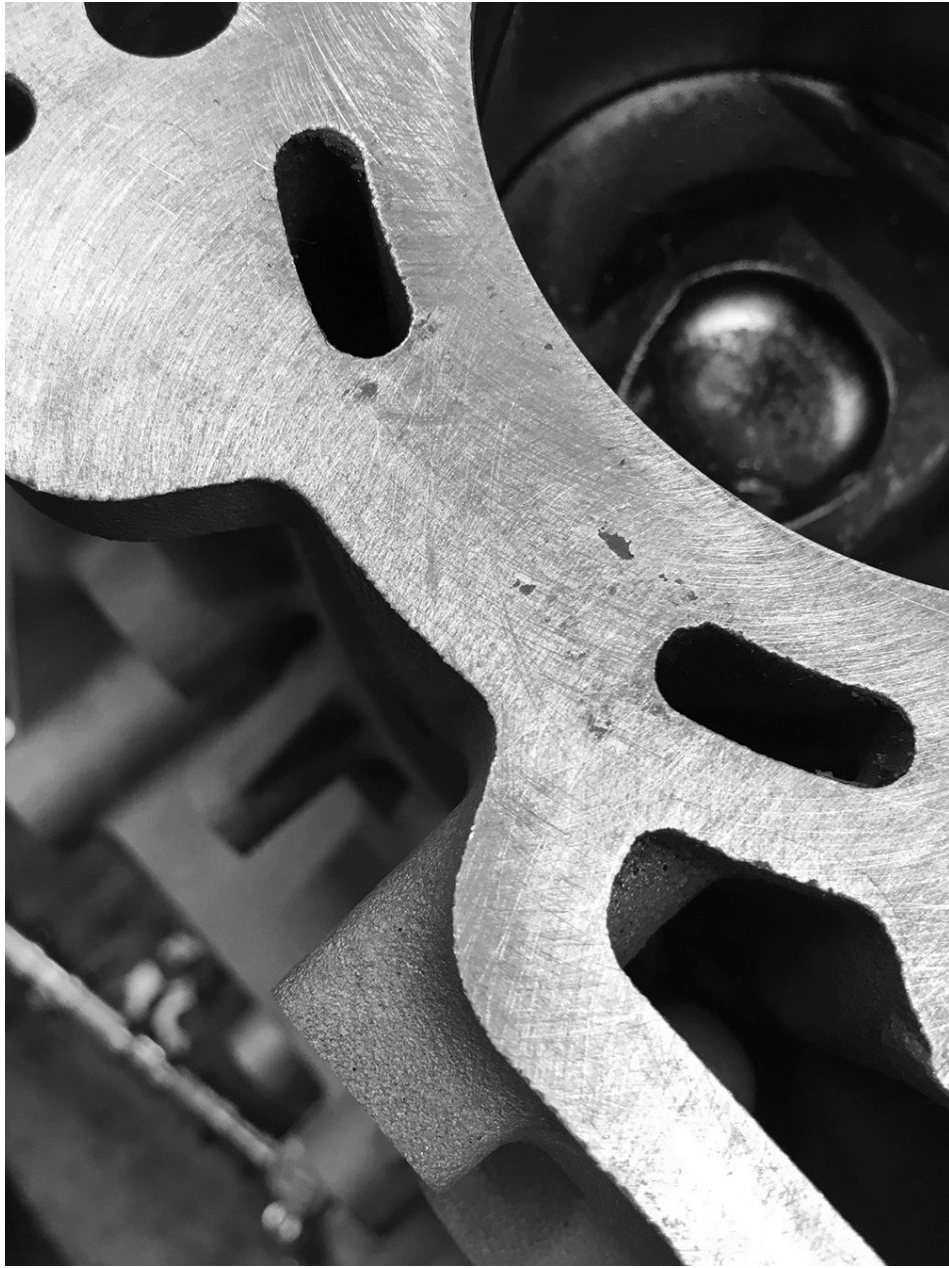
4789846

Scratches from the pad are deeper in some areas than others causing the gasket/seals not to properly seal against an uneven surface.

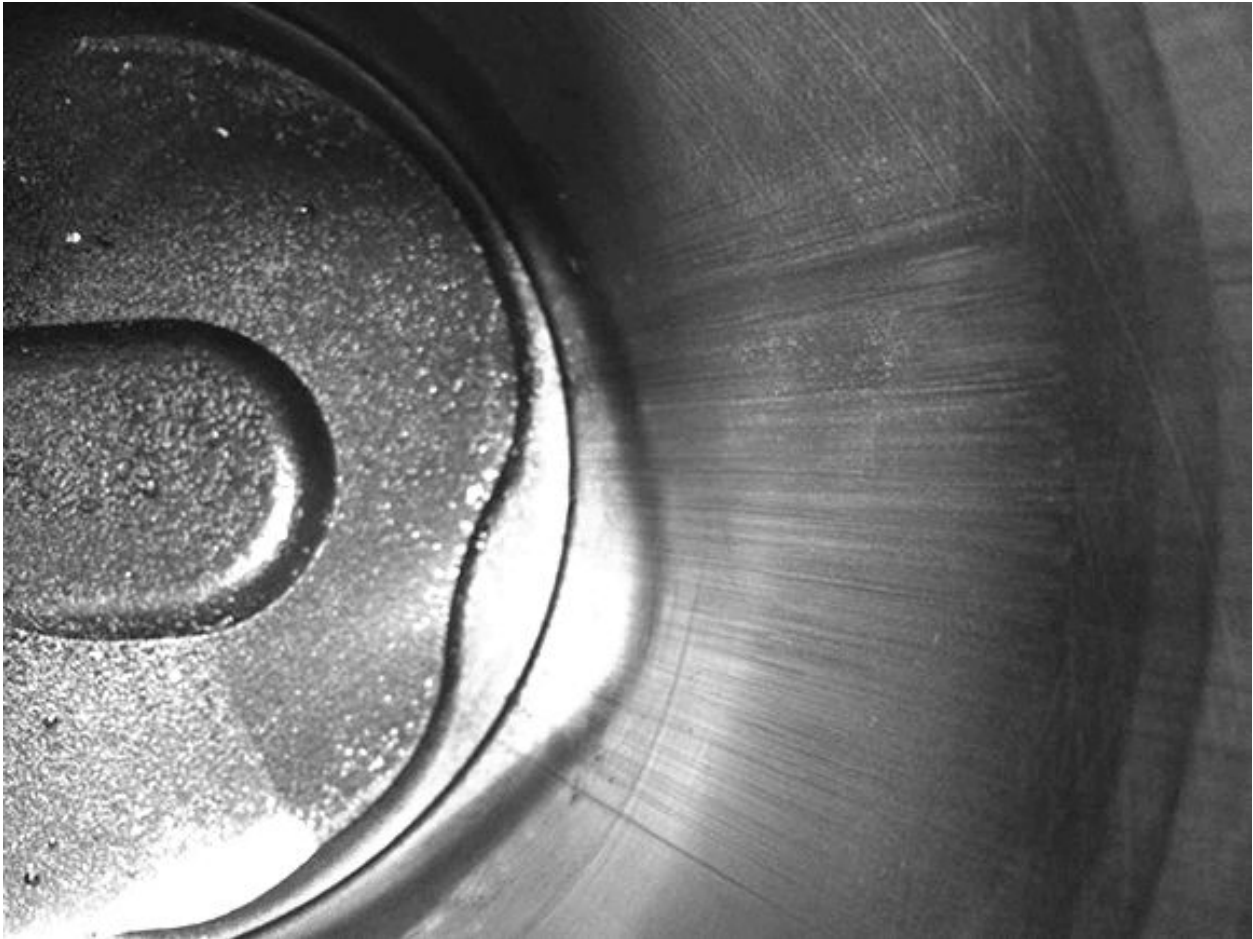
4788657

**Note:** Damage to the pistons and/or cylinder walls may result in an engine knocking, tapping and/or possible low compression.

The sides of this cylinder wall were scarred with scratches because of debris created by the abrasive cleaning pads. This debris gets trapped between the piston head and the cylinder wall causing damage to the cylinder bore as the piston moves up and down.

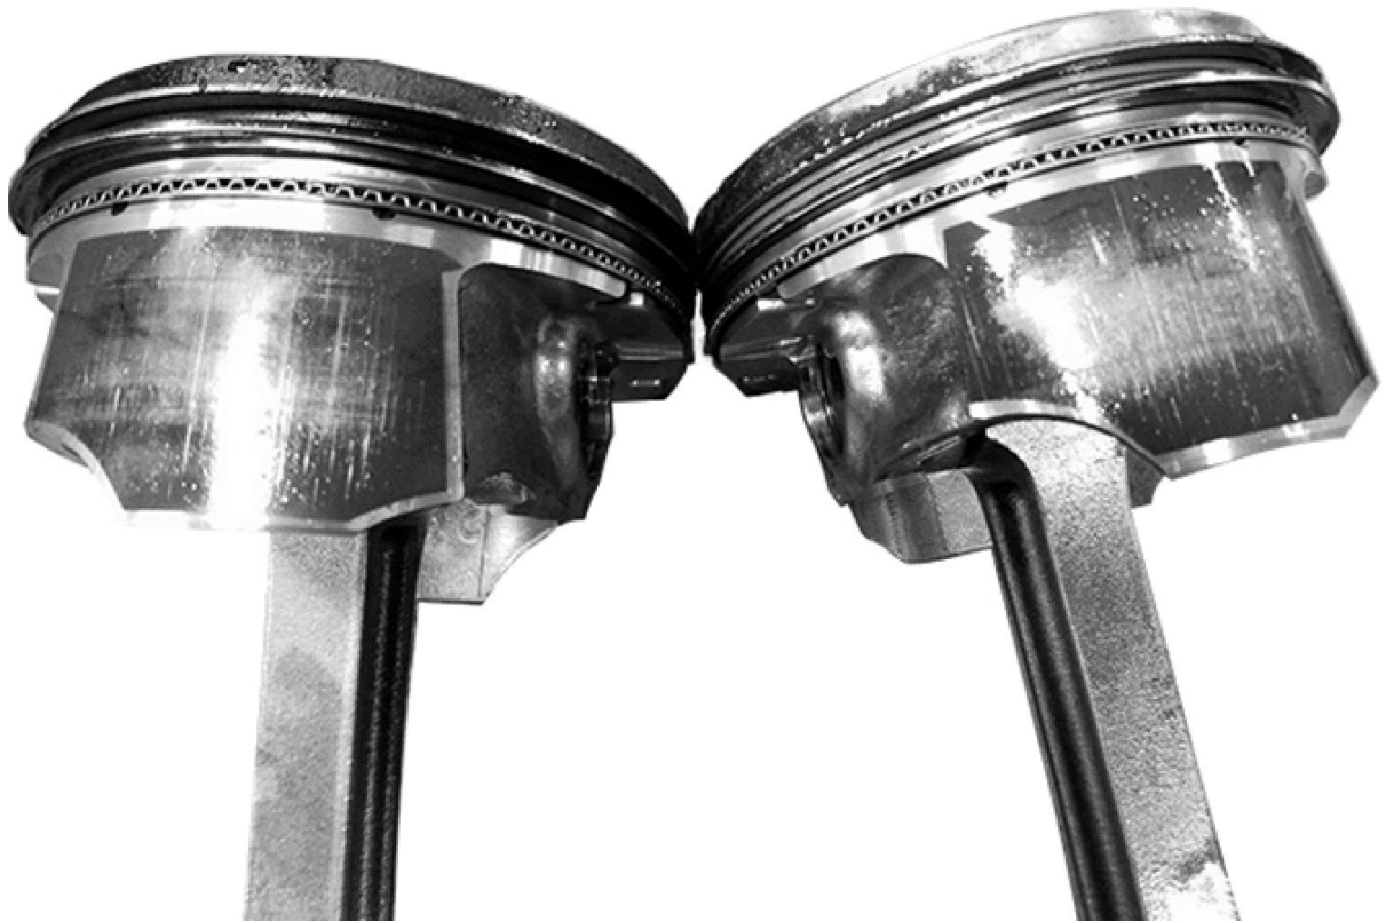
4800927

The piston skirt and piston ring damage caused by abrasive cleaning pads.

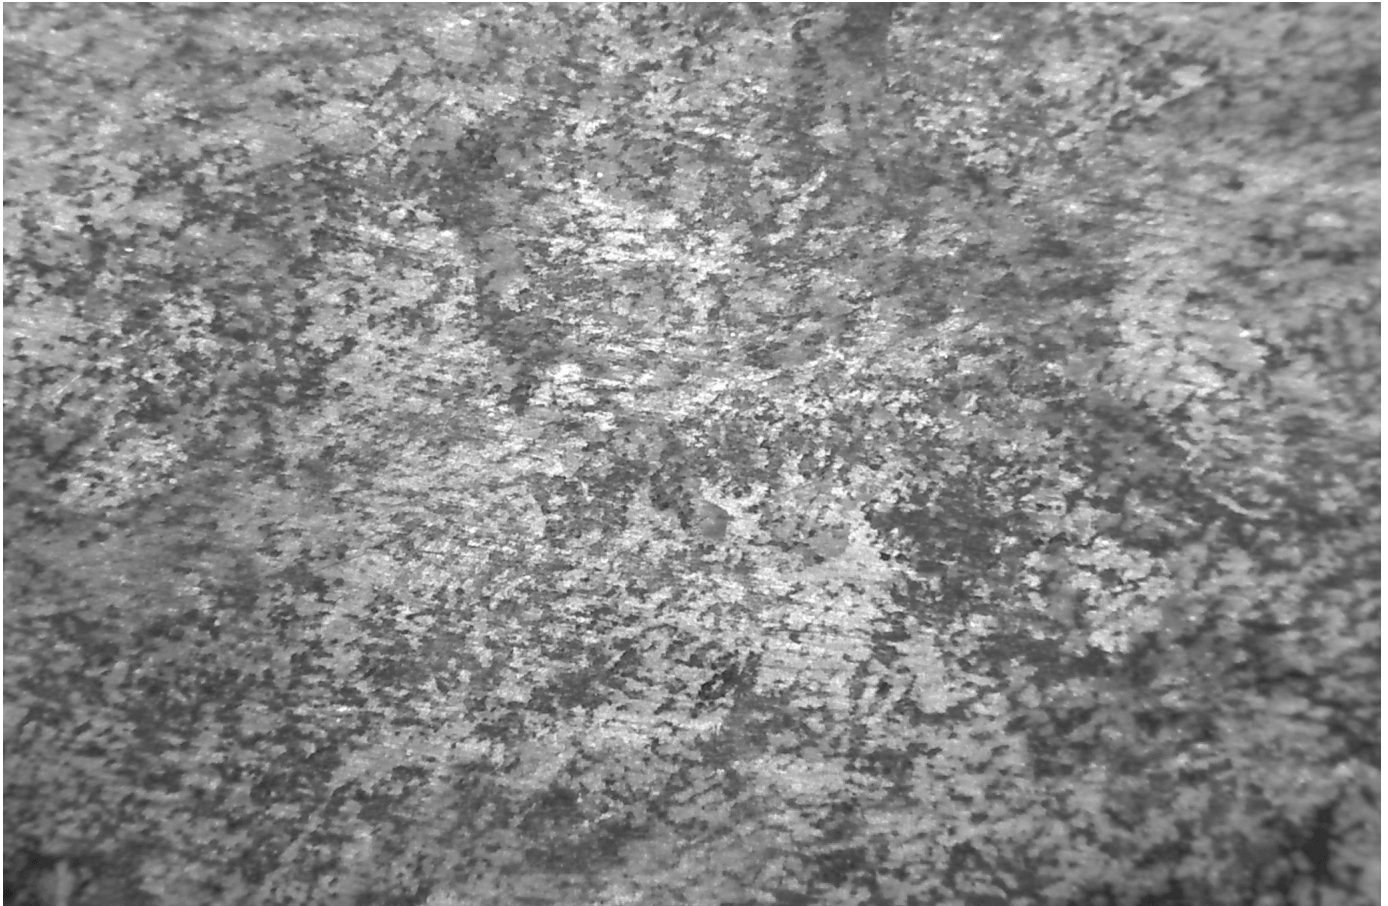
4791153

A close up of the sealing surface after cleaned with GM Low VOC Cleaner and plastic scraper.

To properly clean the sealing surface prior to reassembly, GM Low VOC Cleaner, P/N◆19287401, in Canada, P/N 88901247 and in Australia, P/N 88900163, should be sprayed on the mating surface. Use care to avoid getting solvent in any area other than the mating surface to be cleaned. Allow it to soak in for several minutes to loosen the old RTV sealer/gasket material. GM strongly recommends using a plastic razor blade or non-metallic scraper to remove all loose sealer/gasket material.
