Title: Bus, Durastar & MV Air Compressor Inlet Hose Chaffing / Leaking

Applies To: Bus, Durastar & MV equipped w/Cummins ISB / B6.7

Navistar has identified that, in some circumstances, the Air Compressor Inlet Hose from the Charge Air Cooler (CAC) may chafe or leak during normal vehicle operation. The description and images below offer instructions on how to replace and properly route the new hose assembly.

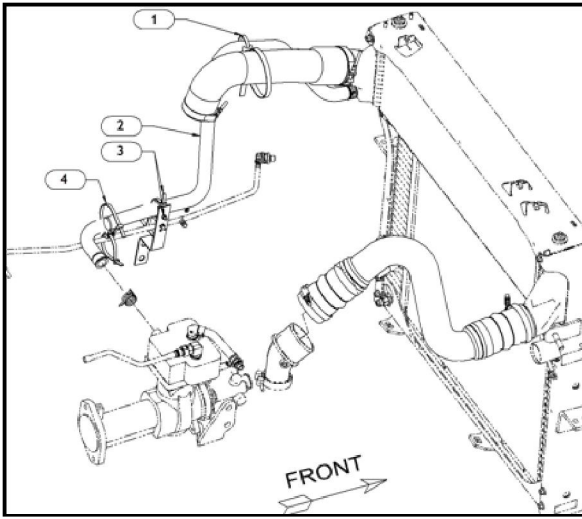
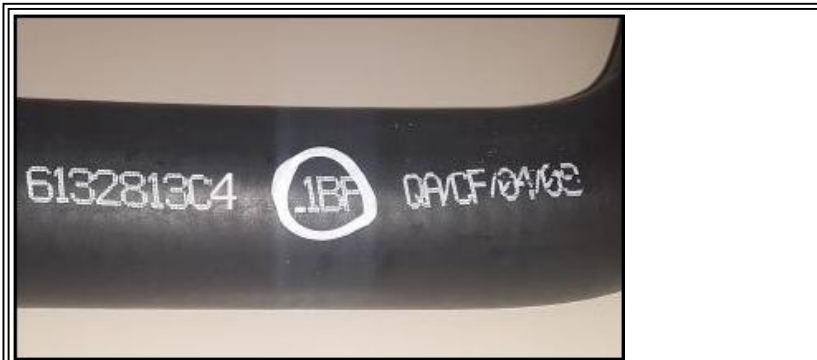
Figure 1: Updated hose PN 6132813C4 & material ID (1BF)

Bus, Durastar & MV (11/18/2019 to June 2022)

| Kit Description | Part Number | Quantity | Notes |
|---|---|---|--|
| HOSE, AIR COMPRESSOR, (1BF) (#2 & 2a) | 6132813C4 | 1 | Only required if chafed or leaking Do not use a worm clamp design, this can cut and damage the new hose. |

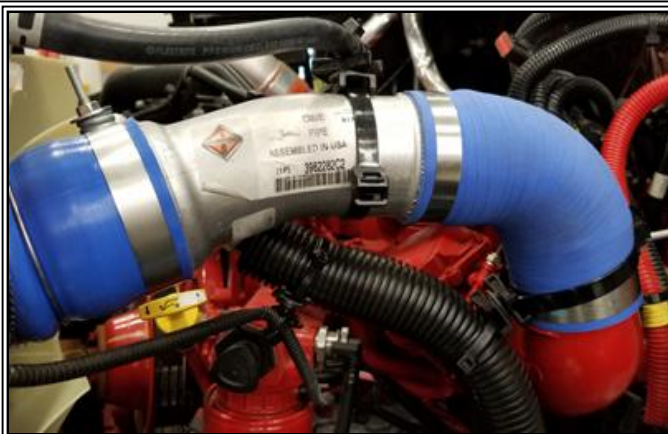
Figure 1: New CAC piping installed

Vehicles built between 5/31/2017 and 11/18/2019 will have the air compressor supply hose routed to the CAC piping per the images below.

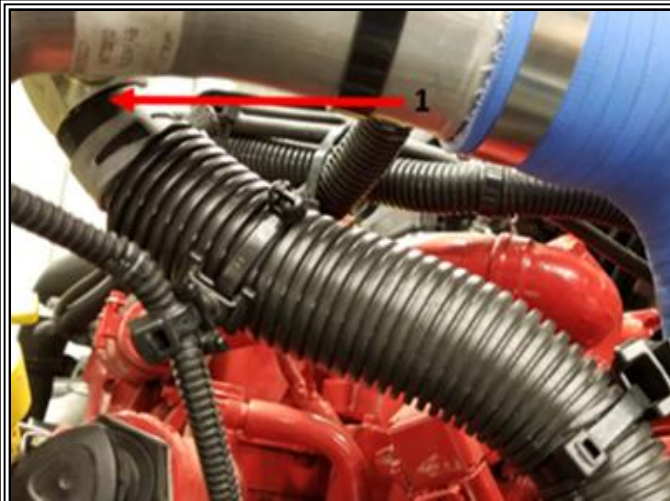
Figure 2: Air Compressor Inlet Hose

Item 1: Air compressor inlet hose cut and installed

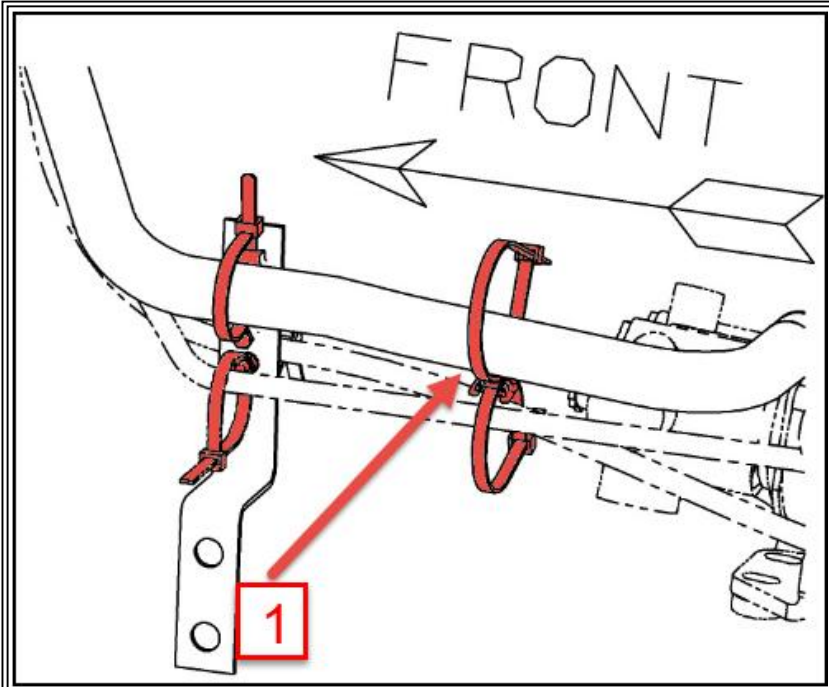
Figure 5: Air Compressor End Securement

Item 1: Ensure cable lock swivel PN 4077219C1 is installed between cable locks to allow for hose movement.

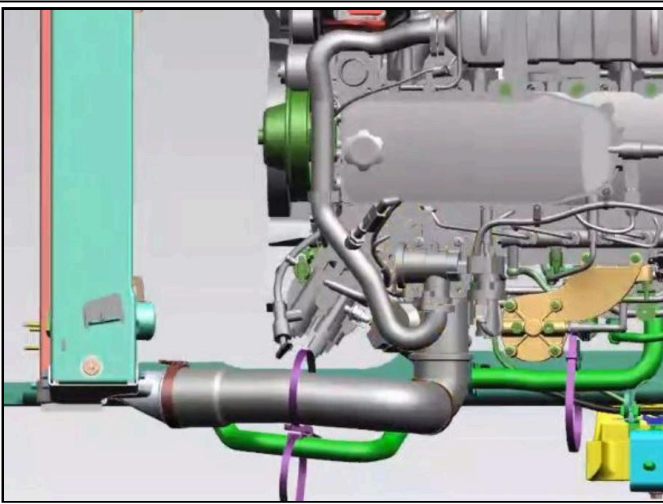
Figure 1: Top View - CAC pipe saddle & tie strap centered

The Air Compressor Intake Hose clipping point on the CAC pipe shall be centered horizontally and securely fastened with the saddle and tie strap.

1. Air Compressor Intake Hose clipping point on the CAC pipe shall be centered horizontally and securely fastened with a saddle & tie strap. (Figure 1)
2. Air Compressor Intake Hose clipping point to the saddle tie strapped on the CAC pipe shall be centered vertically on the CAC pipe and securely fastened with a tie strap. (Figure 2)
3. Air Compressor inlet hose routing shall be routed above and parallel to the fuel line, positioned in the highest clipping point in the stanchion bracket, and securely fastened with a tie strap. (Figure 3)
4. Tie straps located near the driver side motor mount shall have the sharp trimmed edges of tie straps rotated away from the Air Compressor Inlet Hose so sharp edges face the motor mount. (Figure 4 & 5)

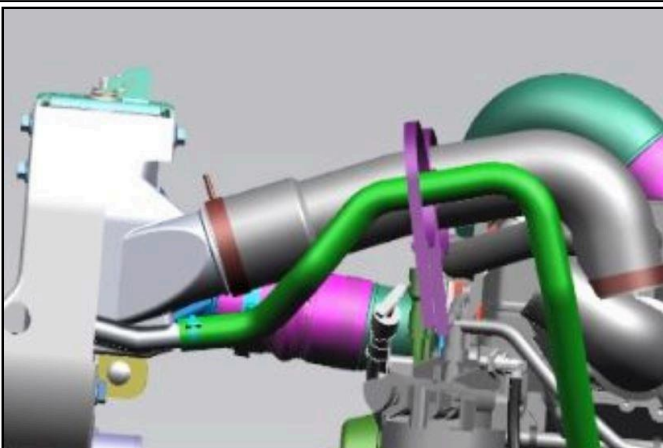
Figure 2: Side View - CAC pipe saddle & tie strap centered

Align the air compressor intake hose with the center of the saddle and tie strap. Pull the zip tie securing it against the

saddle while checking alignment.

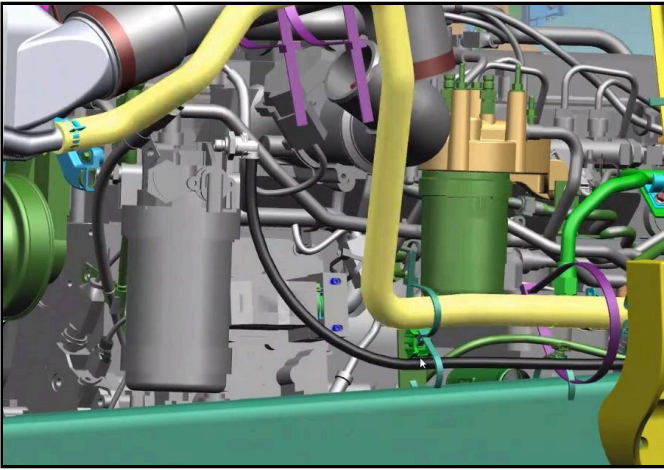
Figure 3: Air Compressor Inlet hose routed above fuel line

Air Compressor inlet hose routing shall be routed above and parallel to the fuel line, positioned in the highest clipping point in the stanchion bracket, and securely fastened with a tie strap.

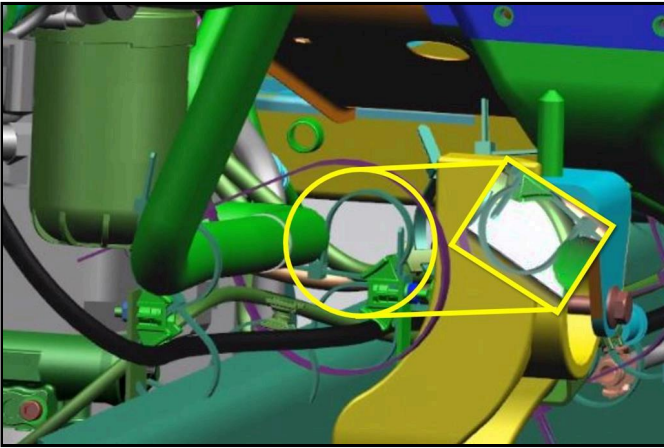
Figure 4: Rearward projection - Sharp Edge rotated to away

Align the air compressor intake hose with the center of the saddle and tie strap. Pull the zip tie securing it against the saddle while checking alignment. Trim sharp pieces of zip ties away from the hose to prevent damage and further rub point.

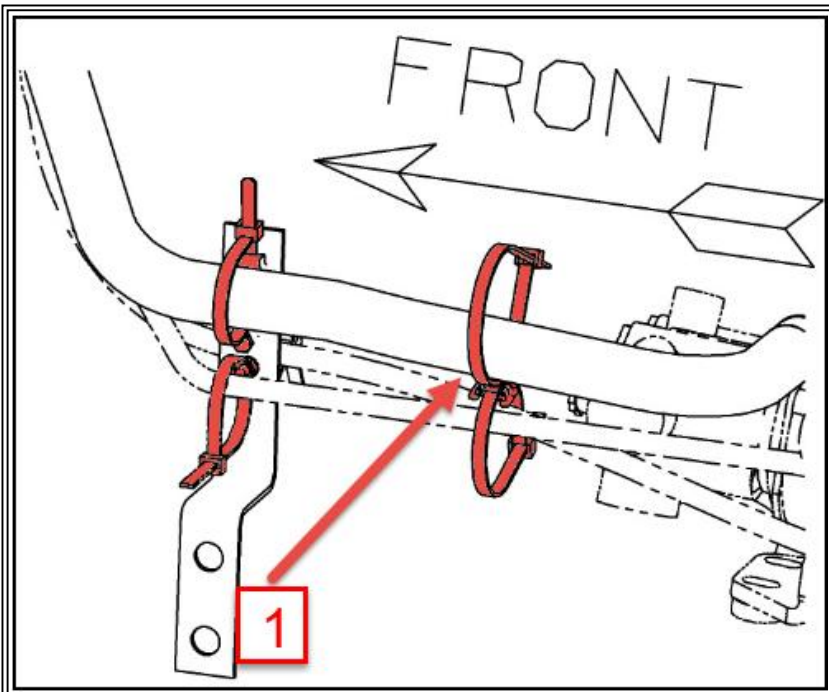
Figure 5: Air Compressor End Securement

Item 1: Ensure cable lock swivel PN 4077219C1 is installed between cable locks to allow for hose movement.
