Service Bulletin

Bulletin No.: 23-NA-061

Subject: Diagnostic Tip for Checking Exhaust System for Leaks for the L5P Engines, Malfunction Indicator Lamp (MIL) Illuminated - DTC P0402, P0421, P11D5, P20EE, P2459, P2463, P249D, and/or P249E

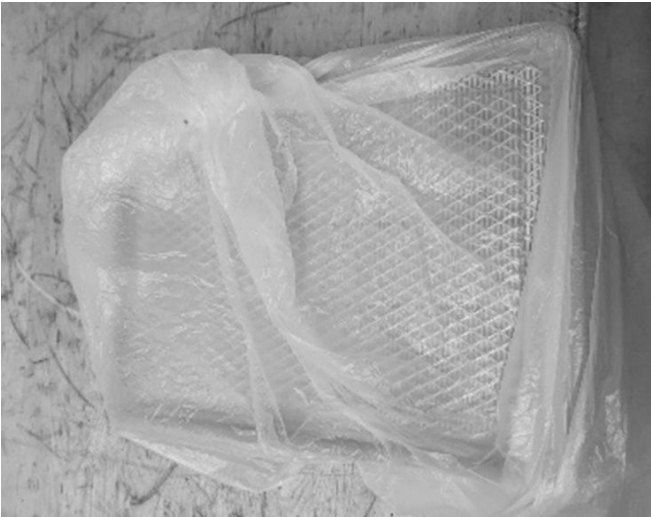
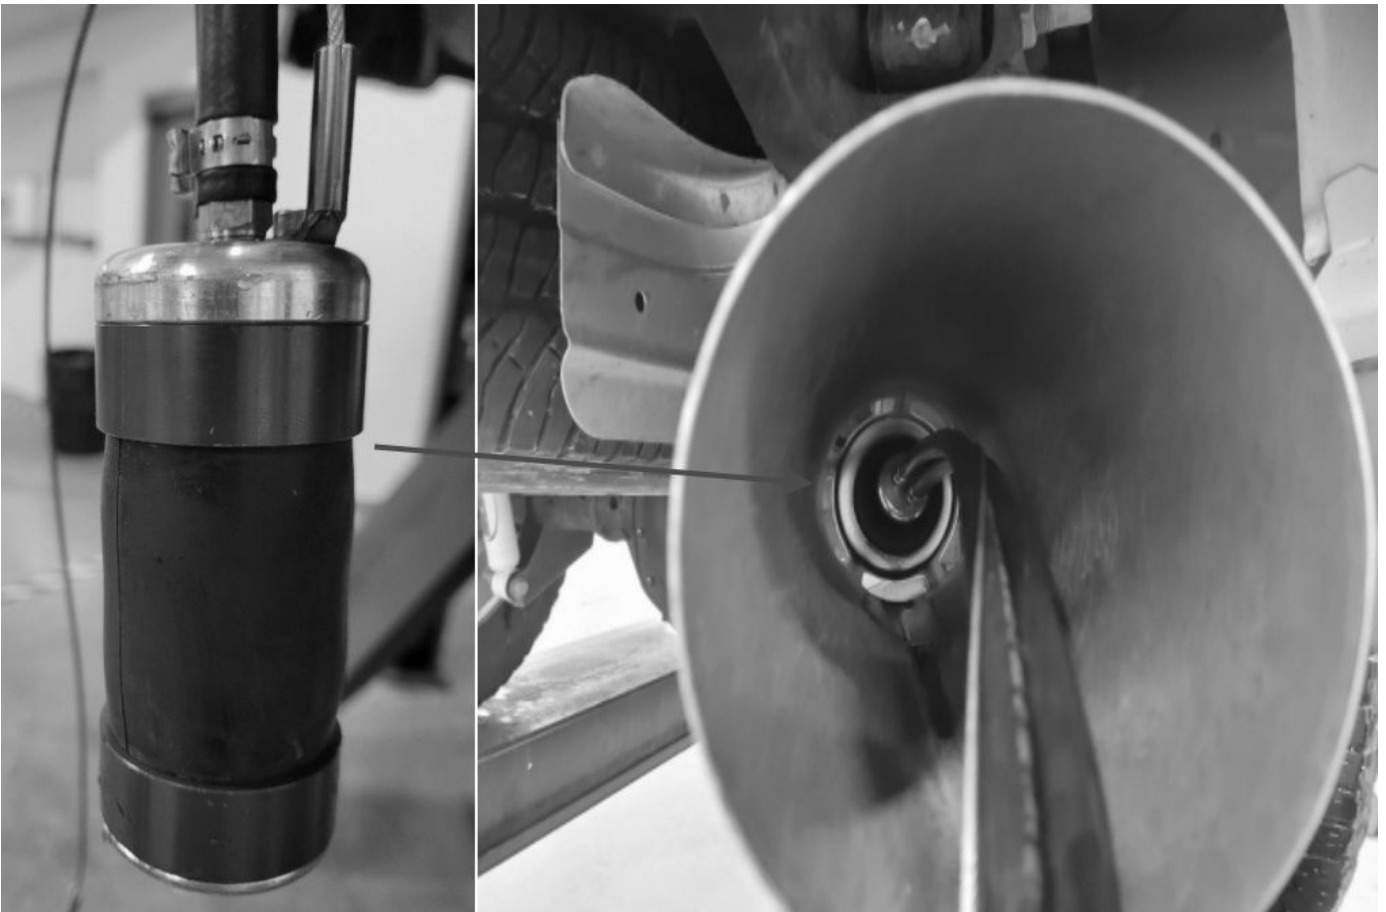
5. Install the inflatable adapter for the GE-52250 machine and insert it into the tailpipe.
6. Attach the GE-52250 to the adapter and shop air supply.
7. Command the vapor test and adjust the test pressure to 34–55 kPa (5-8 psi).
8. Using a soapy water mixture, spray all connections, welds, and sensors with the soapy water mixture, and look for air leaks (See Examples of Exhaust Leak Areas of Concern section below).
9. Once all the leaks are detected and corrected, verify that the exhaust is sealed by retesting with the GE-52250.

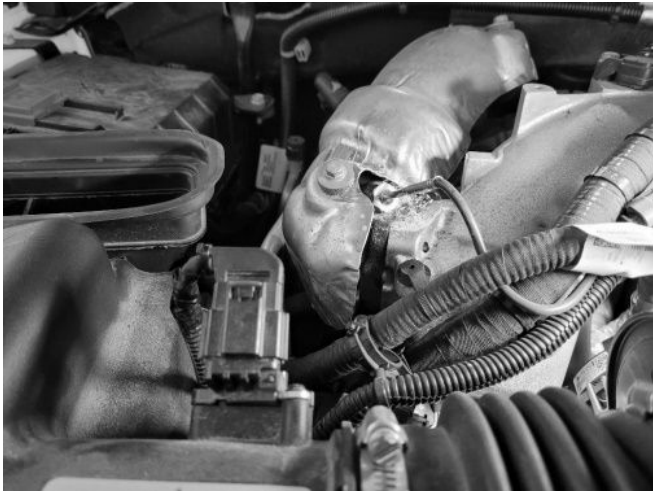
6306801

Left side exhaust manifold

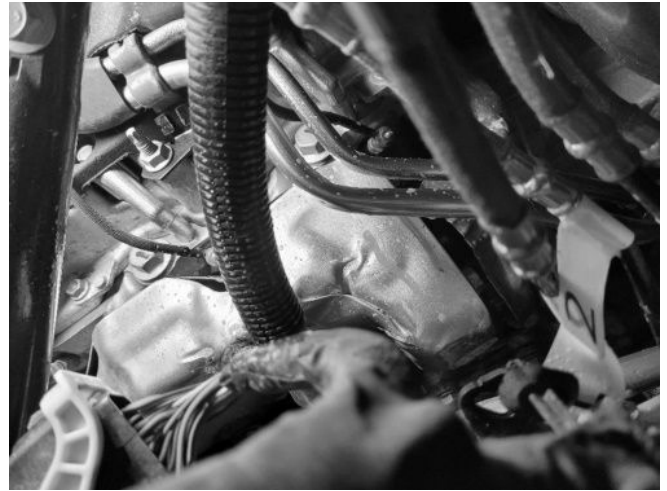
6306794

Exhaust temp sensor

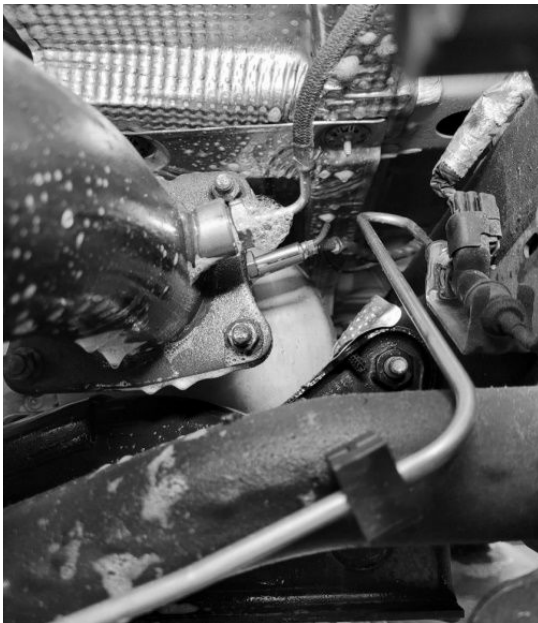
6306796

DEF Injector

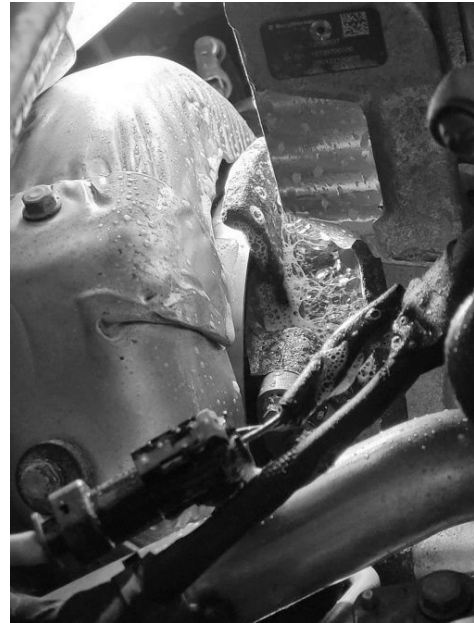
6306802

Note: A leak at the turbocharger vane actuator shaft is considered a normal condition. Any smoke or bubbles from this area should be ignored.

Normal turbocharger seal leakage
