Service Bulletin

Bulletin No.: 24-NA-055

Subject: Removable Sky Panel Creak Pop Snap Noise, Hot Interior Temps

Brand:	Model:	Model Year:		VIN:		Engine:	Transmission:
		from	to	from	to		
GMC	Hummer EV Pickup	2023	2024				
	Hummer EV SUV	2024	2024

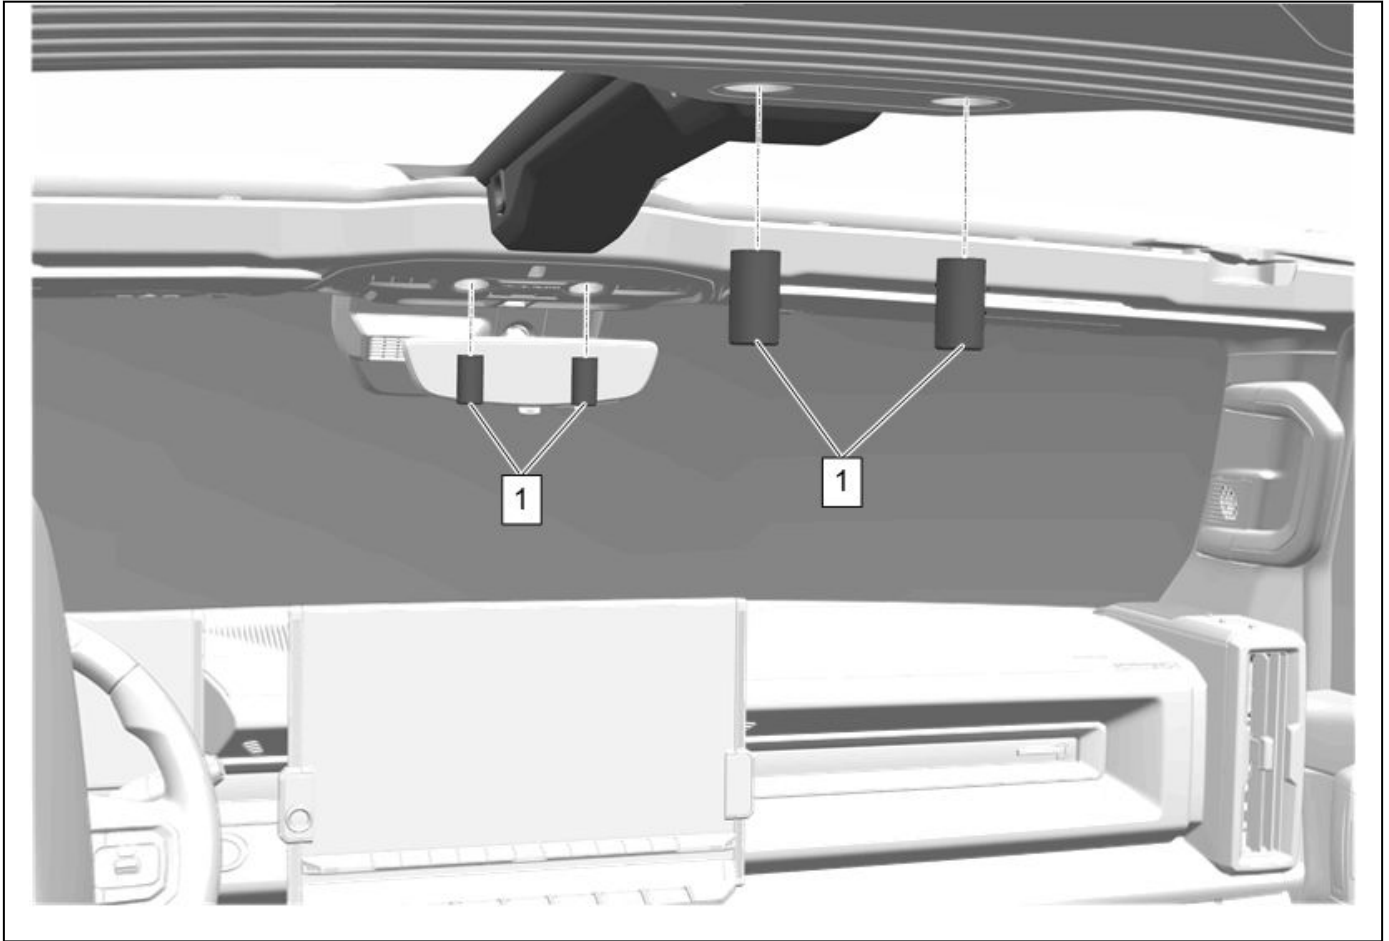
5832341

1. Remove the four nuts (1) from the Front I-Bar.

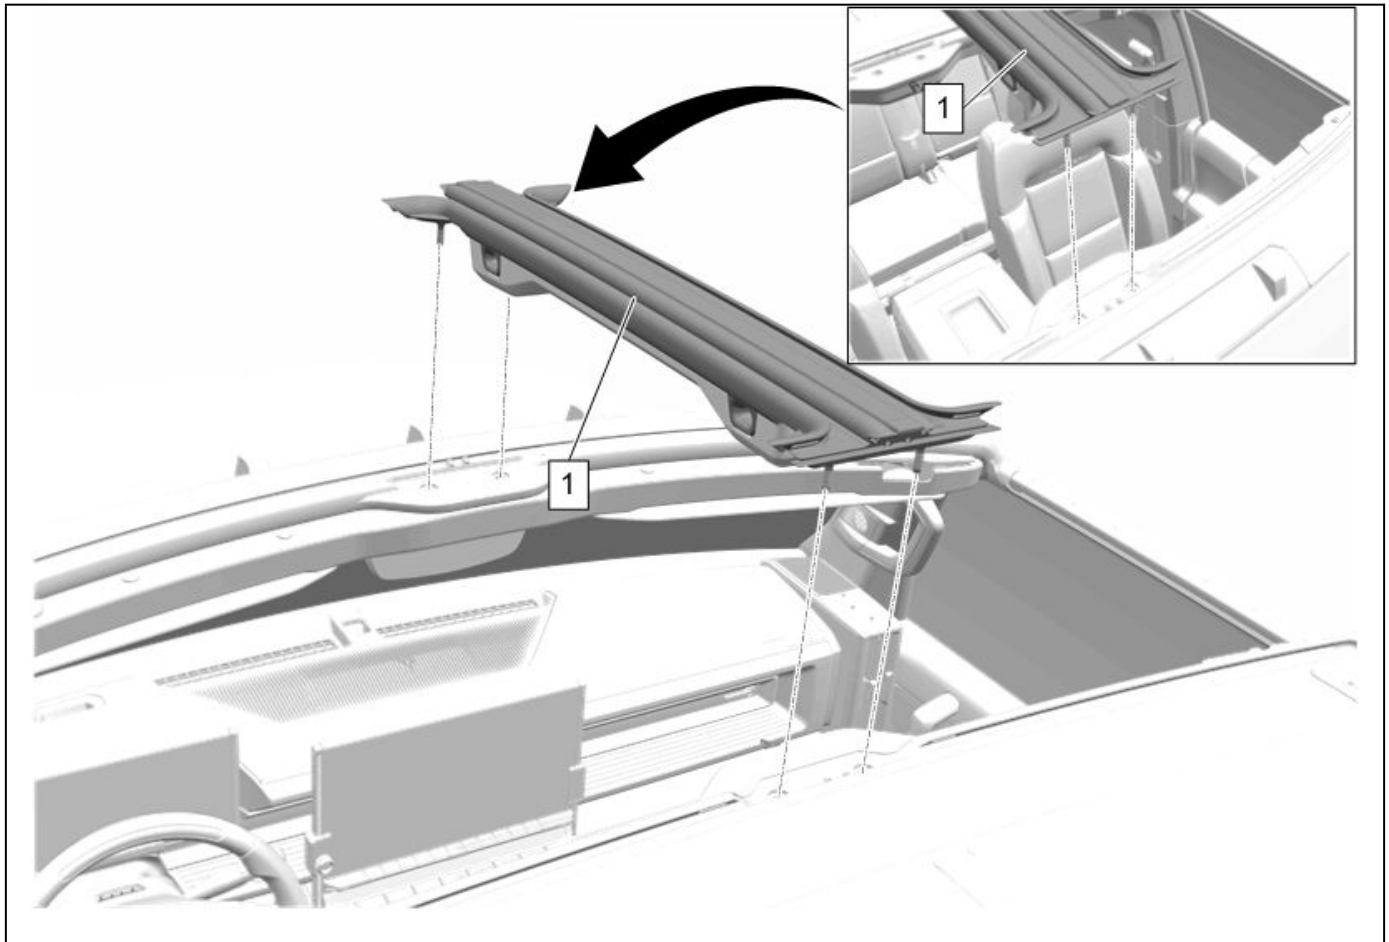
5832364

2. Remove the Front I-Bar (1).

Note: Be careful not to damage the weather—strip cover around the panel when removing the panel.

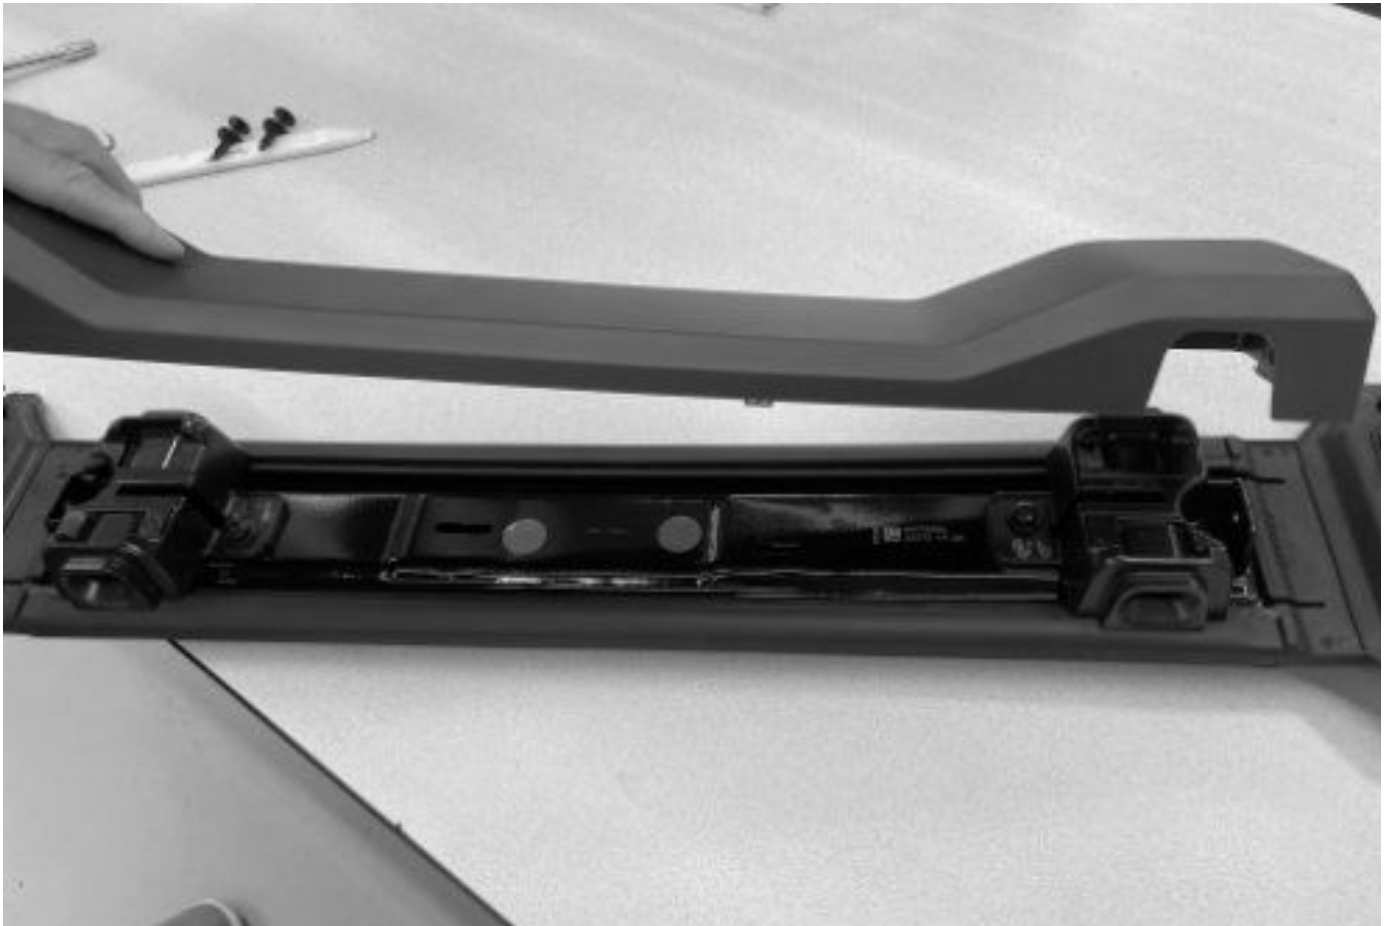
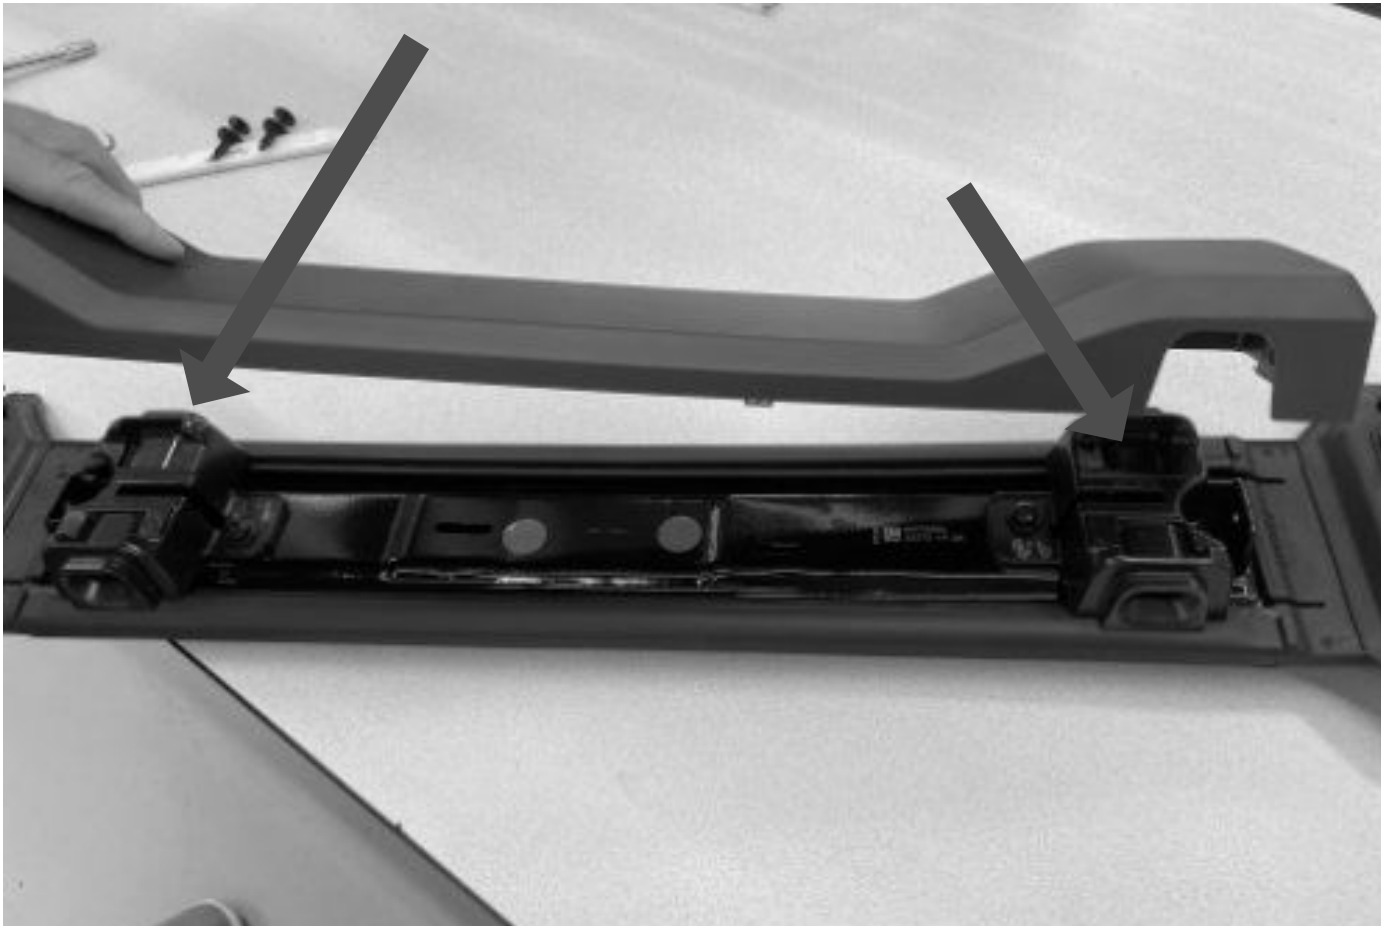
5. Unscrew the I-Bar pocket receivers from the I-bar.

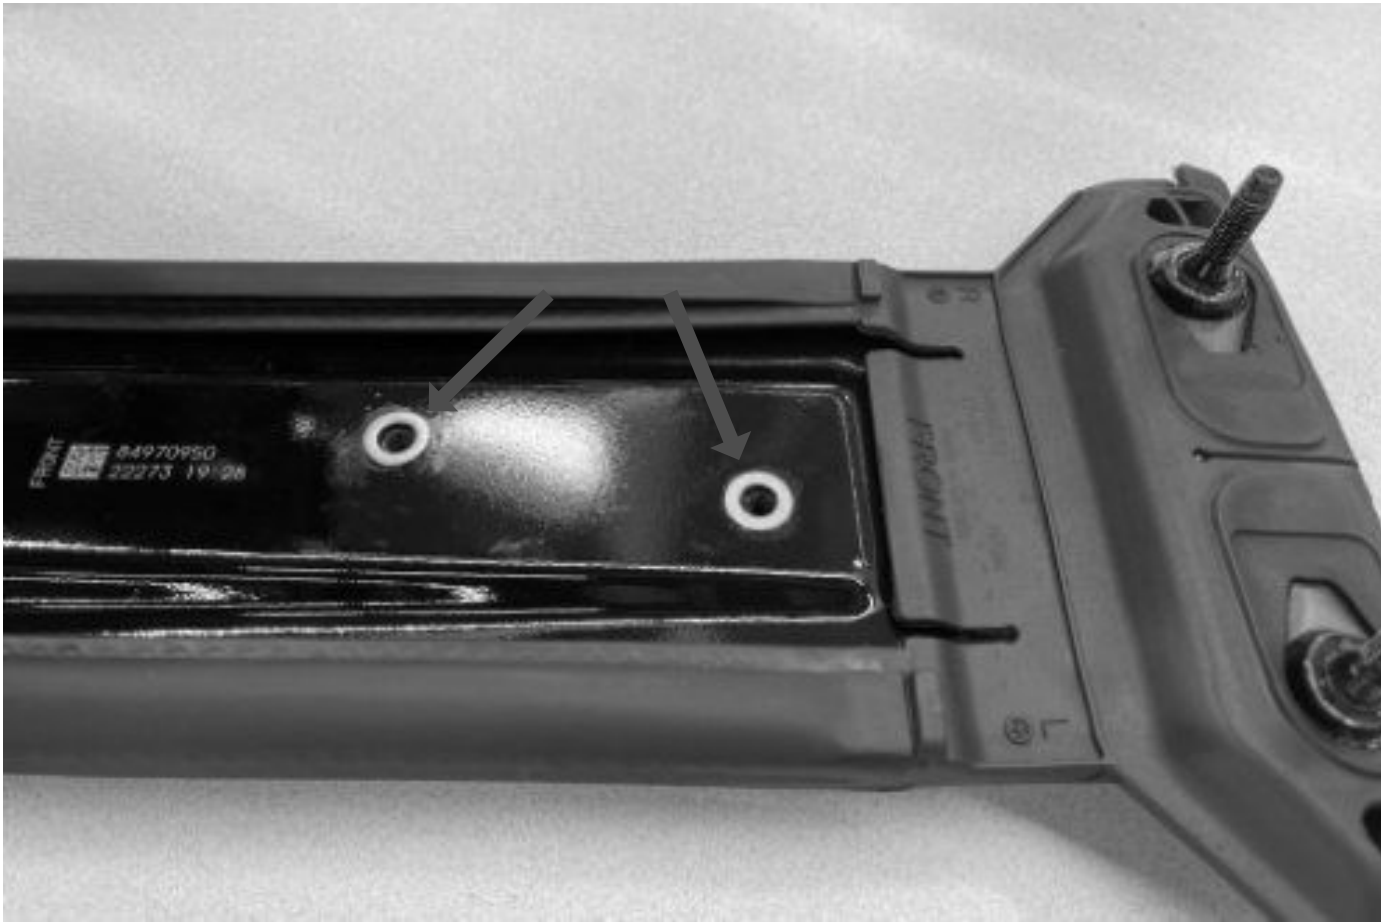
6425388

6. Place a washer at each of the four bolt holes underneath the pocket receivers.
7. Reinstall the pocket receivers, torque to 9 nm.
8. Reattach the trim cover and push-pin fasteners. Reinstall the front I-Bar in the correct orientation.

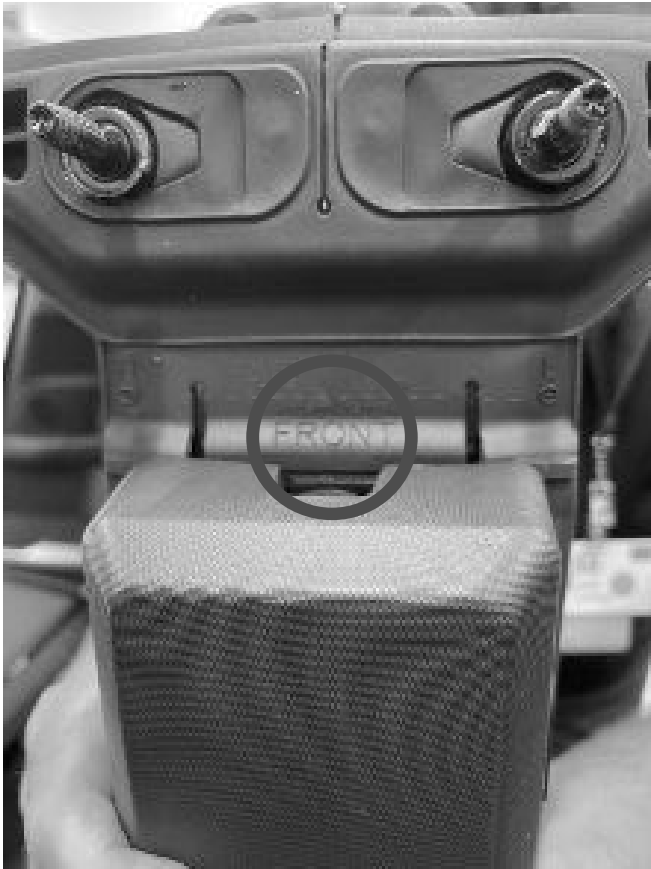
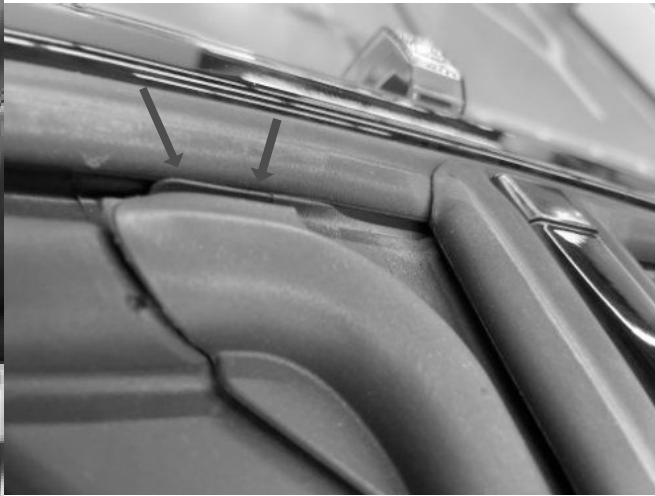
The Center Roof Lift Off Panel is labelled Front, ensure it's properly aligned when reattaching.

Important: Ensure the weather-strip is secured and properly sealed.

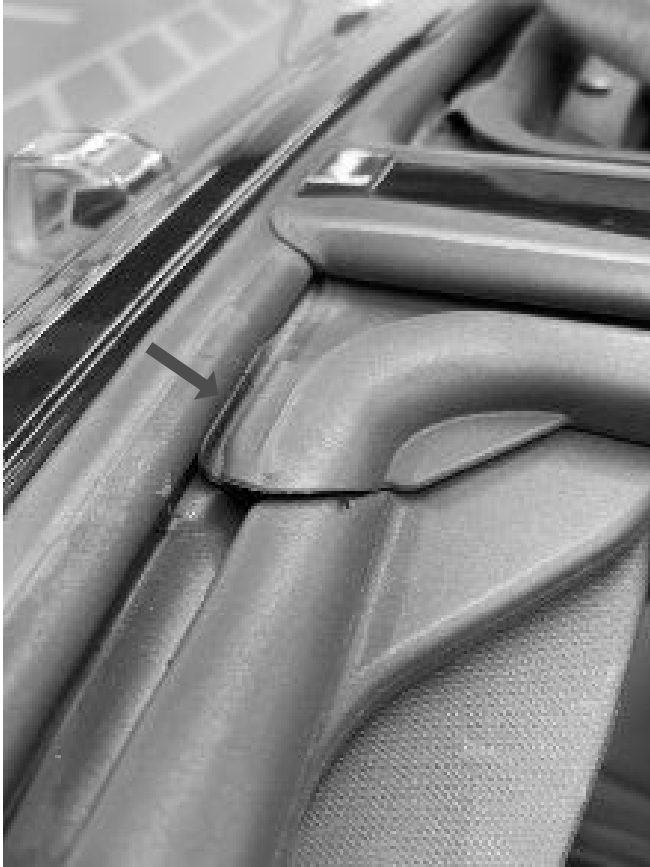
6425394

- Example of an unseated weather-strip. If the weather-strip is left unseated, it can cause water leaks into the vehicle.

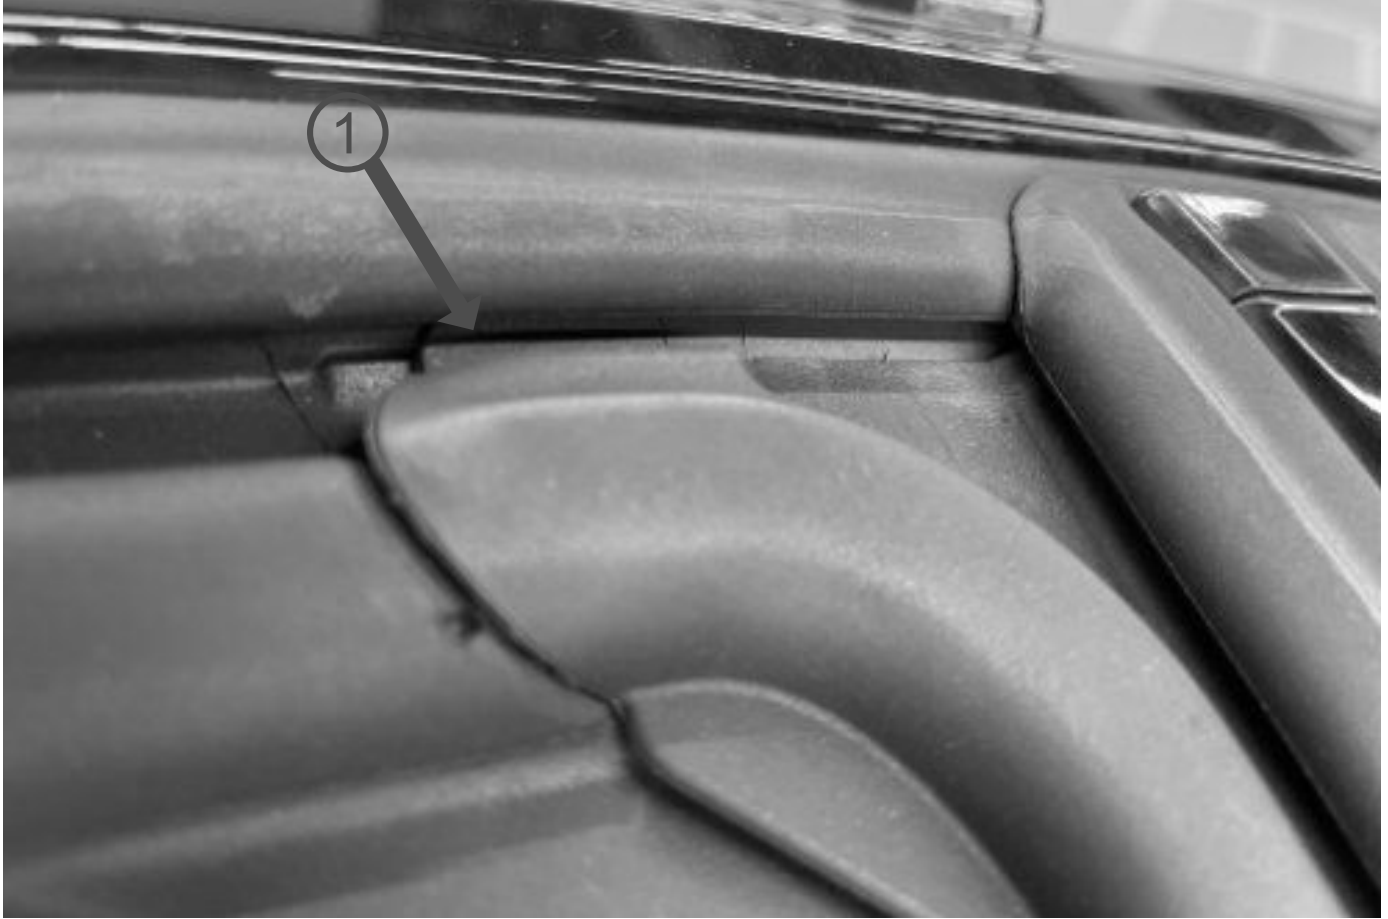
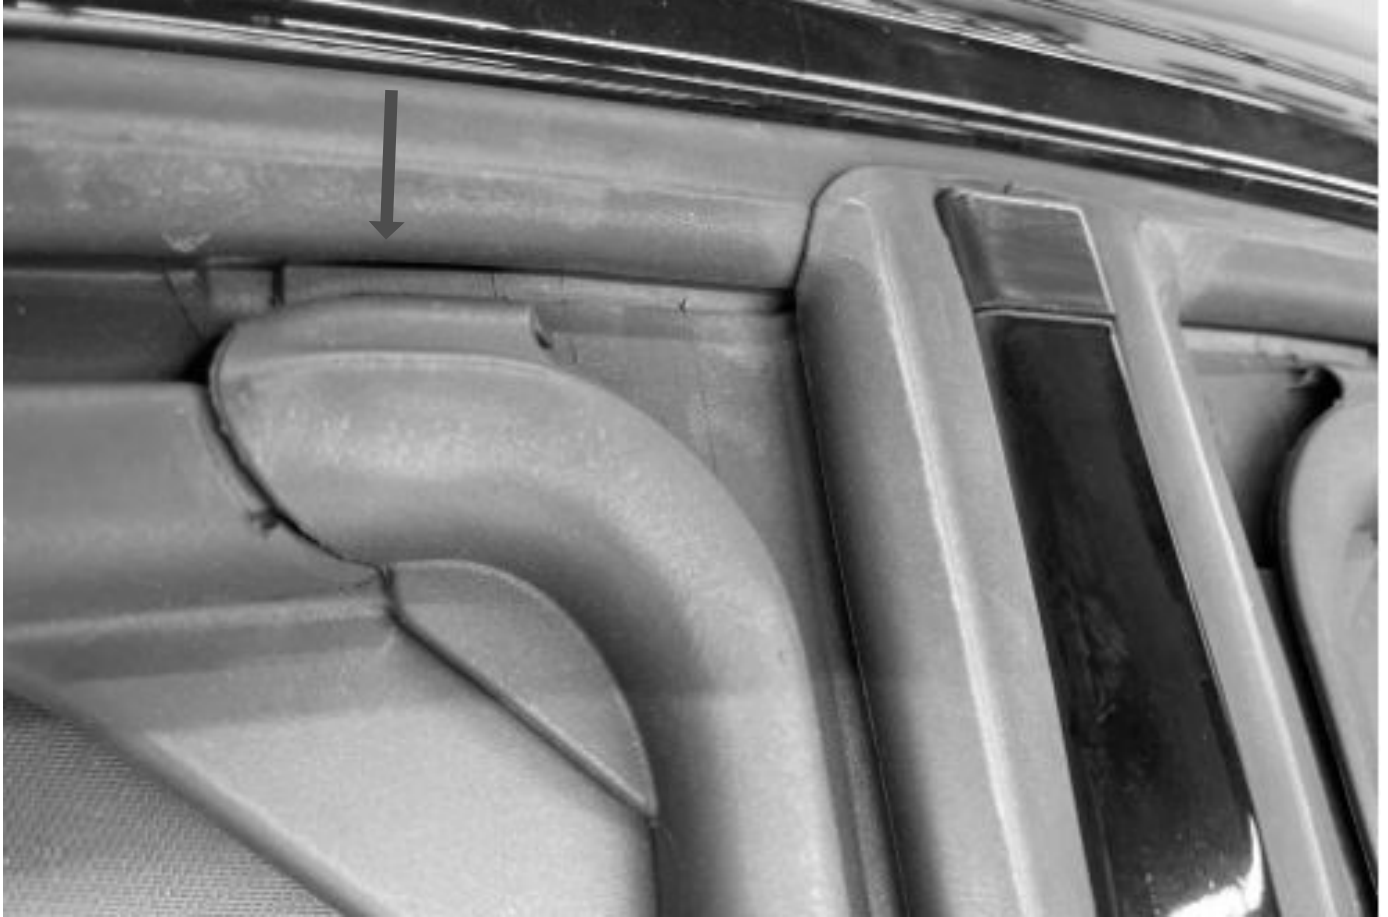
6425397

- Example of the proper weather-strip seal.
9. Use soapy water to clean the weather strips and then apply a very light application of AC Delco Super Lube to the weather strips.
 10. Reattach the front sky panels.

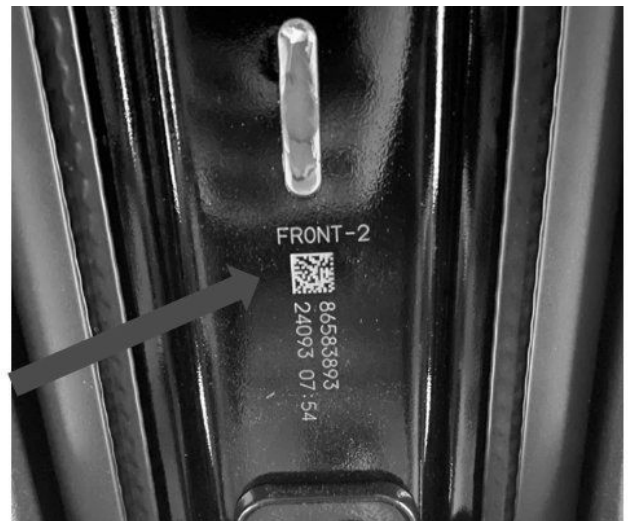
6693889

Before proceeding, inspect the rear I-Bar for proper orientation on MY2024 vehicles ONLY.

FRONT should point towards the front of the vehicle. If the rear I-Bar is reversed, follow SI DOC ID 5835570 to remove and re-install the rear I-Bar.

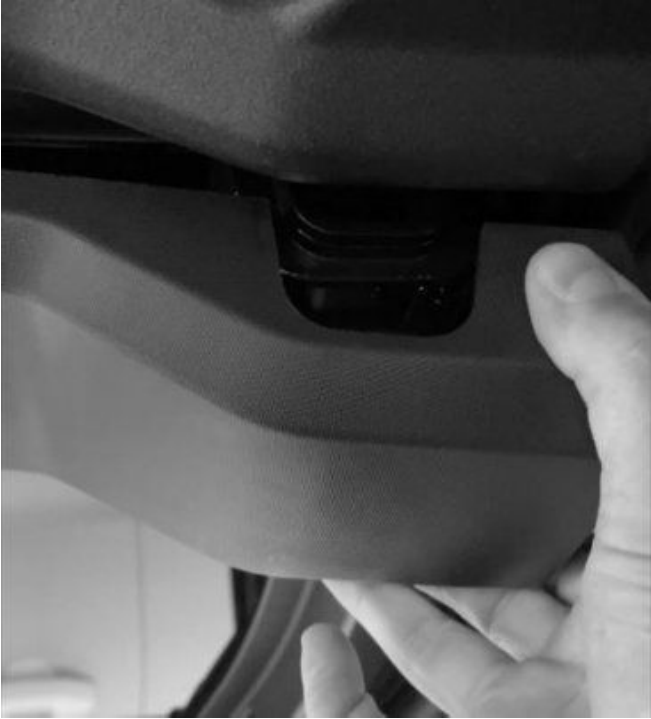
6430469

1. Remove the rear I-Bar trim panel by pulling down on the panel to disengage the retainers.

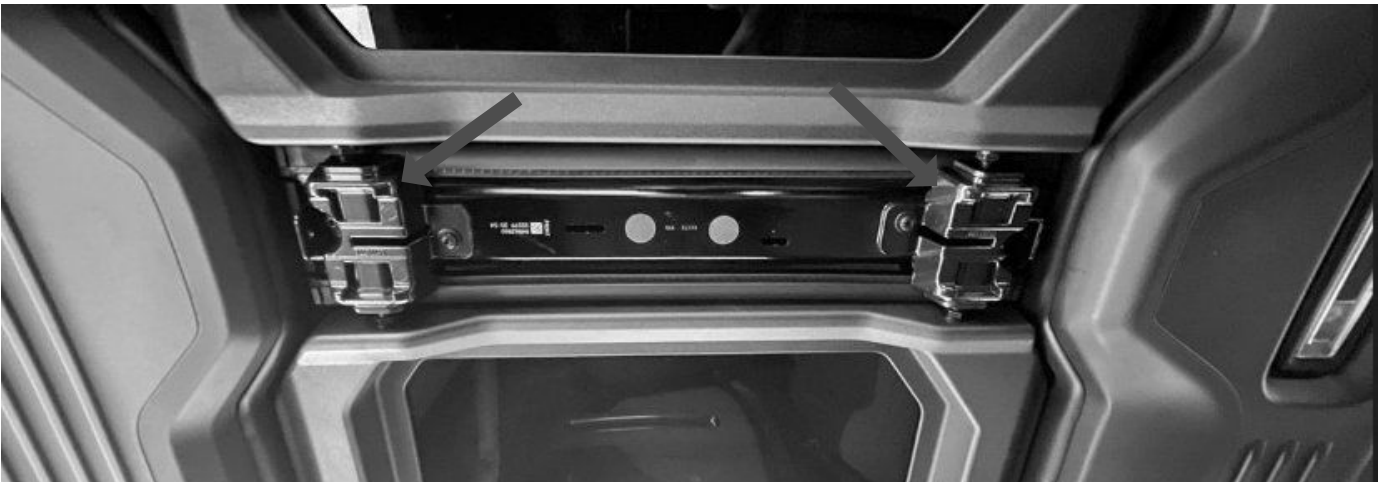
6430466

2. Remove both I-Bar pocket receivers.

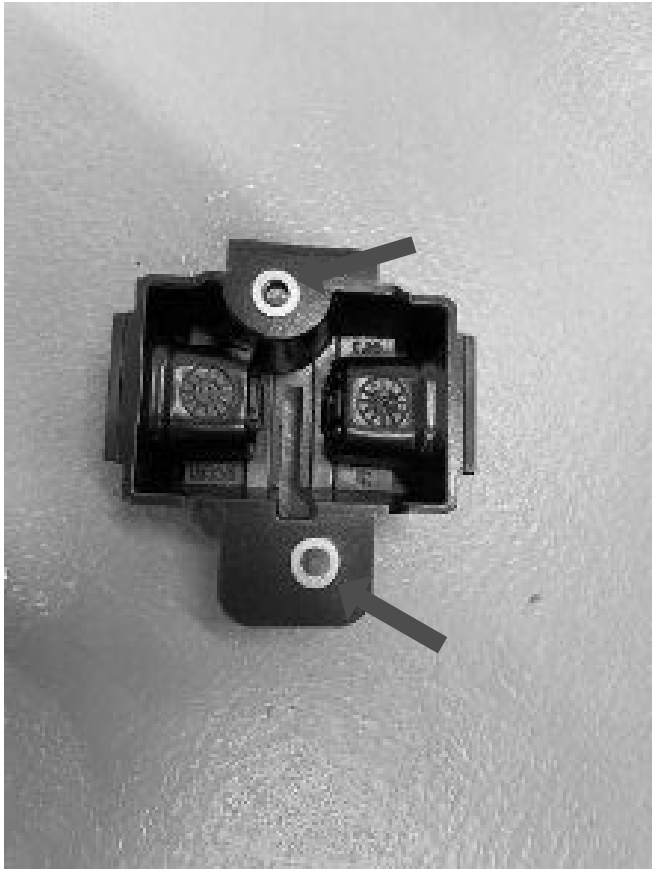
3. Place a washer at each of the four bolt holes underneath the pocket receivers.
4. Reinstall the receivers to the I-Bar, torque to 9nm.
5. Reattach the rear I-Bar trim cover.
6. Use soapy water to clean the weather strips and then apply a very light application of AC Delco Super Lube to the weather strips.
