Technical Service Bulletin

24-DS-003G

WHEEL BEARING NOISE INSPECTION & REPLACEMENT GUIDELINES

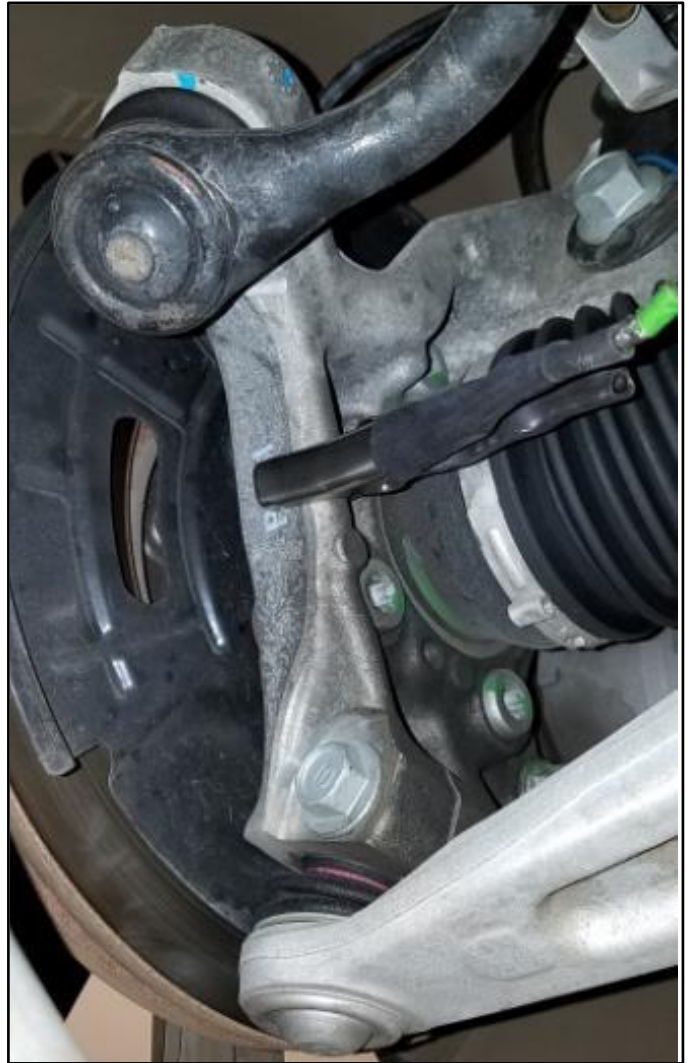
2. Attach chassis ears to the following locations:
 - The knuckle where the source of the noise is suspected.
 - The opposite side knuckle to compare the left and right wheel bearing condition.
 - Other areas of suspected noise sources to compare.

Route the wires of the chassis ears away from moving components: CV shaft, suspension components, etc.

Secure the wires with cable ties or other adequate means, leaving enough slack for suspension and steering movement.

3. Perform a test drive with chassis ears to listen for noise:
 - If the noise is confirmed to be coming from the knuckle, **replace the wheel bearing hub assembly on the side consistent with the noise.** Refer to the applicable shop manual for replacement procedures.
 - If the noise is confirmed to be coming from another source, continue evaluating different sources of the noise until it is found, and repair as necessary.
4. After the repair, perform another test drive to confirm the noise is resolved.

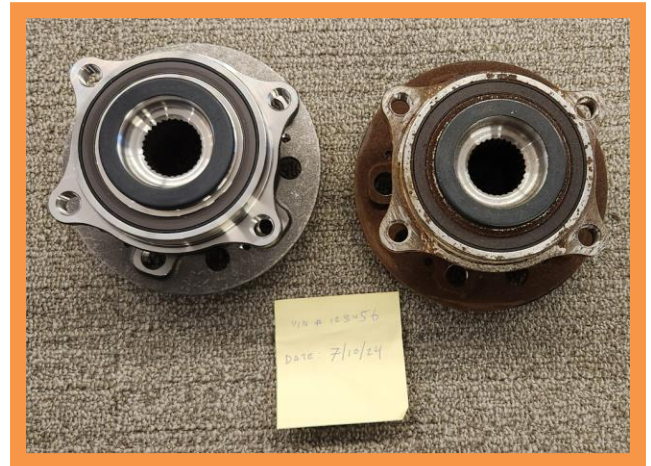
Using STUI, take a photo showing both the new and replaced wheel bearing assemblies with the last 6 digits of the VIN and the date of repair on a piece of paper.
