## Upper Radiator Hose Replacement (2.25 Crank Angle)

Volvo trucks has determined that certain model year 2023-2024 Volvo VN vehicles, could experience an issue with the upper radiator hose collapsing or deforming causing it to leak or interfere with the engine lifting bracket. To correct this issue, follow the instructions below to replace the upper radiator hose with a new one.

## Upper Radiator Hose Replacement 2.25

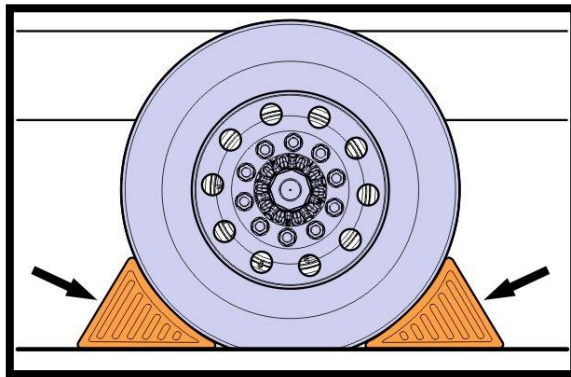
1. Secure truck for service.
2. Apply the parking brake.
3. Place the gear lever in neutral.
4. Install wheel chocks.
