Preview Solution CBR-343-7

AMT Gear Box Air Leaks

Valid for all Mack and Volvo chassis with an AMT

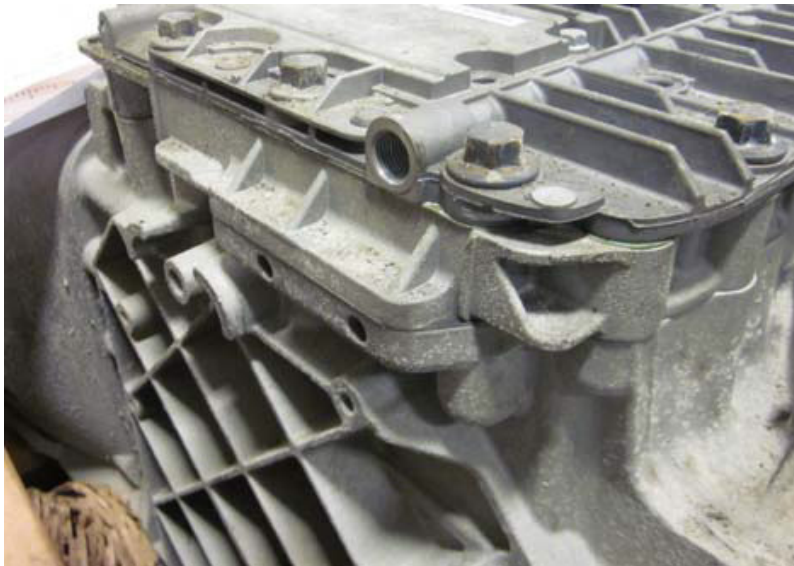
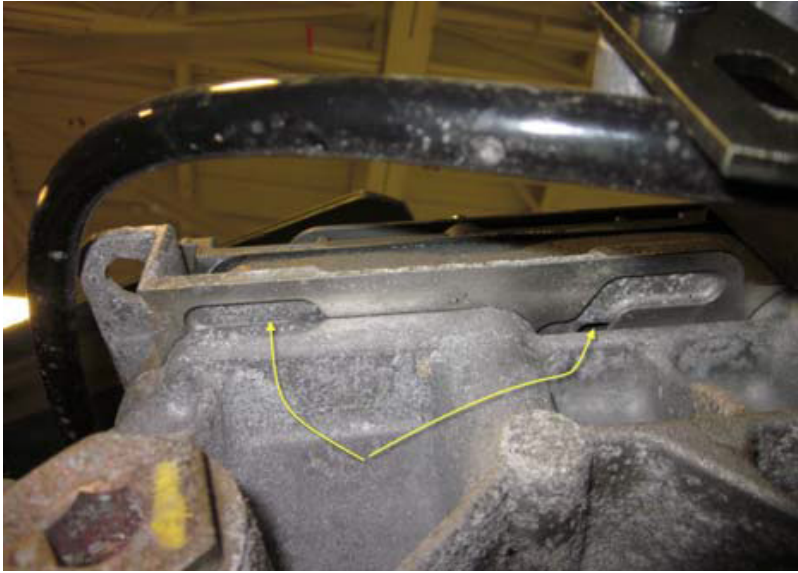
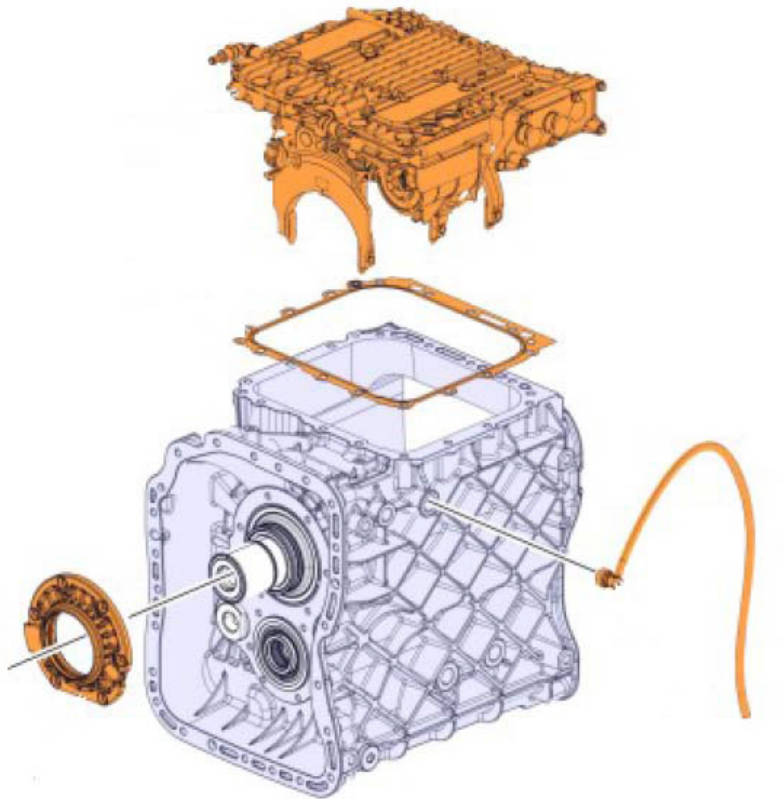
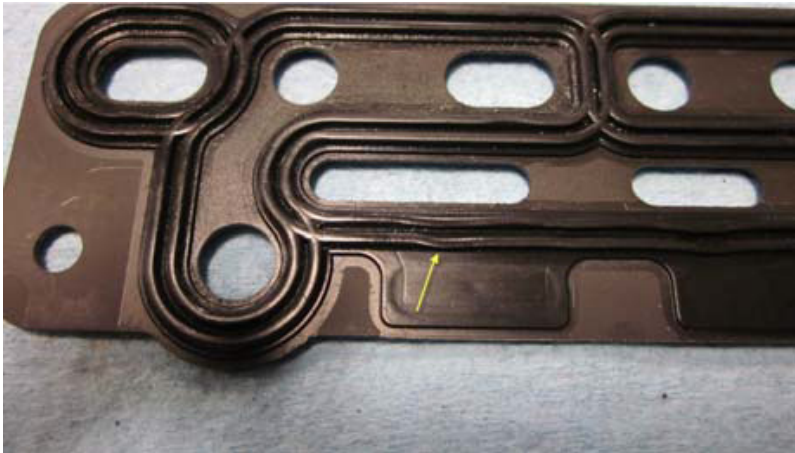
Air Leak from the TECU Vent

- **AMT-D:** An air leak is present at all times from the left or right side vent of the TECU (Transmission Electronic Control Unit). Refer to Figures 2 and 3.
- **AMT-C:** An air leak is present at all times from the gearbox case vent tube. Refer to Figure 5.

- **AMT-C & AMT-D:** One or more TECU shift valves may be stuck open, allowing air to escape through the venting solenoid. This issue can be intermittent. Testing has shown that exercising the valves with TT by forcing shifts may temporarily resolve the leak, but the valve may become stuck again.
- **TECU to Control Housing Seals:** Leaks from these seals can cause similar symptoms. These should be inspected before considering the replacement of major components.
- **Internal Leaks:** A leak between ports in the TECU due to a failed gasket can cause erratic or undesired shifting, as air bleeds into the wrong ports. The seals should be pliable with a peaked appearance; flattened sealing surfaces indicate a bad seal.

- Replace faulty TECU to Control housing seals and retest.
- Replace the TECU if necessary.

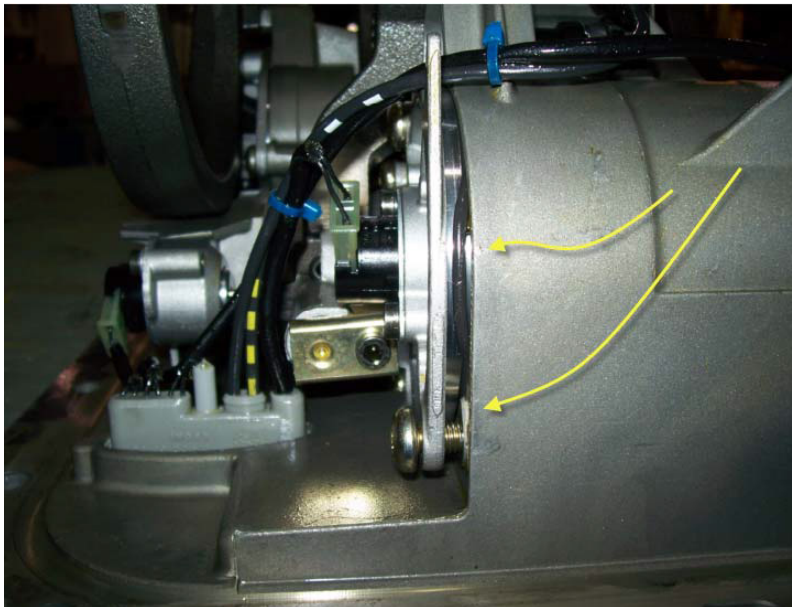
- These leaks are typically due to screws backing out of the shift piston covers (see Figure 4), allowing the end cap to vent air during a shift.
- This issue usually affects only one shifter and in one direction.

- It may result in random gear unavailability, causing the TECU to avoid these gears during operation.
- A key cycle typically resets this, requiring the unit to relearn the affected gears.

Replace the shift control housing, unless other damage is found.

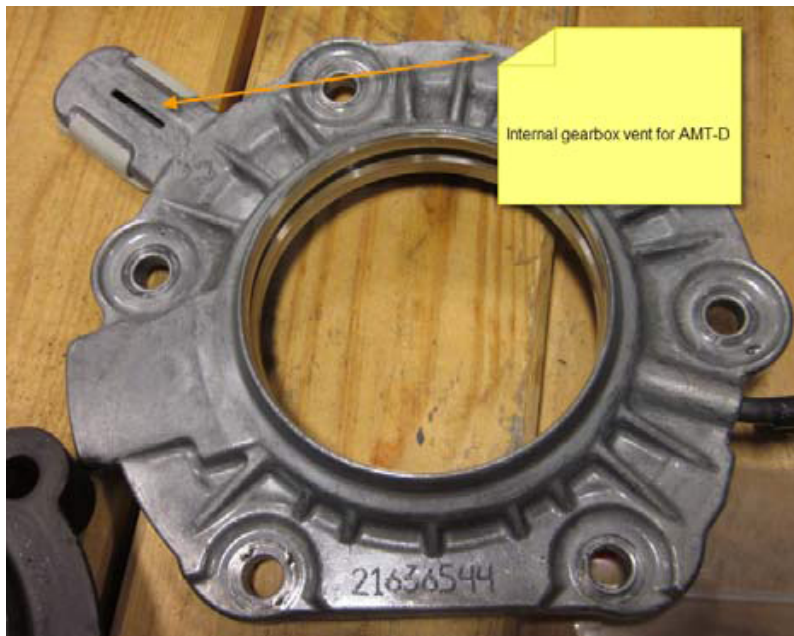
Internal AMT-D venting

Vent Location: The internal venting of the AMT-D is provided in the bearing retainer plate for the rear main shaft bearing. This allows venting and oil separation for return back to the gearbox.

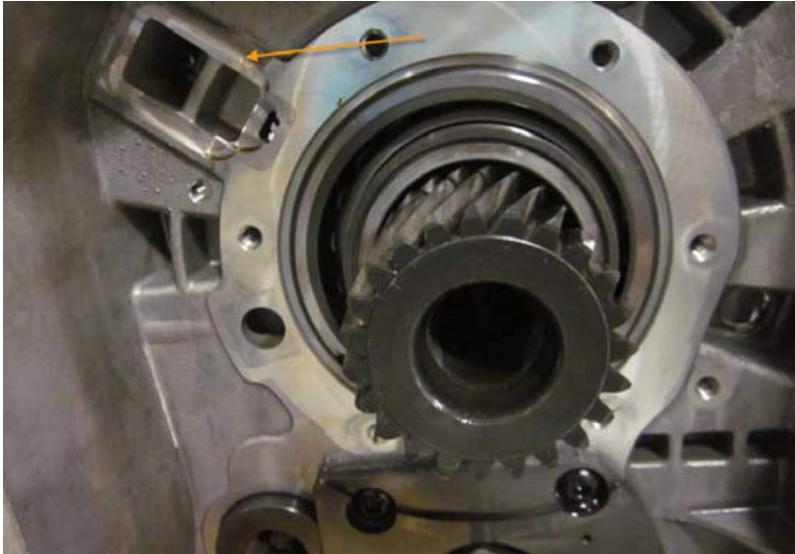
Bearing Retainer Removed: The AMT-D gearbox vents through a port in the main case, leading into the control housing and TECU, and is vented through the ports on the left side of the main case.

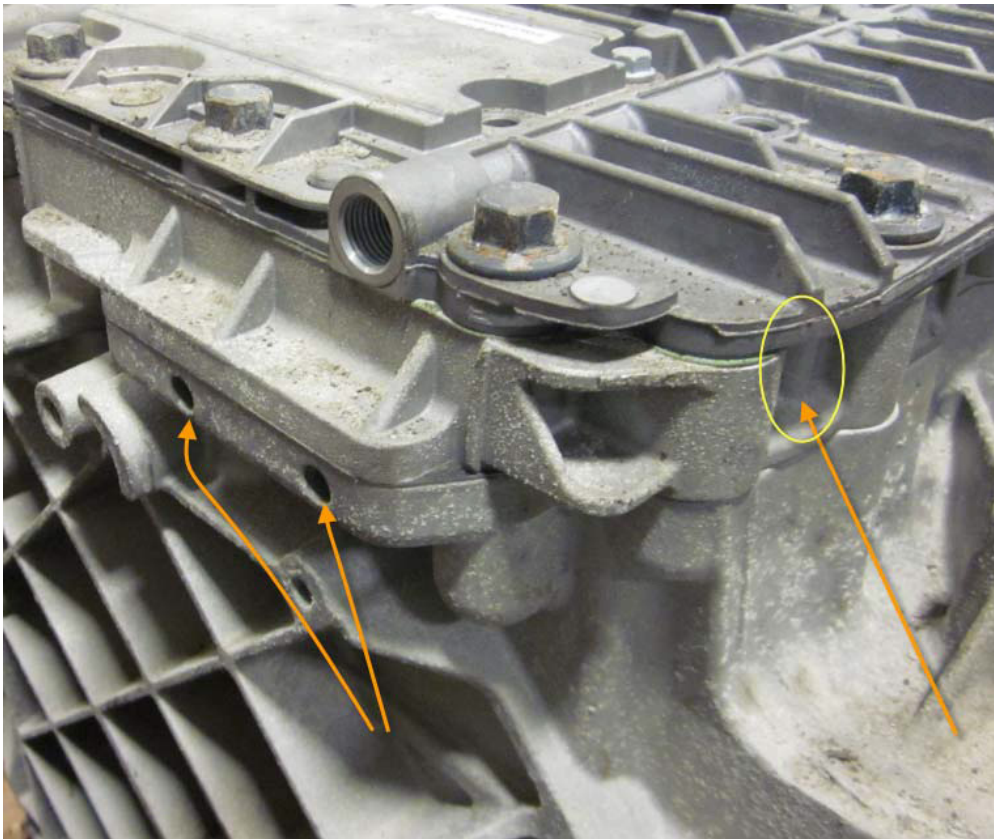
The vent port is cast and drilled in the main case, leading to the control housing and TECU.

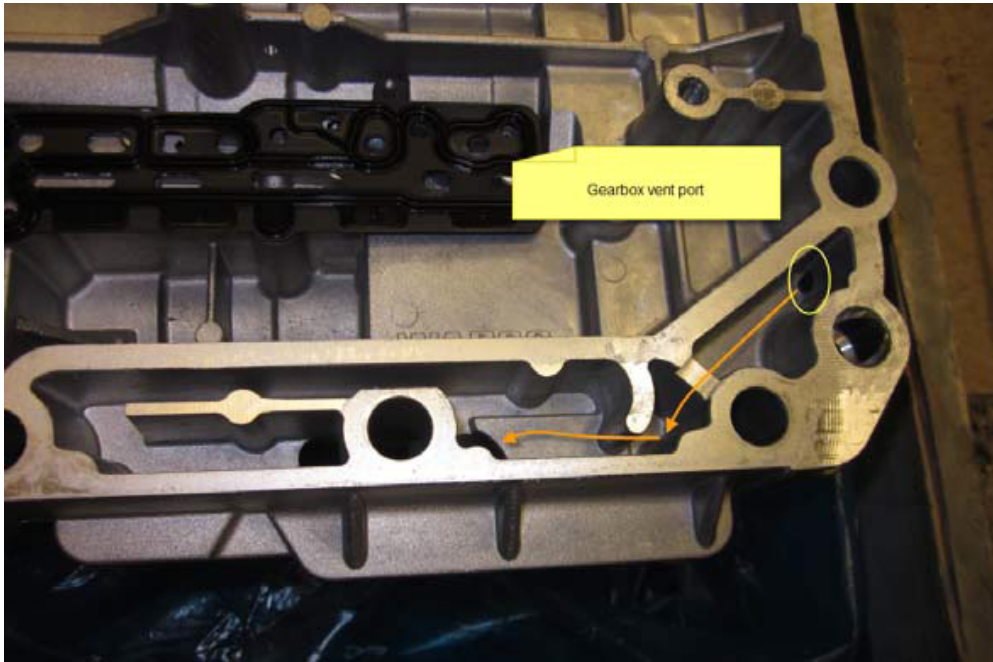
Internal ports in the control housing and the air path for gearbox case venting.

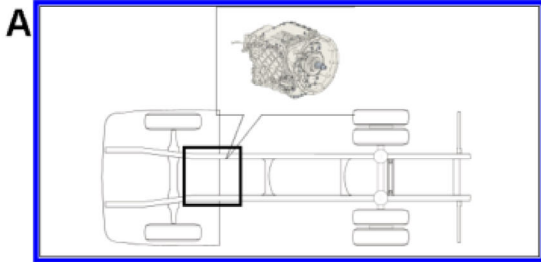
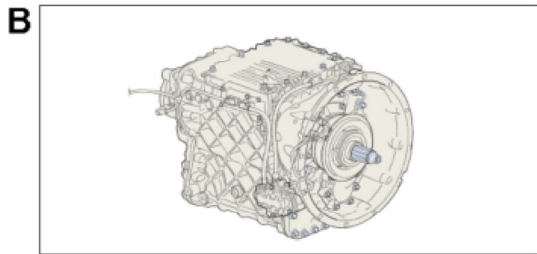
- A leak check can be performed by either listening or using soapy water
- Air will be applied and released to the clutch PWM valves in order to disengage and engage the clutch to check for proper operation (Transmission installed Only)

Select the illustration corresponding to the method or test to be performed

Transmission installed

Transmission removed

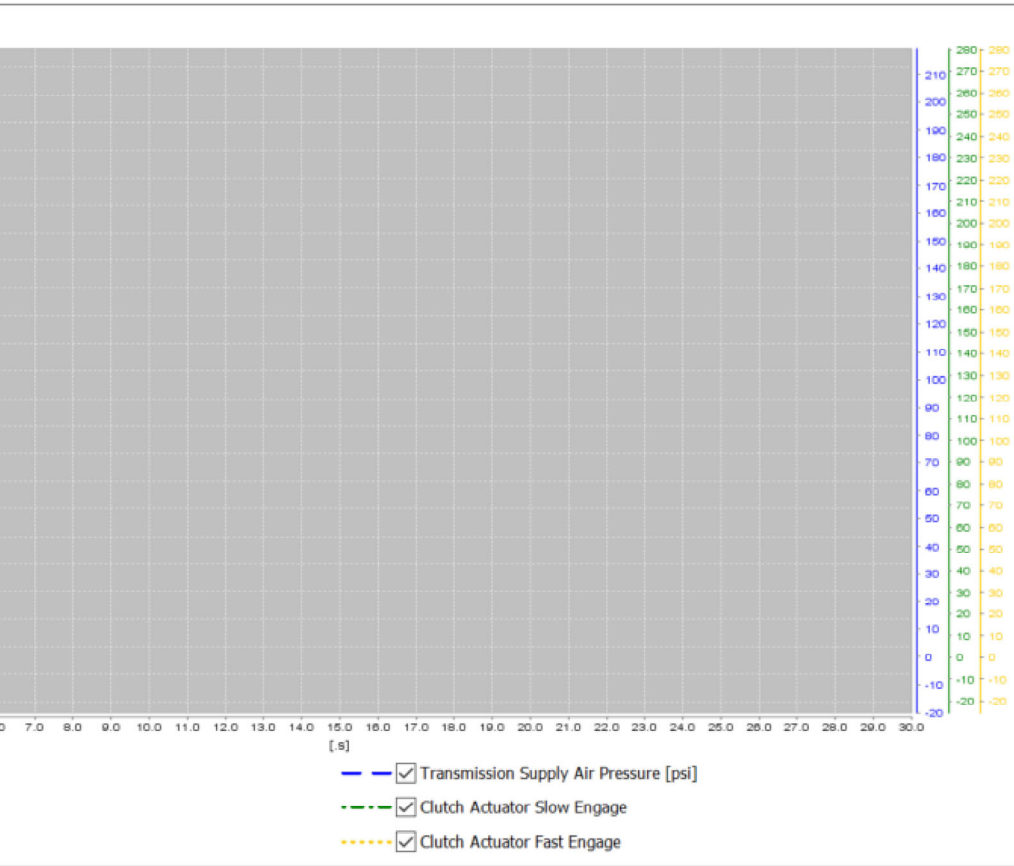
- 1 Engine not running
- 2 The product must be stationary
- 3 Air pressure above 94 psi

Clutch Cylinder Position
Transmission Supply Air Pressure

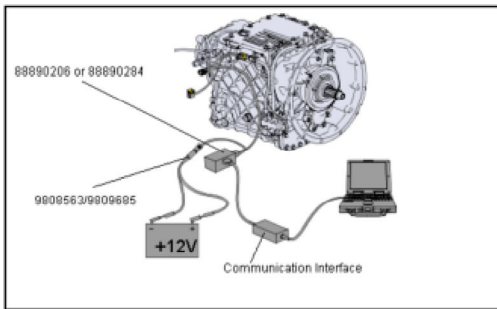
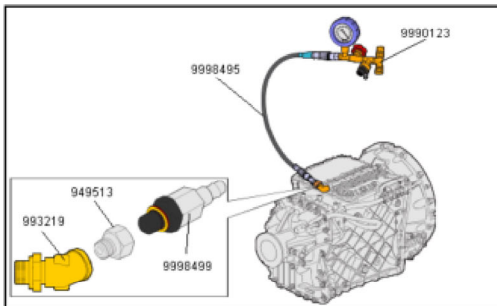
If performing a transmission removed operation and Tech Tool is connected to the product's main diagnostic connector, you must first click Finish Work under the Product tab, then the transmission using the special tools displayed in the illustration

- Connect special tools according to illustration
- Apply compressed air to supply the transmission with a minimum of 700kPa (100 psi) to a maximum of 1000kPa (145 psi)

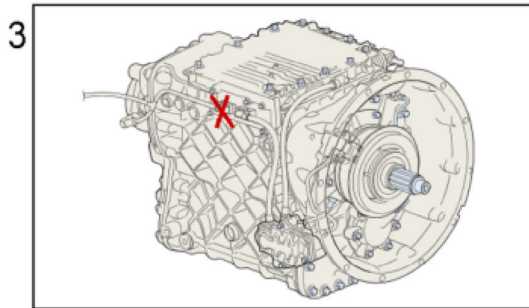
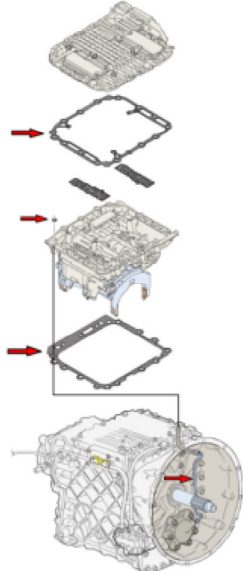
94 psi Air pressure

Solenoid valve

If performing a transmission removed operation and Tech Tool is connected to the product's main diagnostic connector, you must first click Finish Work under the Product tab, then click the Solenoid valve icon to perform the test using the special tools displayed in the illustration
