Technical Service Bulletin (TSB)
Bubbles On Rear Door Panel

REFERENCE:	TSB: 23-049-24 GROUP: 23 - Body	Date:	August 27, 2024	REVISION:	–
VEHICLES AFFECTED:	2024 (BV) Jeep Renegade This bulletin applies to vehicles built on or after May 06, 2024 (MDH 0506XX) and on or before June 23, 2024 (MDH 0623XX).	MARKET APPLICABILITY:			
		<input type="checkbox"/> NA <input checked="" type="checkbox"/> MEA <input type="checkbox"/> SA <input type="checkbox"/> IAP <input checked="" type="checkbox"/> EE <input type="checkbox"/> CH			
CUSTOMER SYMPTOM:	Customers may experience the following: <ul style="list-style-type: none"> • Appearance of bubbles on the rear door panels located in the armrest Fig. 1. 				
CAUSE:	Detachment of the PVC

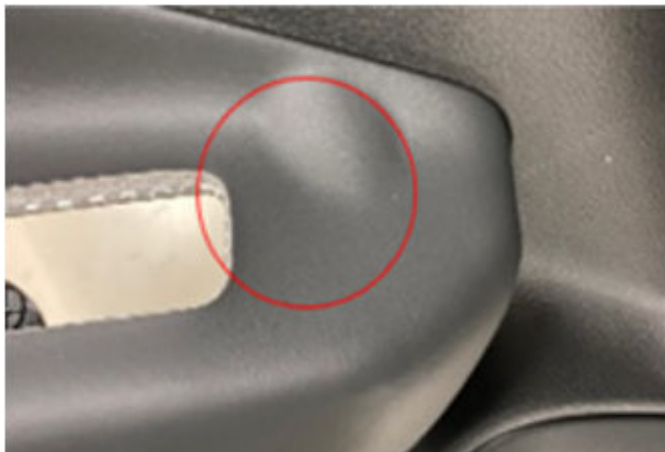
Fig. 1
Bubbles On Armrest

This bulletin involves replacing the left rear door panel.

1. Replace the left rear door panel. Refer to the detailed service procedures available in DealerCONNECT/ Service Library under: Service Info >23 - Body / Doors - Rear / Panel, Rear Door Trim / Removal and Installation.
