# Technical Service Bulletin

<b>Subject:</b>  REAR BRAKE NOISE	<b>Bulletin No.:</b> 04-001/24
	<b>Last Issued :</b> 08/29/2024

2020-2024 CX-30 (Mexico built)

2019-2024 Mazda3 (Japan built) vehicles with VINs lower than JM1 BP\*\*\*\* \*\* 714091 (Produced before Feb. 2, 2024)

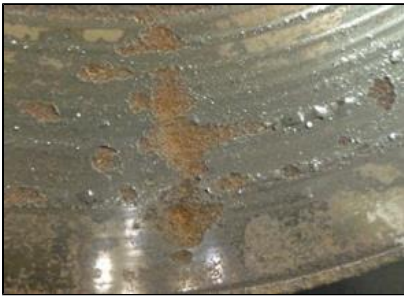
Sample case: If lathe is not applicable.  
Some areas of the surface have fallen off due to rust and are too thin.

1. Verify the customer concern **of grinding noise and/or vibration**.
2. Check the disc surface to see if the cause of noise and vibration is the disc's rust (Some areas of the surface have fallen off due to rust and are too thin, which may look like black stains on the surface). If rust is the cause of the noise or vibration when applying the brakes, lath the discs or replace them with new ones and replace the brake pads.

- Check the disc thickness using a micrometer before lathing, if the thickness is below 8.7 mm for 2WD or 9.7 mm for AWD, replace the disc with new ones (DO NOT lath). Measure the thickness in the relatively less rusted area where the pads are hitting but not in the severely rusted area.
- Disc replacement is acceptable if an on-car lathe is not available.

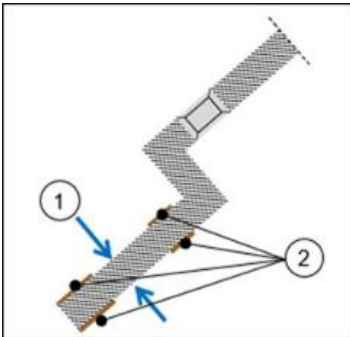
SECTION A-A

**NOTE:** Measure the thickness at the least rusted area.

- (1) Measuring points  
(2) Rust

3. After lathing the disc, re-measure the disc thickness. Replace the discs if the thickness is below the machining limit of 7.8 mm for 2WD and 8.8 mm for AWD as well as the brake pads. Refer to the instructions on MGSS online:
