**Fluid in Rear Left Footwell / Rear Window Washer System does not Work: Replacing T-Piece and Section of Hose for Rear Window Washer System (94/23)**

Model Line: **Macan (95B)**

Model Year: **As of 2019 up to 2023**

Concerns: **Rear window washer system**

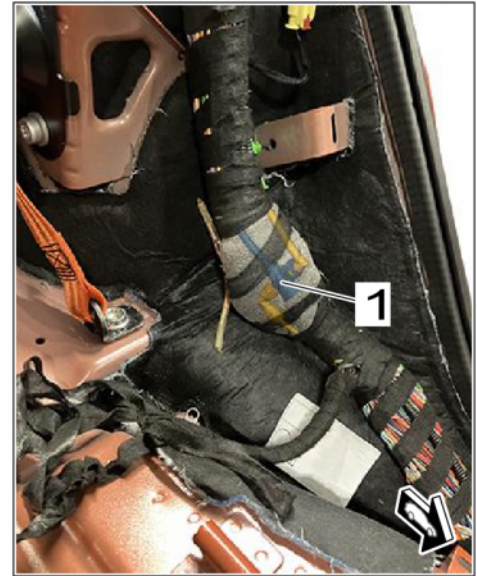
*T-piece and section of corrugated tube for rear window washer system (installation position under foam shown)*

Work Procedure: 1 **Carefully** cut open the fabric adhesive tape and foam. Uncover T-piece ⇒ *T-piece and section of corrugated tube for rear window washer system (installation position under foam shown) -1-* and approx. 100 mm of the corrugated tube of the rear window washer system.

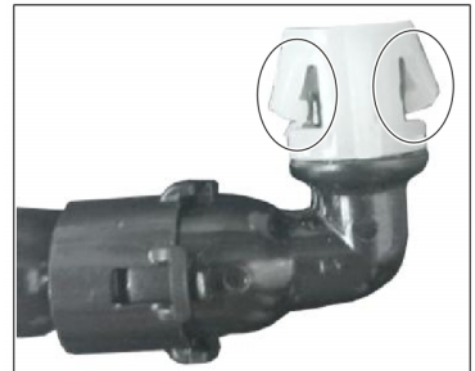
*Locking element released*

- 2.3 Turn (white) locking element  $\Rightarrow$  *Hose connections for rear window washer system -1-* of the hose connection of the washer fluid pump **clockwise by 90°**  $\Rightarrow$  *Hose connections for rear window washer system -Arrow-* to release the hose connection (the white locking lugs of the locking element protrude).  $\Rightarrow$  *Locking element released*

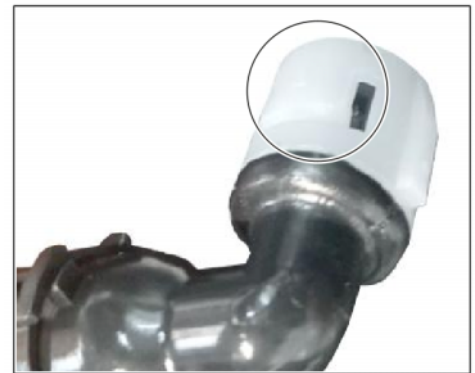
*Locking element locked (locking position)*

- 2.4 Pull off the hose from the T-piece. Then turn locking element (white)  $\Rightarrow$  *Hose connections for rear window washer system -1-* back **to the locking position** (the white locking lugs in the locking element are flush).  $\Rightarrow$  *Locking element locked (locking position)*
