GROUP	MODEL
General	2020-2024MY Telluride (ON)
NUMBER	DATE
PS770	August 2024

SUBJECT: HEADLAMP ASSEMBLY DESICCANT PACK DISPOSAL

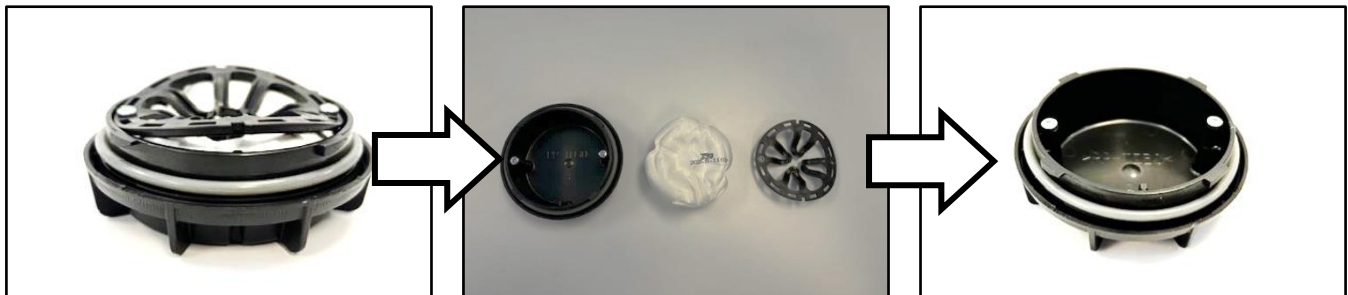
Image 1:
Expanded Desiccant Pack
with Dust Cap

Image 2:
Removed Desiccant Pack
and Bracket from Dust Cover

Image 3:
Dust Cover without
the Desiccant Pack & Bracket

This Pitstop provides information regarding the disposal of the headlamp assembly desiccant/absorbent pack(s) on some 2020-2024MY Telluride (ON) vehicles equipped with either Halogen or LED lamps. The headlamp desiccant pack(s) may expand over time during normal vehicle operation. Desiccant pack expansion is normal. Desiccant packs are a consumable part and once the pack has fully expanded, it is no longer a functioning part. If the desiccant pack/bracket is determined to be expanded as shown below, it is recommended to be removed from the dust cap and then be discarded without a required replacement.

Note: The headlamp dust cover may be reinstalled after removing the desiccant pack/bracket.
