SERVICE ACTION

Global Service Action
Number: **N870v5**

Subject: Single Speed Transfer Case Front Output Shaft Flange	Publication No.: N870v5
	Model: Range Rover Sport (L1)
	Model Year: 2024 - 2025
	Date of Issue: 07 August 2024
	Expiry Date: 31 August 2026

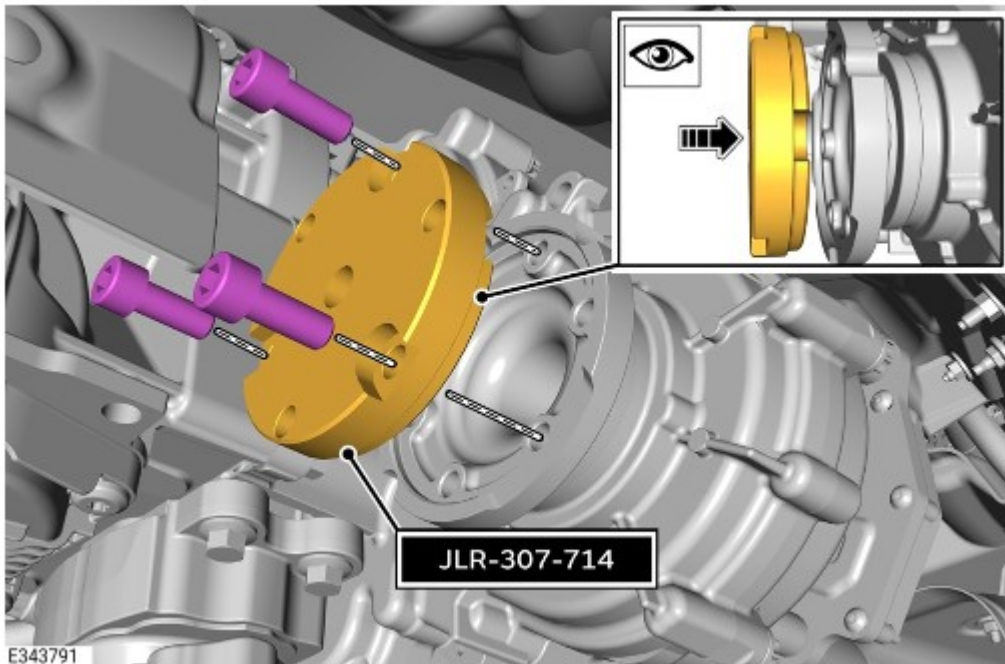
2. Install JLR-307-714 to the transfer case front output shaft and flange assembly, as shown in the illustration.

- Torque: **10 Nm**

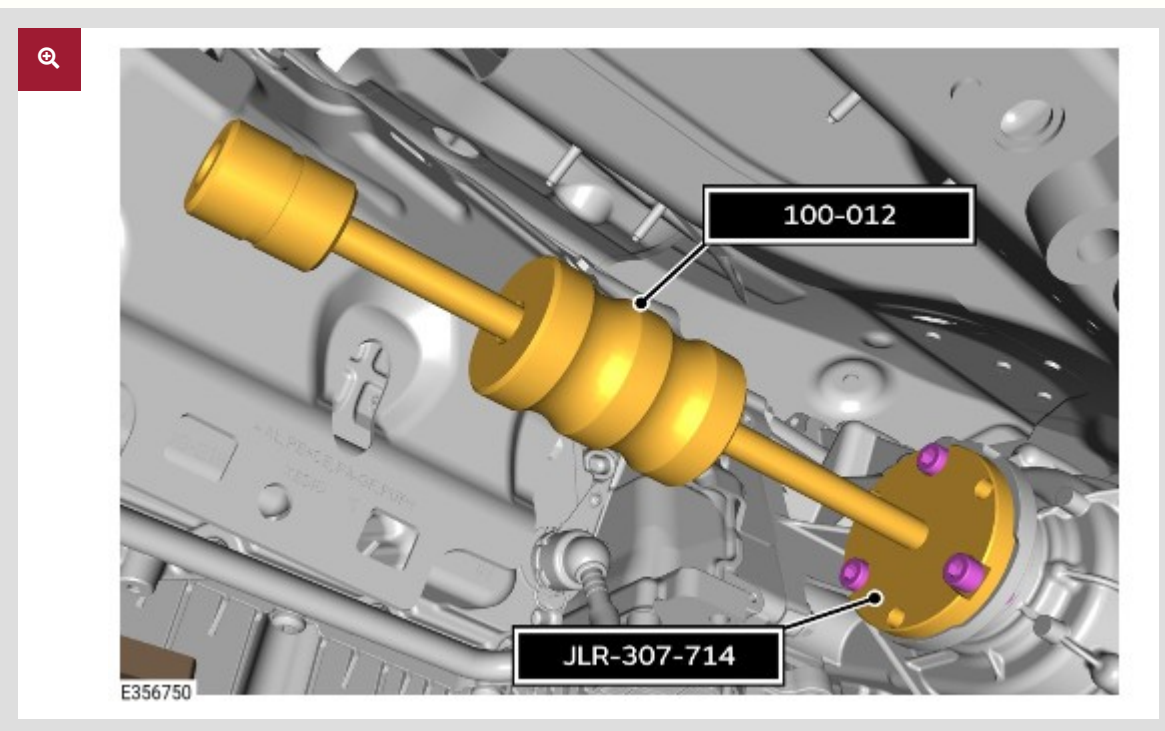
5. Remove 100-012 and JLR-307-714.

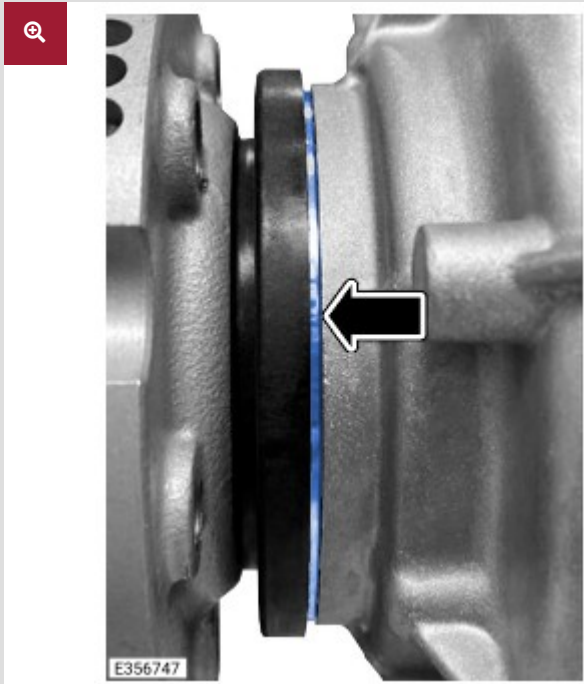
When measuring the gap you must not move the transfer case front output shaft and flange assembly. Failure to follow this instruction may lead to a false measurement.

Using a vernier caliper, or other suitable high accuracy measuring equipment, measure the gap between the transfer case casting and the plastic dust cover, as shown in the illustration.

- If the measurement **IS** 1.66 mm or below, **continue to Service Inspection - Measurement 2.**
- If the measurement **IS NOT** 1.66 mm or below, the transfer case has **FAILED** the inspection and a new transfer case must be installed. **Continue to the Service Instruction..**

1. Subtract **measurement 1** from **measurement 2** to find the difference between the two measurements.

- If the difference **IS BETWEEN** 0.25 mm and 1.25 mm inclusive, the transfer case has **PASSED** the inspection. **Continue to step 2.**
- If the difference **IS NOT BETWEEN** 0.25 mm and 1.25 mm inclusive, the transfer case has **FAILED** the inspection and a new transfer case must be installed. **Continue to the Service Instruction.**

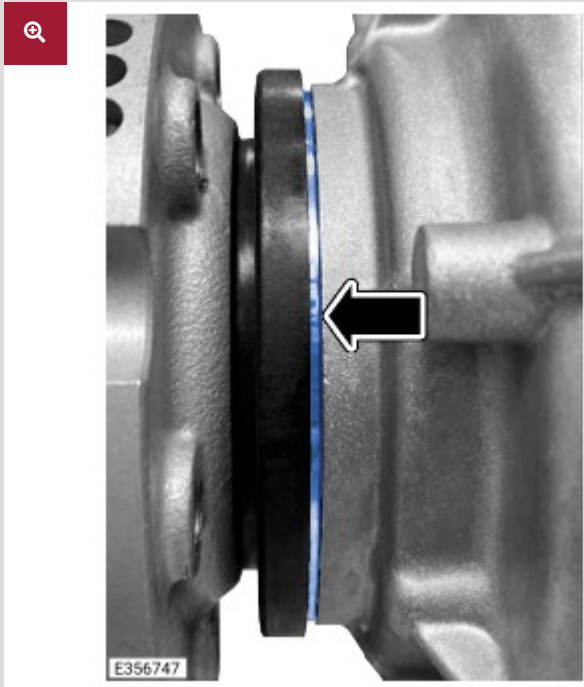
When measuring the gap take you must not move the transfer case front output shaft and flange assembly. Failure to follow this instruction may lead to a false measurement.

Using a vernier caliper, or other suitable high accuracy measuring equipment, measure the gap between the transfer case casting and the plastic dust cover, as shown in the illustration.

- If the measurement **IS** 3.35 mm or below, **Continue to Service Inspection - Measurement Result.**
- If the measurements **IS NOT** 3.35 mm or below, the transfer case has **FAILED** the inspection and a new transfer case must be installed. **Continue to the Service Instruction..**

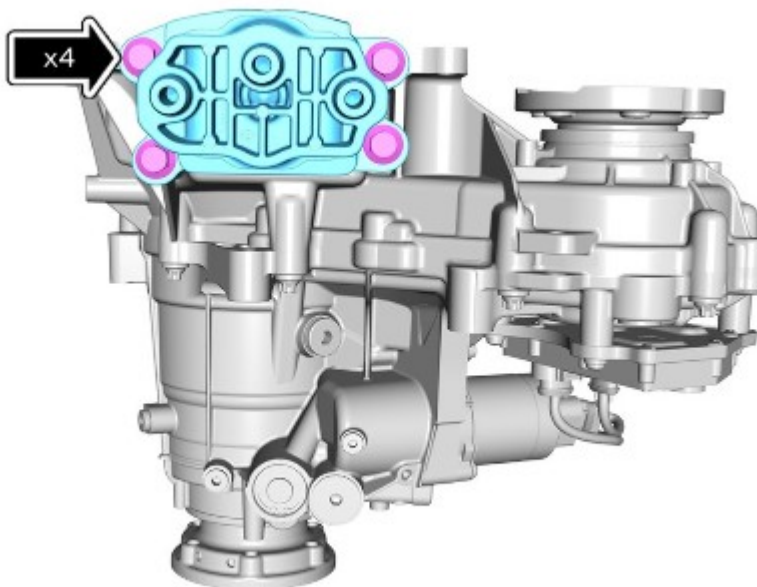
E356534

22. Remove the transmission support insulator.

- Remove the 4 bolts.
