Technical Service Bulletin

72 Folding cover for rear center armrest is loose

72 24 58 2074897/1 August 27, 2024.

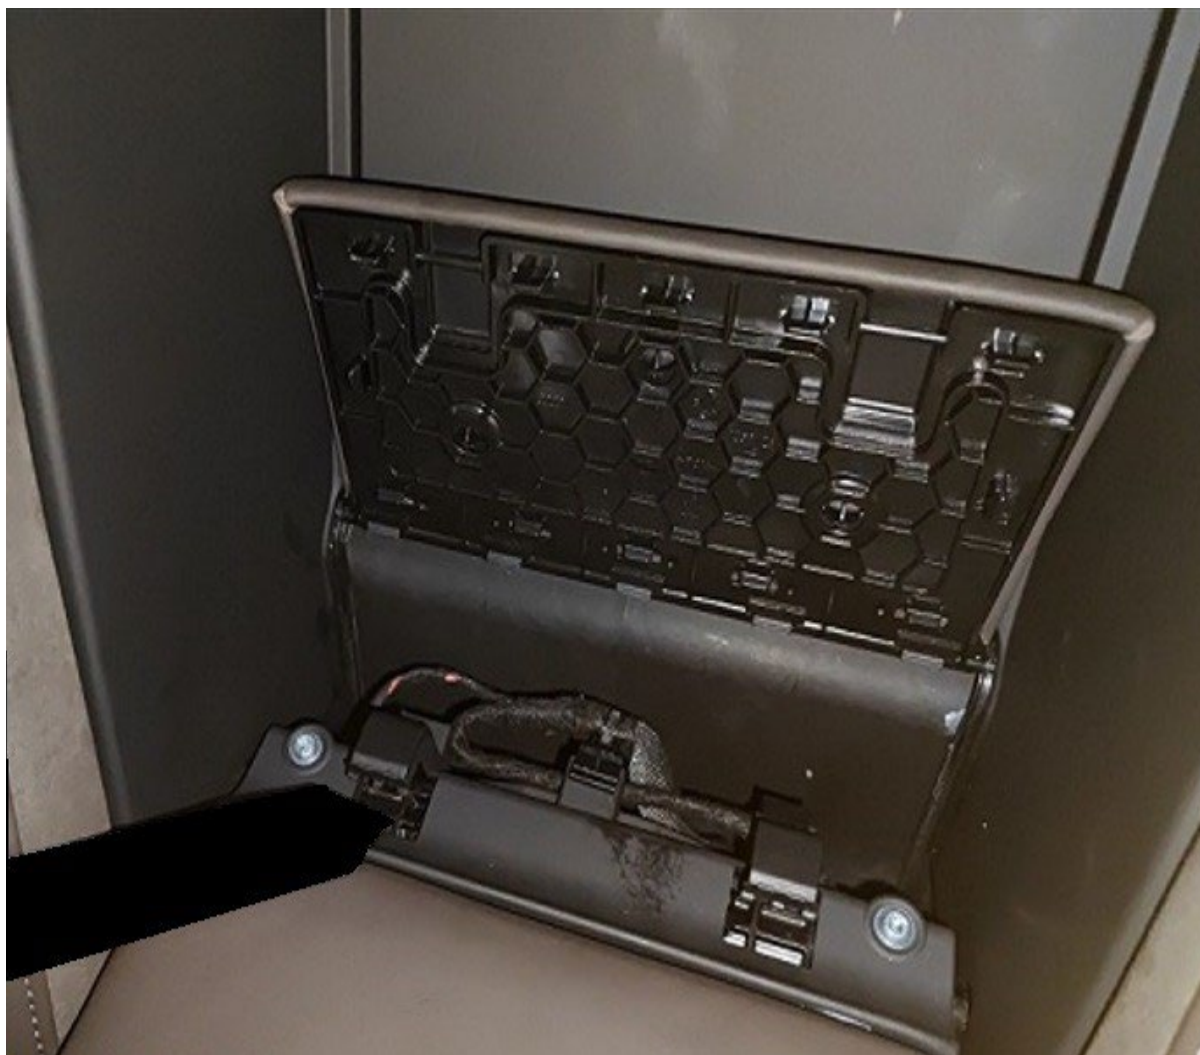
- The brackets for the armrest cover have broken (Figures 1, 2).

Figure 1. Broken armrest brackets

Figure 2. Broken armrest brackets

Component analyses have clearly shown that the brackets have broken due to external influences.

Claims for replaced parts will not be reimbursed.

This damage is due to outside influence and is not covered by any Audi Warranty.
