Service Action

Code: 10H9

Subject Engine Cover

An engine cover was either not installed during vehicle production or was removed as part of a previous recall remedy. A new and improved engine cover is now available and will be installed on affected vehicles free of charge.

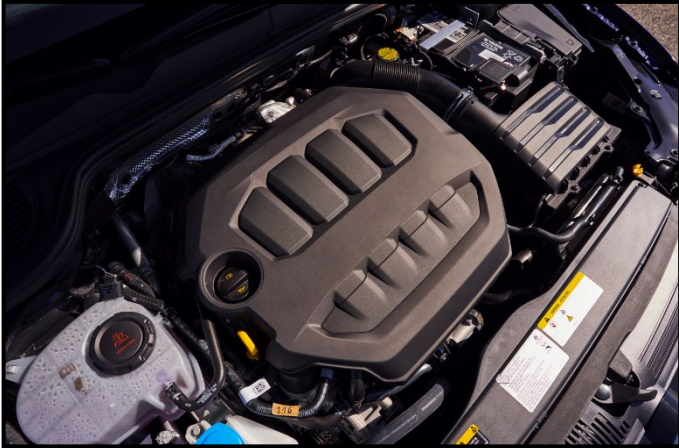
Repair Overview

- Install new engine cover.
