INSTRUCTION TO SERVICE

ITS61121		August 9, 2024
SECTION:	420-Shell Exterior	
WRITTEN BY:	New Flyer Service Engineering	
SUBJECT:	Install handle lever stopper brackets on the Rear Side Service & Wheelchair Lift doors	
ISSUE:	Lock Handle is loose which causes the door not to open	
SUMMARY:	Handle lever stopper bracket allows the door to function correctly

ITS61121

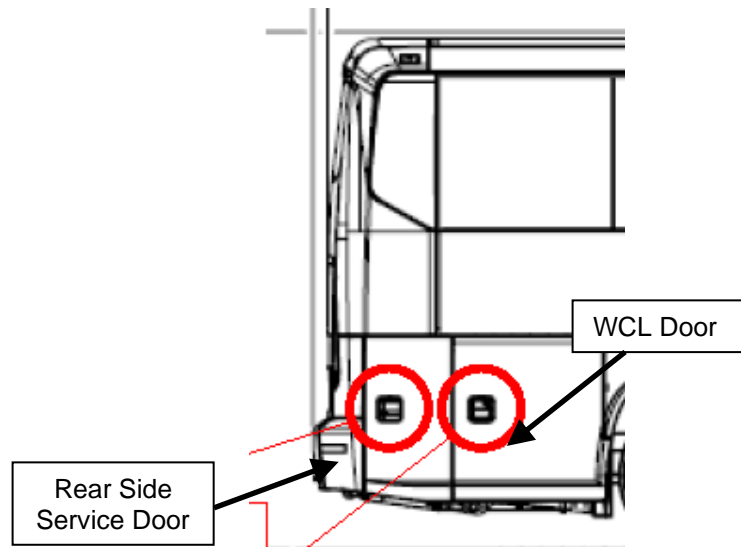
Figure 1: Lock Handle Locations Rear Right of Coach

1. Set park brake and chock wheels.
2. Turn the main battery disconnect switch to the “OFF” position.
3. Locate the wheelchair lift door and the rear side service door as shown in Figure 1.
