Technical product information

Topic	Flying B mascot clear wings replacement procedure
Market area	Bentley: worldwide (2WBE), China 796 VW Import Comp. Ltd (Vico), Beijing (6796)
Brand	Bentley
Transaction No.	2074992/1
Level	EH
Status	Approval
Release date

New Flying Spur

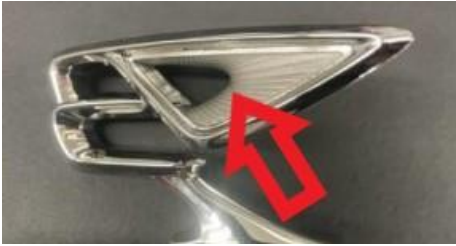
Figure 1

One or both of the Flying B mascot clear wings are missing (Figure 1)

In the event that one Flying B wing is missing the operative must replace both wings to eliminate a repeat repair

VERY IMPORTANT: It is no longer a requirement to replace the complete Flying B mascot assembly if the clear wings are missing, the process within the Measure section details how to fit new replacement clear wings

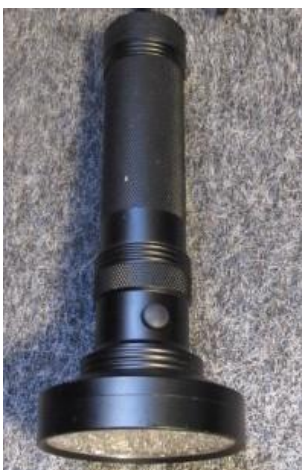
Figure 2

UV light (Figure 2) the specification must be as follows:

- Minimum power output must be 5W

The UV Wavelength must be as follows:

- Minimum wavelength of 395nm (nanometres)
- Grey or dark brown UV safety glasses must be worn when conducting the adhesive bonding procedure
- Standard safety glasses must be worn whilst conducting all other steps other than the UV adhesive bonding procedure
- Dymax Ultra light weld 3094-GEL-REV- A - 30 ML (Figure 3)
- 3M surface cleaner or same specification

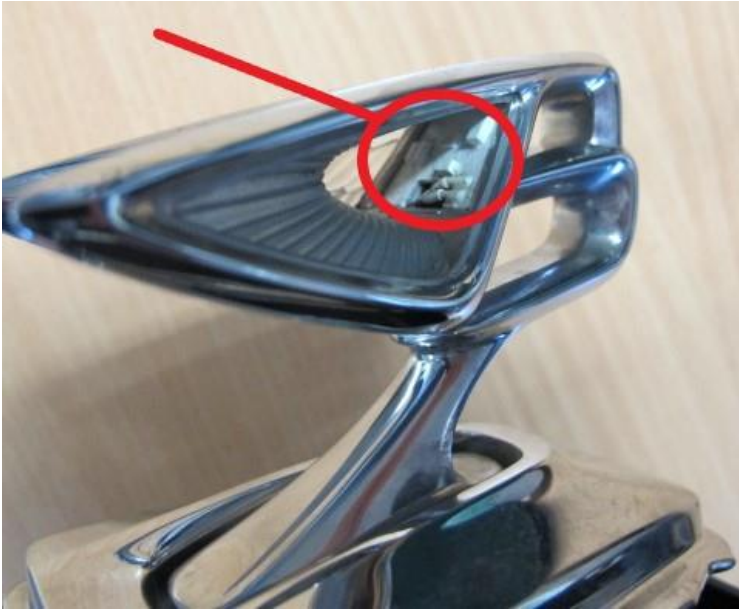
Figure 5

1) Due to the location of the LED light (Figure 5) damage can be caused to the Flying B mascot therefore it is imperative the wings are drilled at the exact location shown within Figure 6

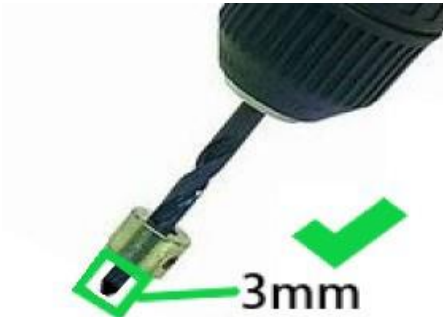
Figure 9

Hint: A standard 3mm drill bit can be used however the drill must be used in conjunction with a drill stop tool to ensure a depth of 3mm is not exceeded (Figure 9)

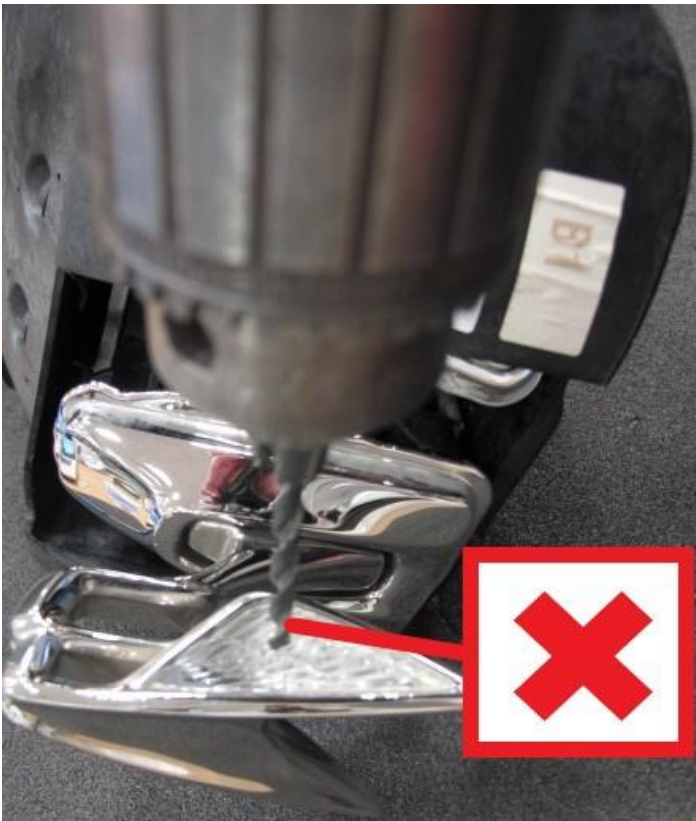
Figure 10

- Do not use a standard drill without using a drill stop as damage can easily be caused to the mascot or LED (Figure 10)

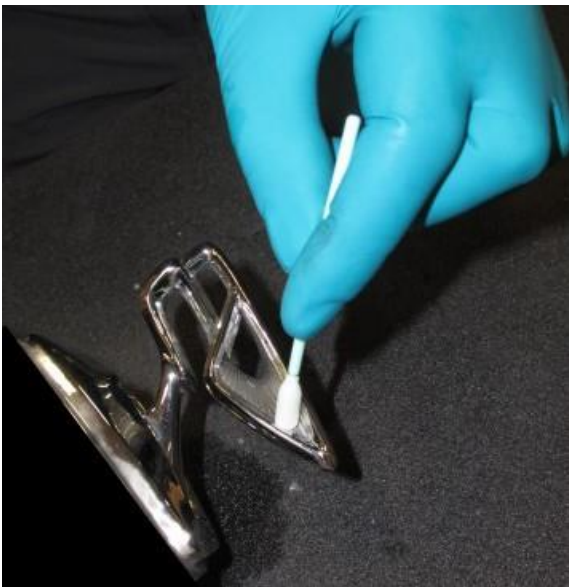
2) Referring to Figure 11 - Using foam cleaning tips in conjunction with 3M surface cleaner thoroughly clean the Flying B aperture

Once the adhesive has been removed using the 3M cleaner the operative should wait 60 seconds to allow the liquid to evaporate

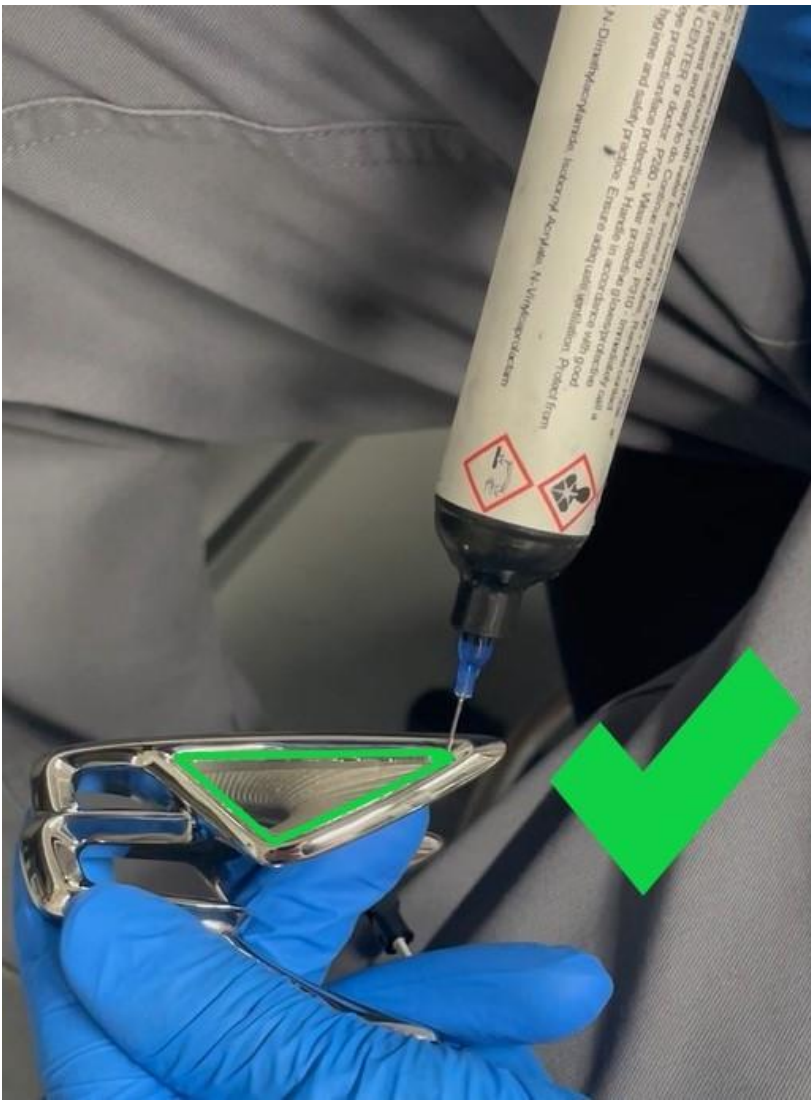
4) Referring to Figure 12 - Apply the adhesive as shown ensuring the adhesive is applied in a consistent manner noting the following:

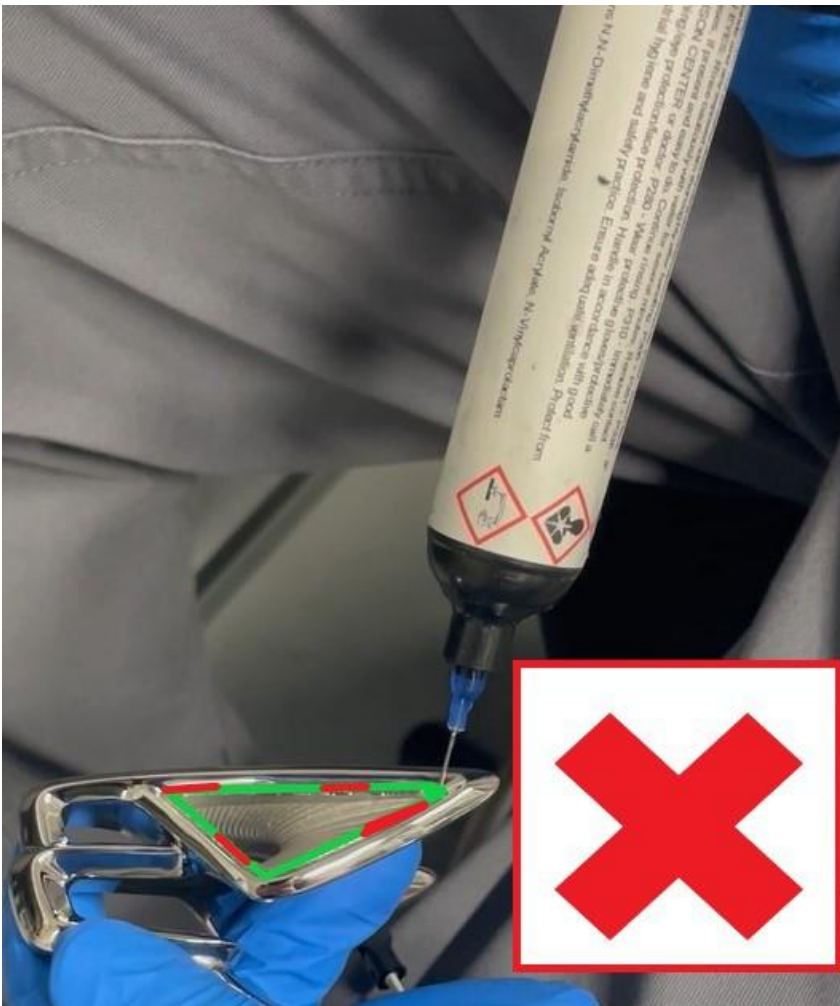
Figure 13

Should the adhesive dosage be sporadic/not consistent (Figure 13) there is a risk of insufficient sealing and water ingress

- Poor Cleaning of the Flying B mascot can lead to debris inside the mascot
- Should too much adhesive be applied the excess will be visible and would be seen through the clear wings

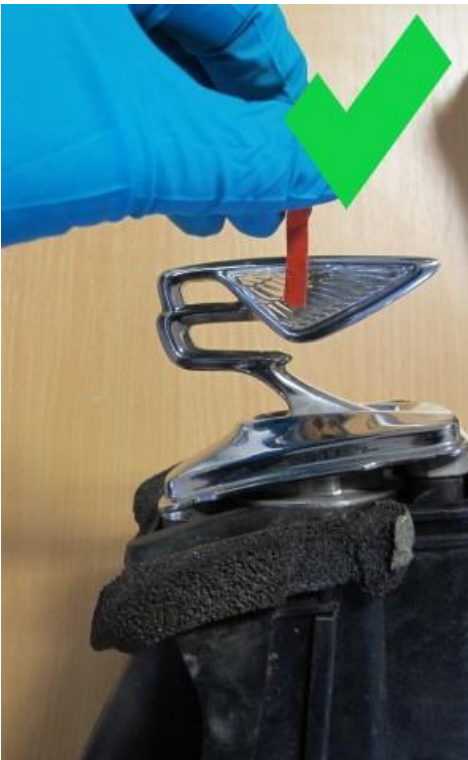
5) Referring to Figure 16 - Ensuring suitable gloves are worn – Use suitable double sided tape to hold the wing at the location shown, fit the replacement wing ensuring the adhesive is not disturbed, once fitted wipe away any excess adhesive from the outside of the clear wing and mascot using a clean cloth and 3M surface cleaner

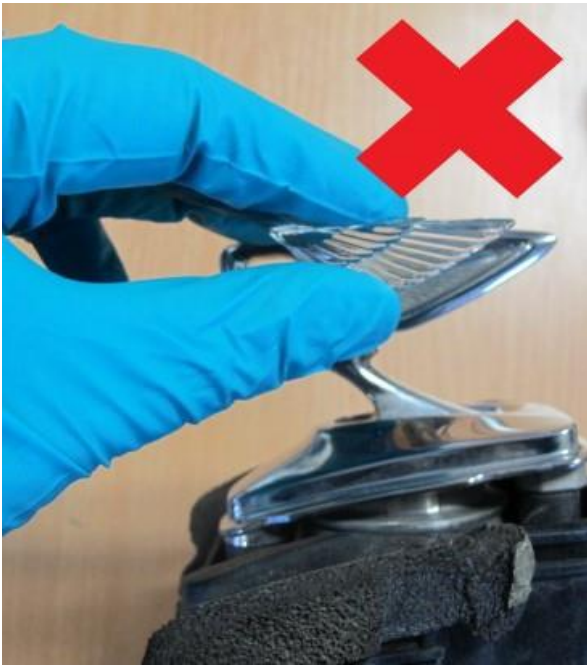
Do Not hold the wing as shown in Figure 17 as the adhesive can easily be disturbed when using this method

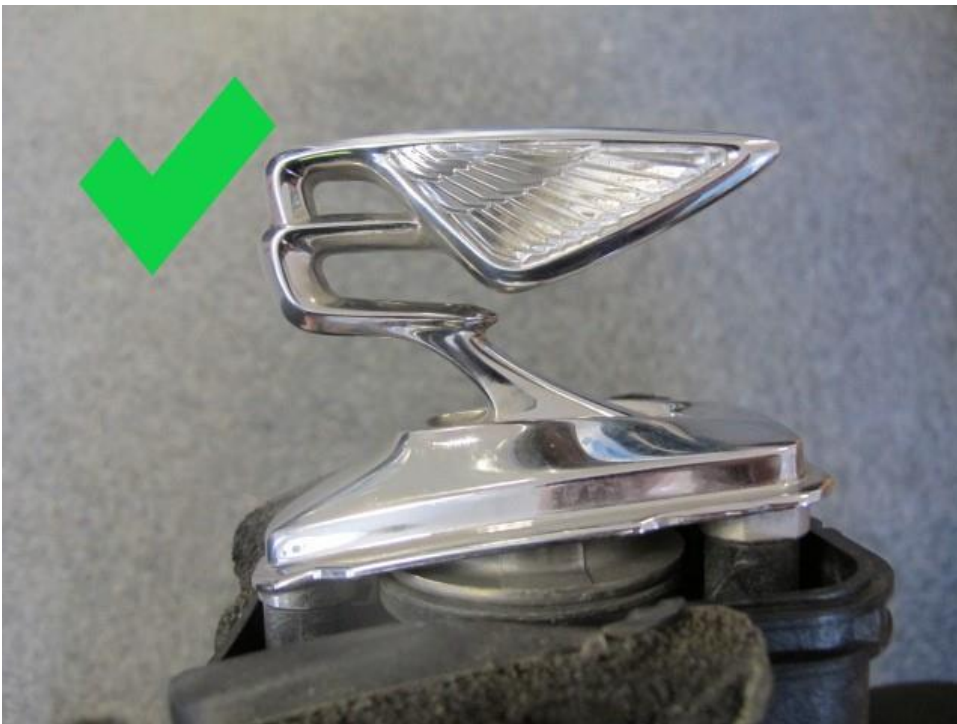
6) Once fitted the wing should be as shown in Figure 18

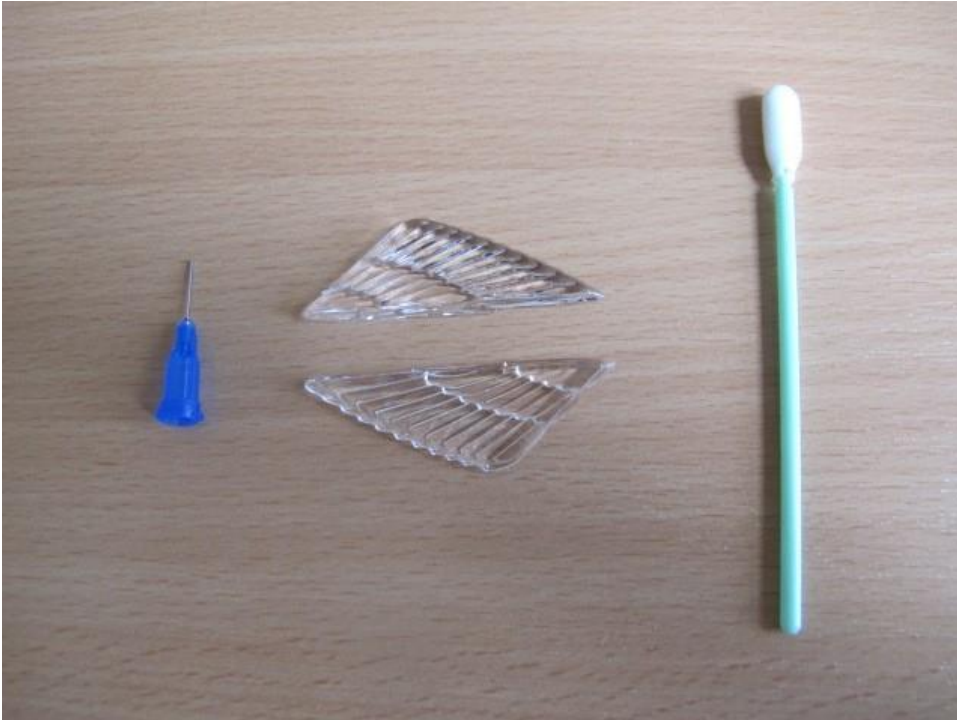
Figure 20

3SE 898 810 - REPAIR KIT FLYING B WINGS (Figure 20)

The kit contains the following and can be used on multiple vehicles

- Syringe Needles x5
- Sets of clear wings x10 (5 left hand side wings - 5 right hand side wings)
- Foam Cleaning Tips x5
