| Subject | Broken Interior Step Treads | | | | | Number | | 24-002 | | |
| | | | | | | Model | | Solitude | | |

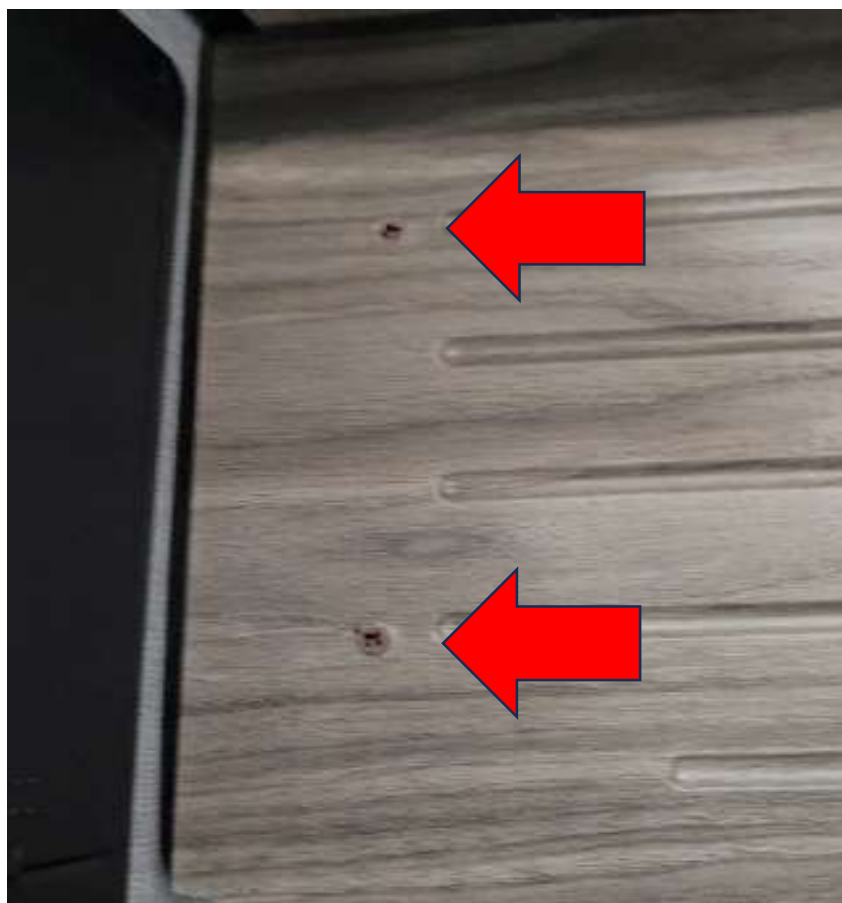
1. Verify if the step tread is held in place by a screw. If so, you will need to remove the screws first.

| Concern: | Steps may break at the riser due to the amount of overhang. | | | | | | | | | |
| Remedy: | Replace the treads. | | | | | | | | | |

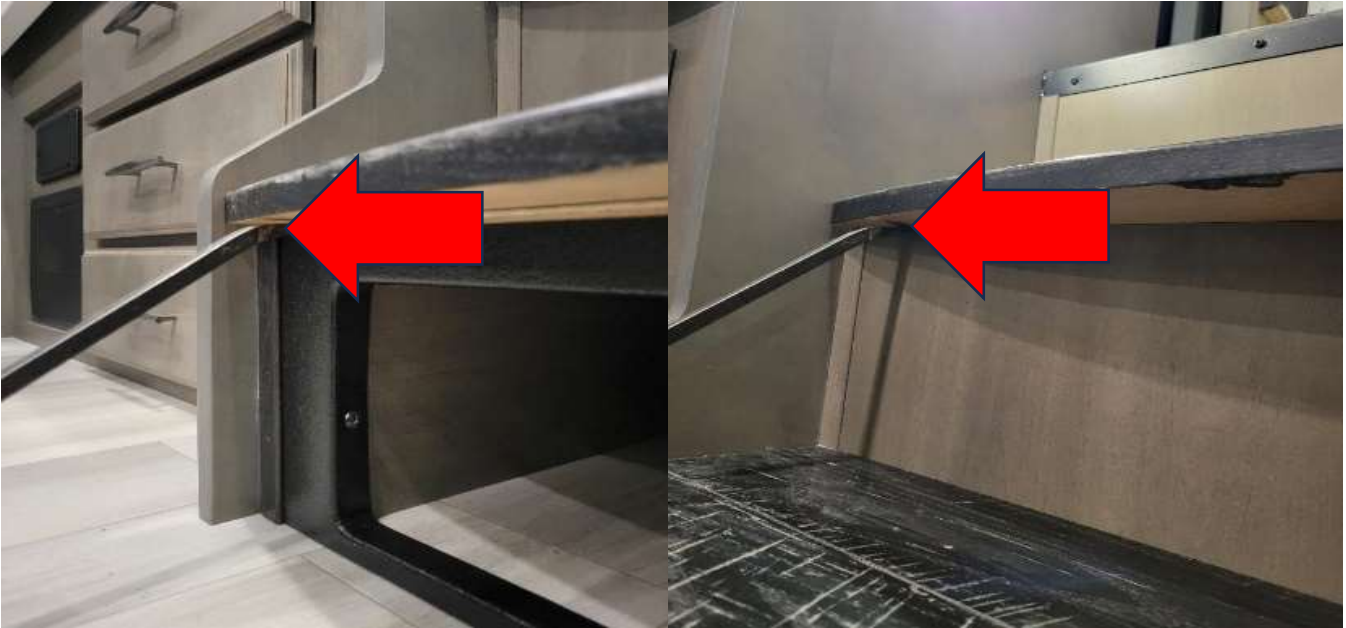
2. Next you will need a pry bar or comparable tool. Place the prybar under the step tread where it meets the step riser. Lift at this point to remove the tread from the frame.

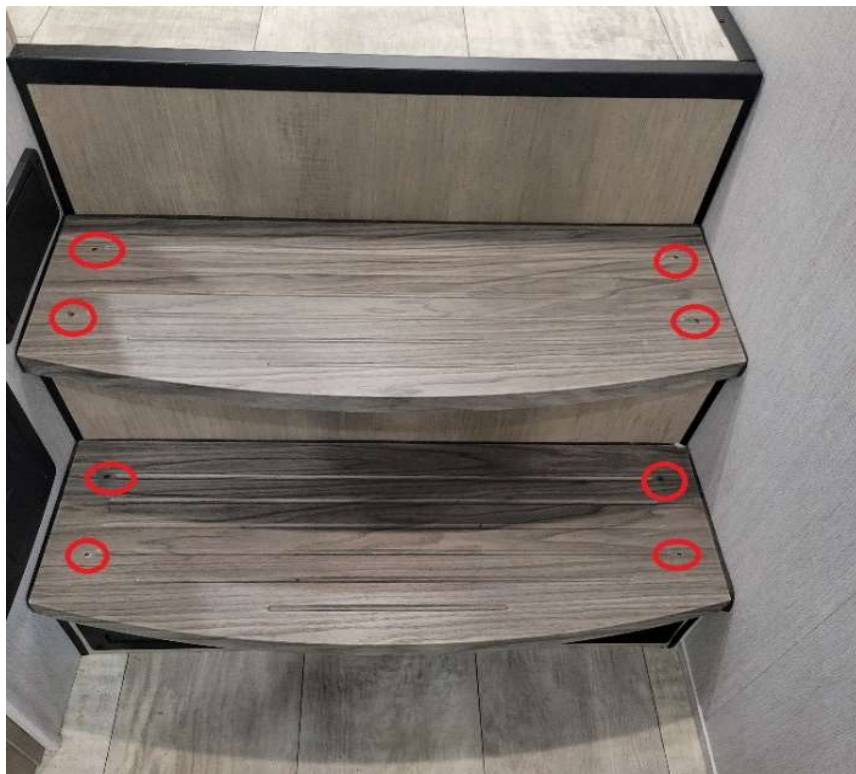
3. Dry fit the replacement step tread. Be sure the replacement tread is fully seated against the riser. Measure and predrill for the screws. Countersink the screw hole so the head of the screw is slightly below flush with the surface of the step tread. Remove the tread and place a bead of Sika-Flex on the side supports and riser for the step. Attach the replacement step and secure with screws verifying they are below the surface of the step tread. Repair complete.
