Technical Journal Title Long Range PHEV ERAD Knocking Noise Repair Kit		Ref. No. TJ 36894.3.2	
Issuer (Dept.) Technical Service		Issue Date 7/23/24	Status Date 7/24/24
Car Market United States and Canada	Partner 3 US 7510 Volvo Car USA	Function Group 4632	
Function Description Electrical rear axis drive		Page Page 1 of 9

TJ Instruction VCC-528981-1

Title	ERAD bearing	Page	1 (7)
Action	Product fix	Operation number:	97733-3 98298-2

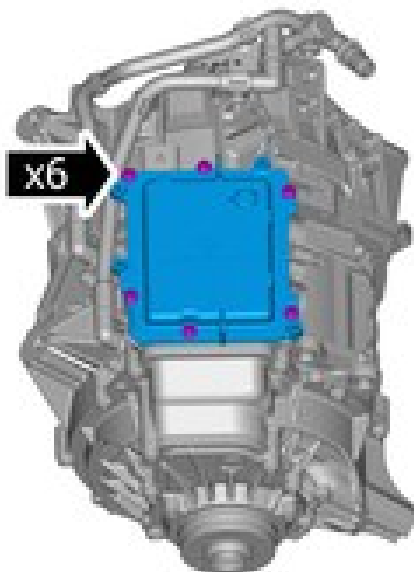
Remove the screws.

Remove the marked part.

High voltage wiring harness lid, ERAD ,
9 Nm

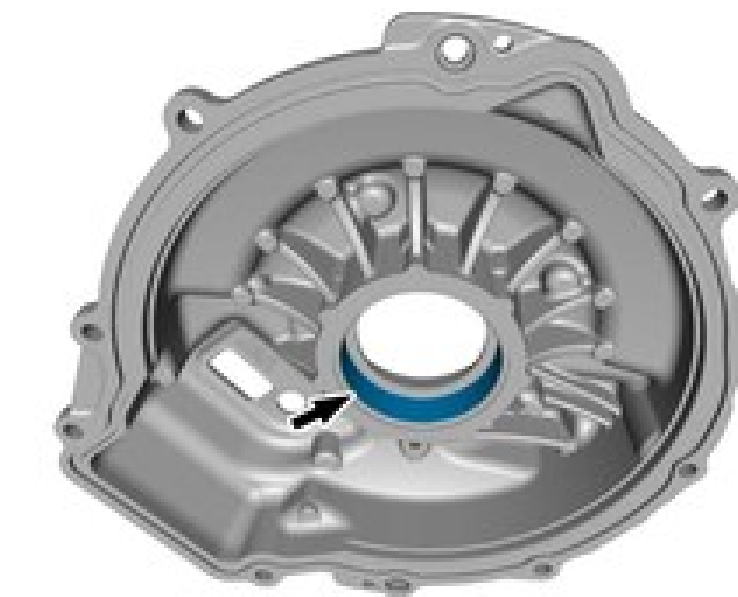
Caution! Make sure that the surface is clean and free of foreign material.

Clean the marked area.

Use: Abrasive cloth , 9511024
