STAR ONLINE PUBLICATION

Case Number: S2423000041 Rev. A

Symptom/Vehicle Issue: 2nd Row Seat Is Hard To Put Back In Position After Moving It Forward To Access The 3rd row seat.

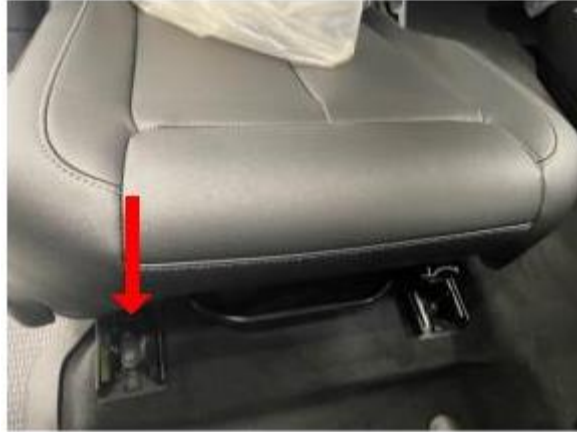
Fig 1
Location Of Seat Roller.

1. Tip forward the second-row seat.
2. Locate the seat rollers (Fig 1)
3. Add grease on both rollers of each seat (Fig 2).
4. Move the seat forward and backward multiple times and test operation.

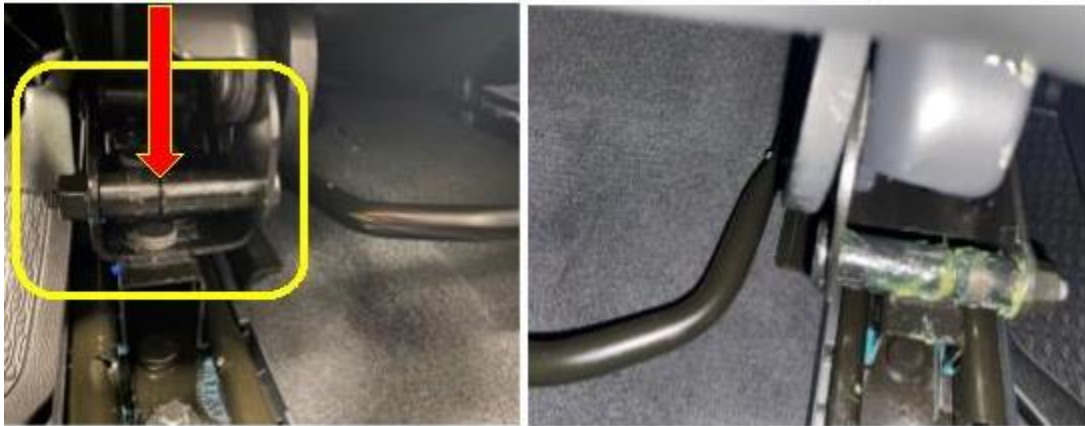
Fig 2
Application Area For Grease (Left). Grease Applied (Right).

Parts Required: MOPAR Multi-Purpose Grease 05083160AA or equivalent.
