# HYUNDAI Technical Service Bulletin

GROUP <b>BODY</b>	NUMBER <b>24-BD-011H</b>
DATE <b>SEPTEMBER 2024</b>	MODEL(S) <b>KONA (OS)</b>

**SUBJECT:** REAR SPOILER PAD REPLACEMENT

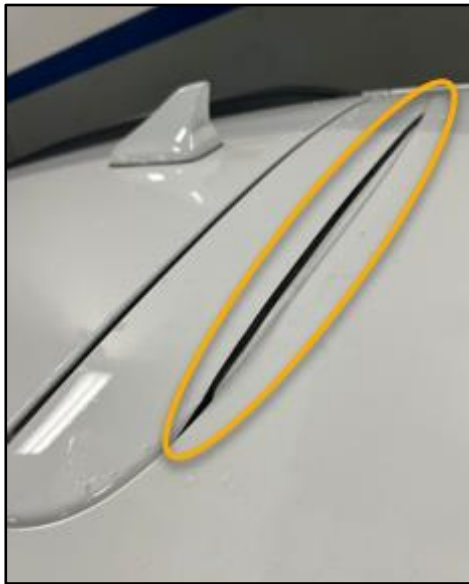
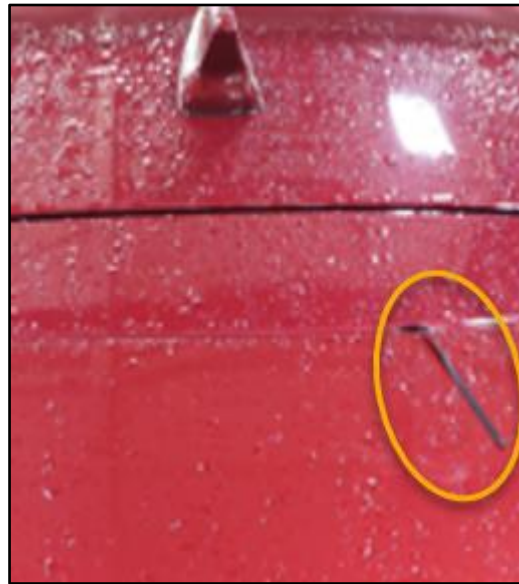
**Description:** Certain 2023MY Kona (OS) vehicles may have a detached pad between the rear spoiler and roof panel due to an error in the assembly process. Follow the procedure outlined in this TSB to replace the pad on the rear spoiler.
