September 18, 2024

Version 1

Water Intrusion in the Rear Hatch Area

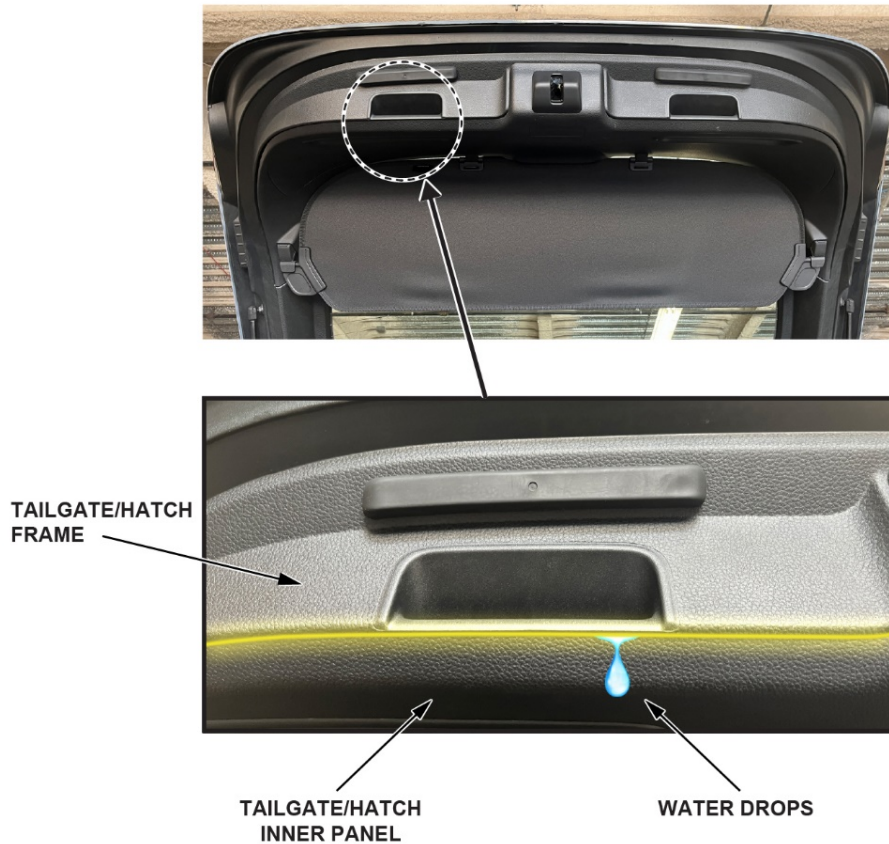
1. Spray water on the roof and rear hatch area or run the vehicle through a car wash.
2. Open the rear hatch.
3. Examine the rear hatch inner panel for water droplets or evidence of water residue, then shake the rear hatch to detect any water noise from inside the rear hatch.

4. If the water leak is verified to be coming from the highlighted area of the rear hatch, proceed with the REPAIR PROCEDURE.
5. If there is no evidence the water leak is coming from the rear hatch, this bulletin does not apply. Proceed with normal troubleshooting.

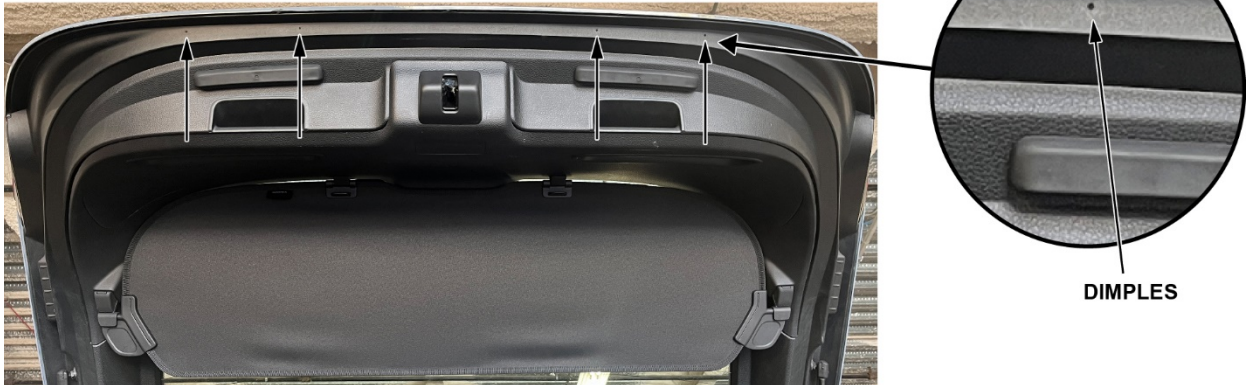
1. Open the rear hatch and locate the dimples in the panel on either side of the latch.

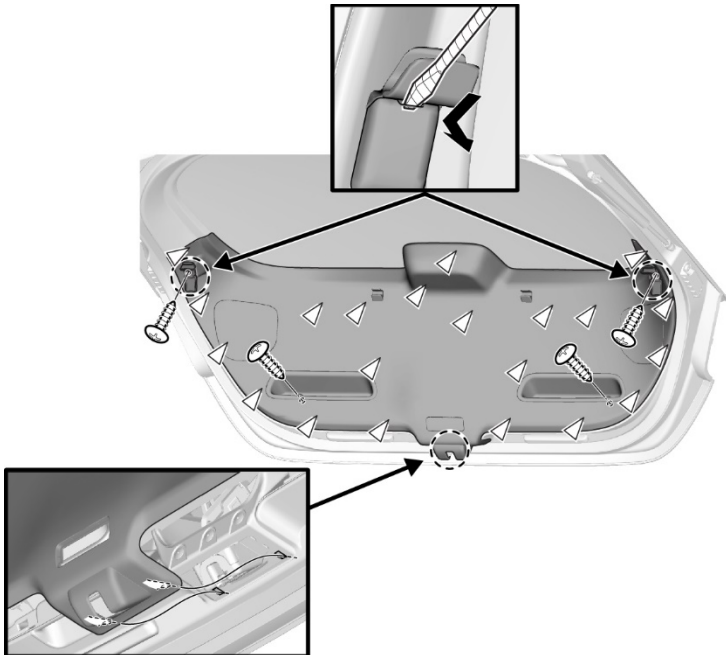
2. Remove the rear hatch interior trim panel.

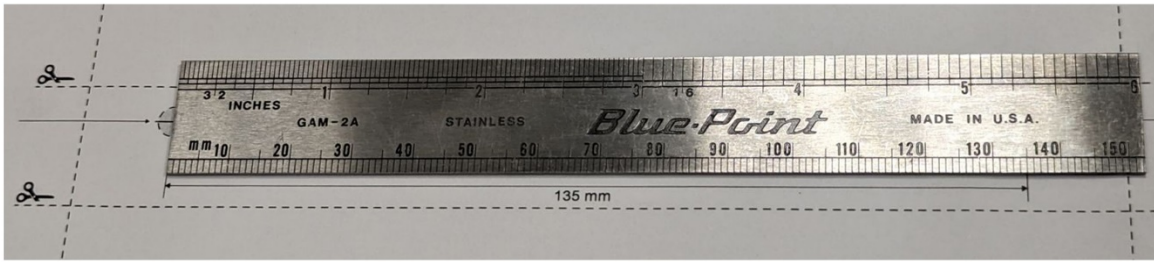
4. On the last page of the printed service bulletin, confirm the template size is accurate by verifying the measurement between the center of the two end holes is **135 mm (5.31 inches)**, as marked on the template.
- NOTE: If the measurement does not equal **135 mm (5.31 inches)**, check the print settings to confirm the **Actual Size** setting is selected.

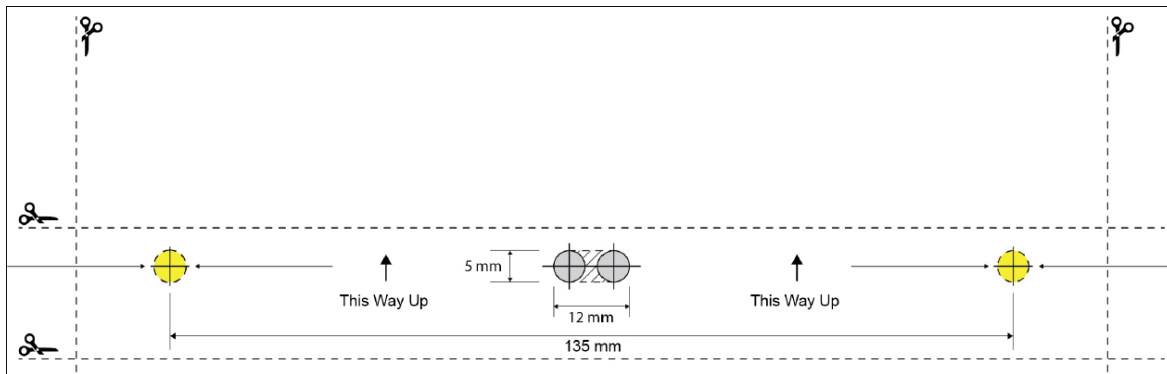
5. Cut out the drilling templates, then cut out the end holes (marked in yellow) with a paper hole punch. There are two templates, one for each side of the rear hatch.

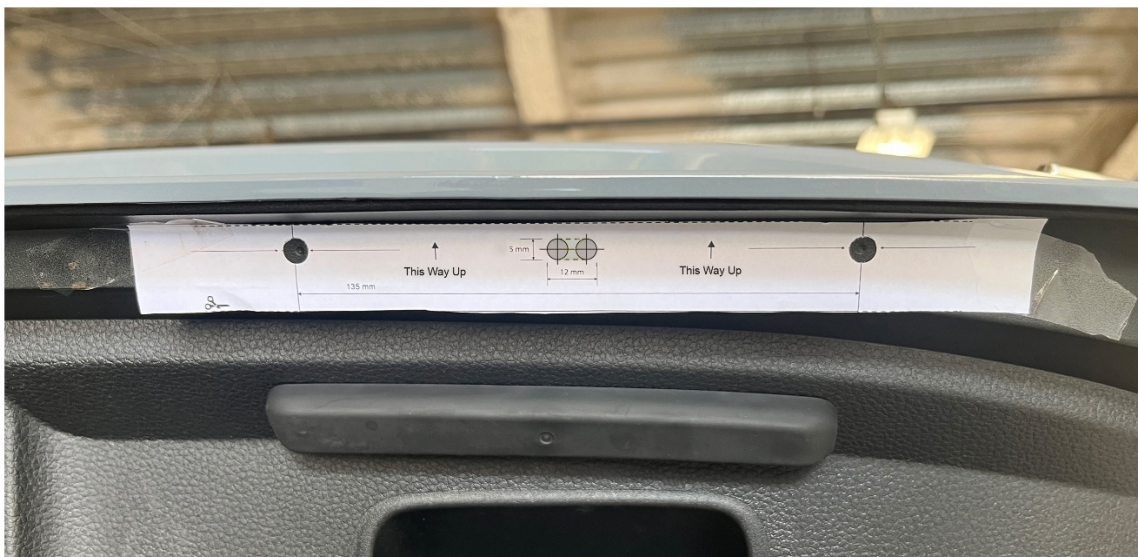
6. Line up the end holes in the template with the dimples in the rear hatch, and confirm the template arrows are pointing up, then secure the template with tape at each end.

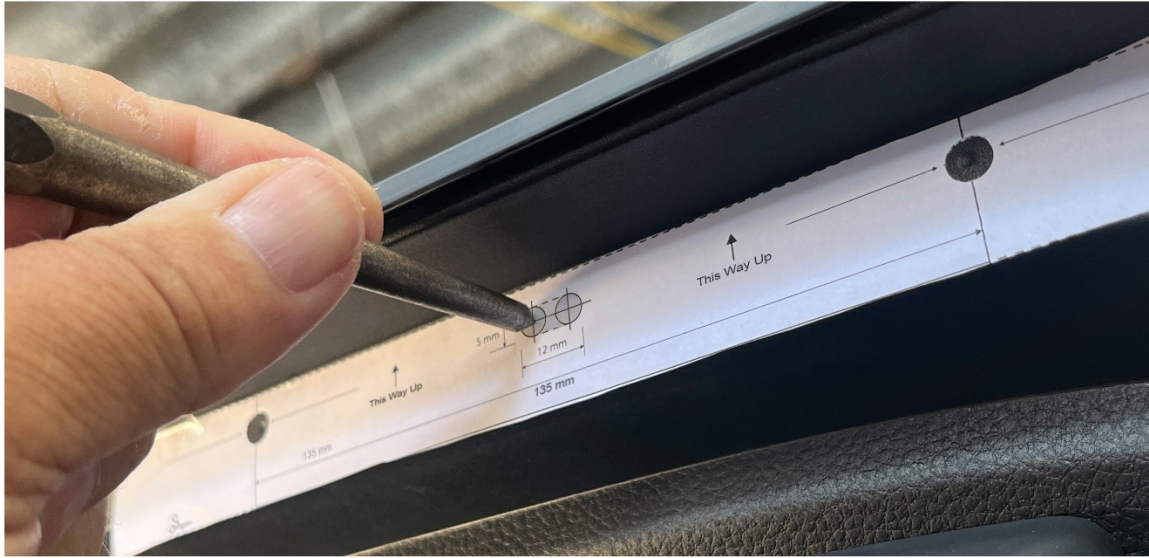
7. Using a centerpunch, mark the drilling locations on the ⊕ markings on the template.

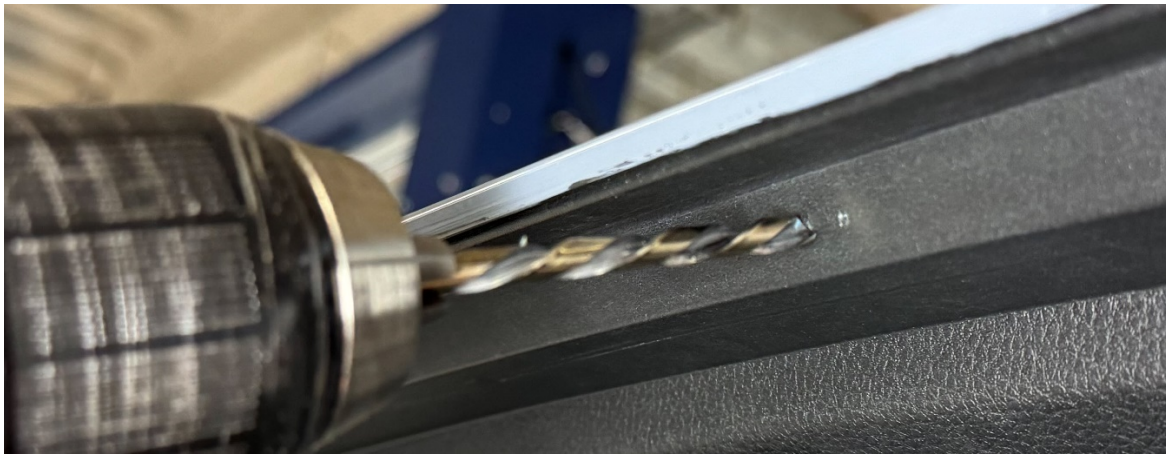
8. Using a 5 mm drill bit, drill a hole at each of the marked locations.

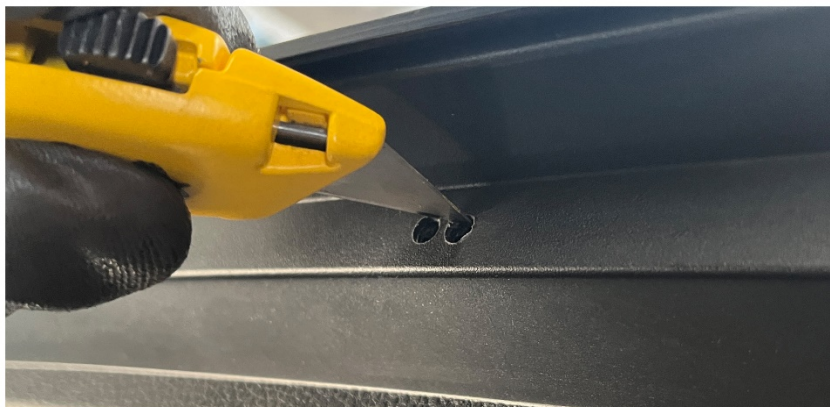
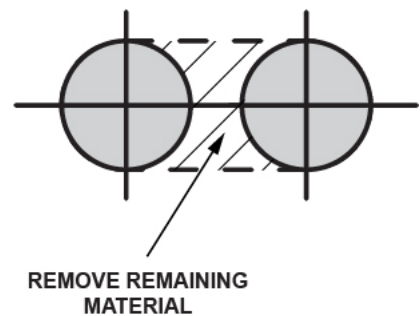
9. Use a utility knife to remove the remaining material between the two drilled holes, matching the outline on the template.

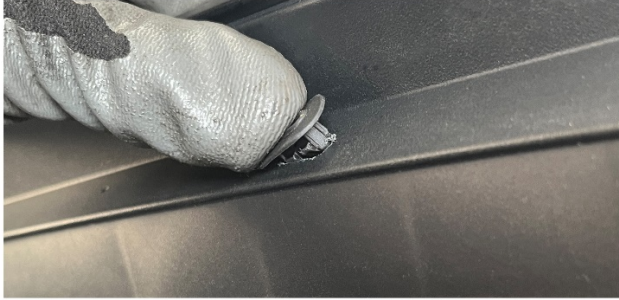
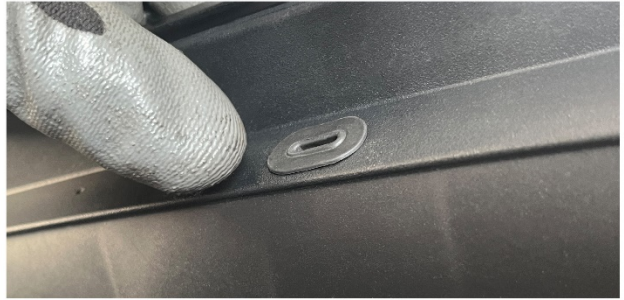
12. Install the plug by pushing until it sits flush with the panel.
